REGIONAL WATERSHED MASTER DRAINAGE PLAN

APPENDIX B DATA COLLECTION AND REVIEW

**San Jacinto Regional Watershed
Master Drainage Plan**

**Halff Associates, Inc.
TBPE Firm Registration No. 312**

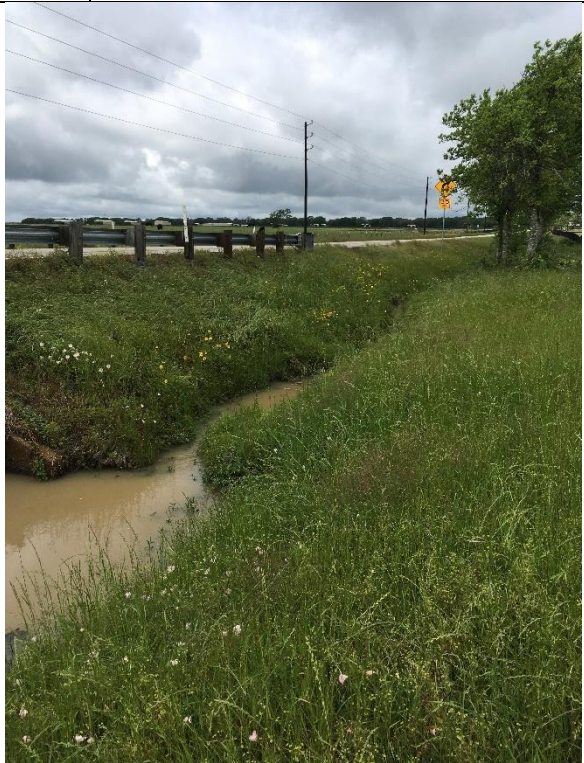
Stream: Spring Creek (J100-00-00)		Field Grid: N/A		HMS Subbasin:	
OBJECTID: 127815_a	View of channel upstream of FM 1736 between Mitchell Rd. and FM 1488.	OBJECTID: 127815_b	Face of 6' W x 5' H double barrel culvert on downstream side of FM 1736 between Mitchell Rd. and FM 1488.	 	
OBJECTID: 127815_c	View of channel upstream of FM 1736 between Mitchell Rd. and FM 1488 with noticeable bank erosion.	OBJECTID: 127816_a	Roadside ditch on upstream side of FM 1736 between Mitchell Rd. and FM 1488 with noticeable bank erosion. Facing South.

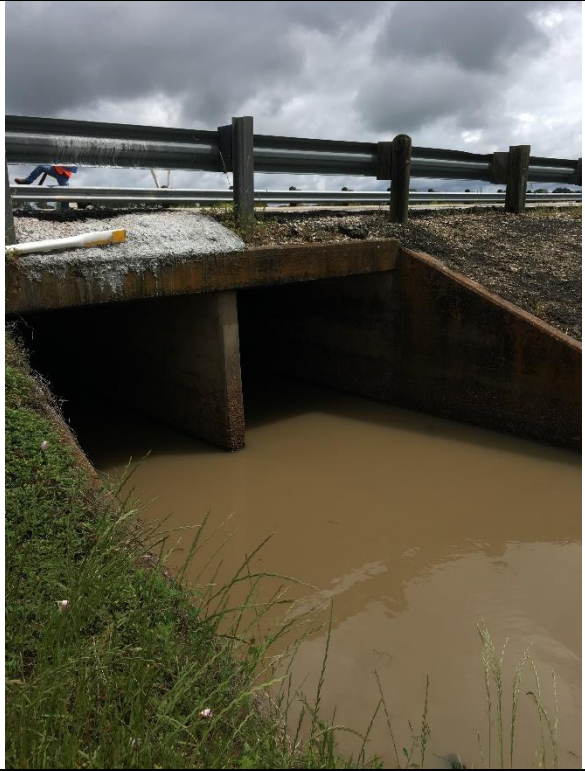
Stream: Spring Creek (J100-00-00)		Field Grid: N/A		HMS Subbasin:	
OBJECTID: 127816_b	Roadside ditch on upstream side of FM 1736 between Mitchell Rd. and FM 1488 with noticeable bank erosion. Facing North.	OBJECTID: 127816_c	View of channel upstream of FM 1736 between Mitchell Rd. and FM 1488. Large amounts of ponding in front of culvert.

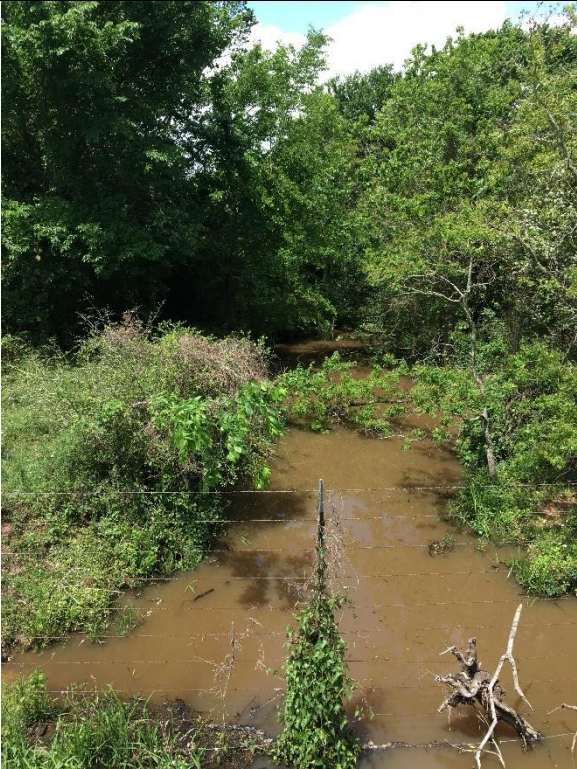
OBJECTID: 127821_a	View of channel downstream of Fields Store Rd. between Mayer Rd. and Joseph Rd. High amounts of collected debris.	OBJECTID: 127821_b	View of channel downstream of Fields Store Rd. between Mayer Rd. and Joseph Rd. High amounts of collected debris.

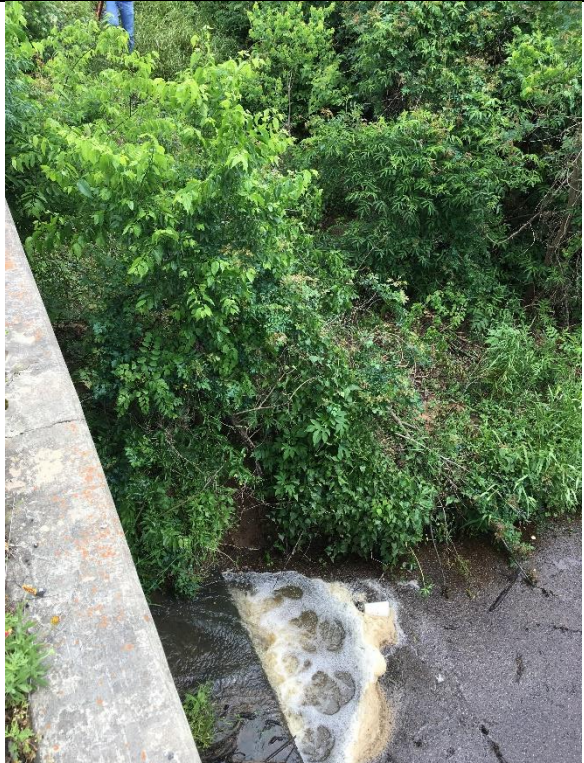
Stream: Spring Creek (J100-00-00)		Field Grid: N/A		HMS Subbasin:	
OBJECTID: 127821_c	View of channel downstream of Fields Store Rd. between Mayer Rd. and Joseph Rd. High amounts of collected debris.	OBJECTID: 127821_d	Culvert intake on upstream side of Fields Store Rd.

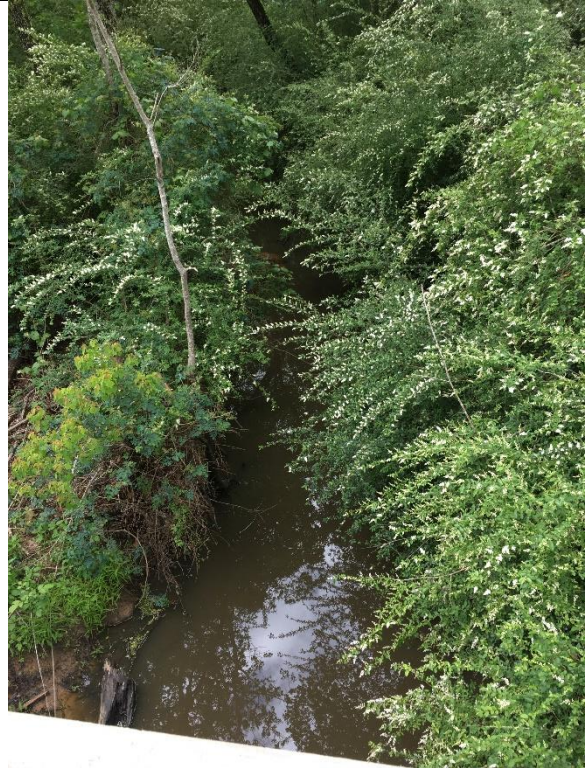
OBJECTID: 127823_b		Overgrown roadside ditch on downstream side of Kickapoo Rd. Facing North.		OBJECTID: 127823_c		Face of bridge on downstream side of Kickapoo Rd. between Joseph Rd. and Castle Rd.

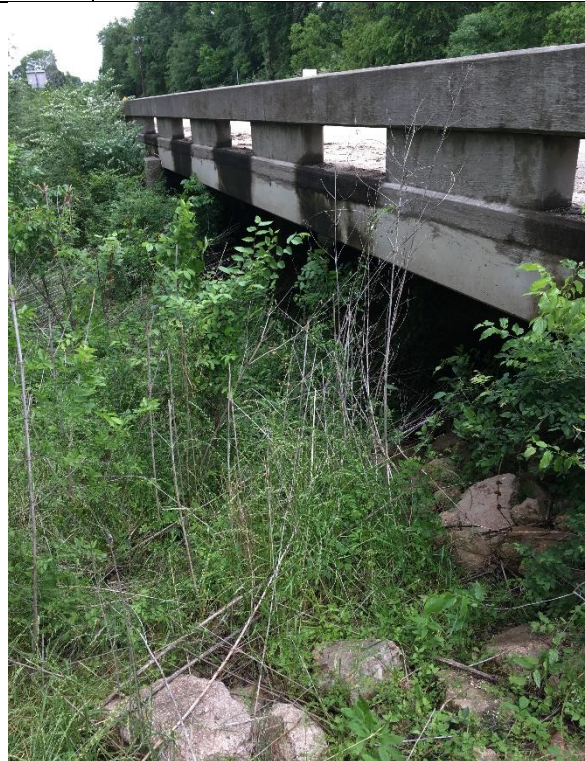
Stream: Spring Creek (J100-00-00)		Field Grid: N/A		HMS Subbasin:	
OBJECTID: 127823_d	View of channel downstream of Kickapoo Rd. between Castle Rd. and Joseph Rd. from below bridge.	OBJECTID: 127829_a	View of channel downstream of Margerstadt Rd. between Kickapoo Rd. and Hegar Rd. Defunct outfall pipe.

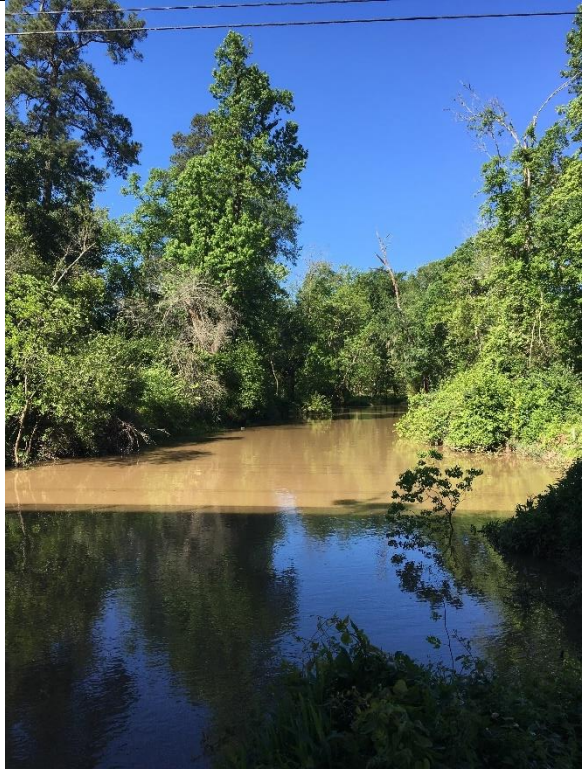
OBJECTID: 128219_b	Face of bridge on upstream of 249 between Sentinel Oaks and Zion Rd.		OBJECTID: 128219_c	Face of bridge on upstream of 249 between Sentinel Oaks and Zion Rd. Outfall culvert under construction.

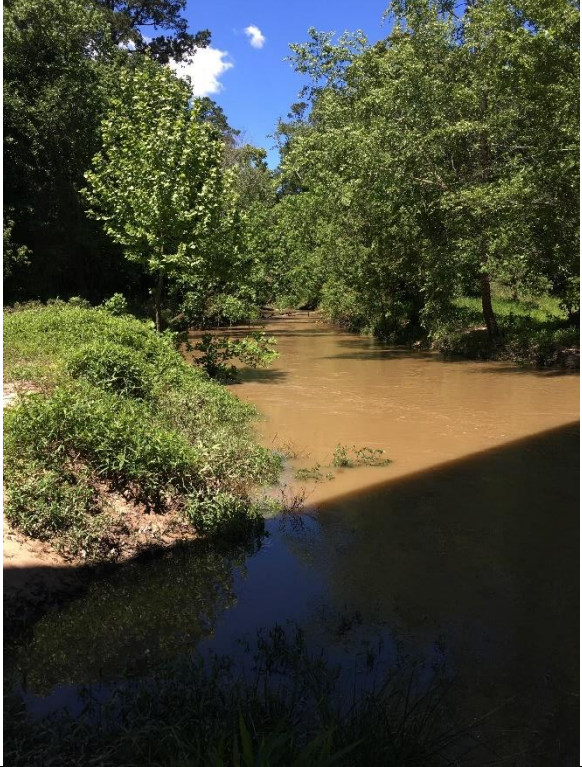
OBJECTID: 128229_b	Face of bridge on upstream side of Gosling Rd. between Flintridge Dr. and Creekside Forest Dr. Highly vegetated overbanks.	OBJECTID: 128229_c	Face of bridge on upstream side of Gosling Rd. between Flintridge Dr. and Creekside Forest Dr. Highly vegetated overbanks.

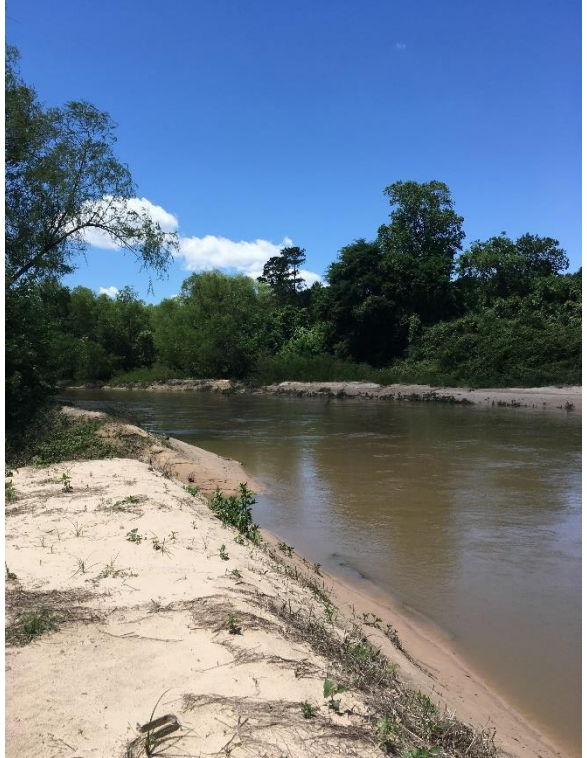
Stream: Spring Creek (J100-00-00)		Field Grid: N/A		HMS Subbasin:	
OBJECTID: 128231_c	Heavy erosion on upstream side of I-45 between Pruitt Rd. and Springwoods Village Pkwy.	OBJECTID: 128231_d	View of channel looking upstream from underneath I-45 between Pruitt Rd. and Springwoods Village Pkwy.

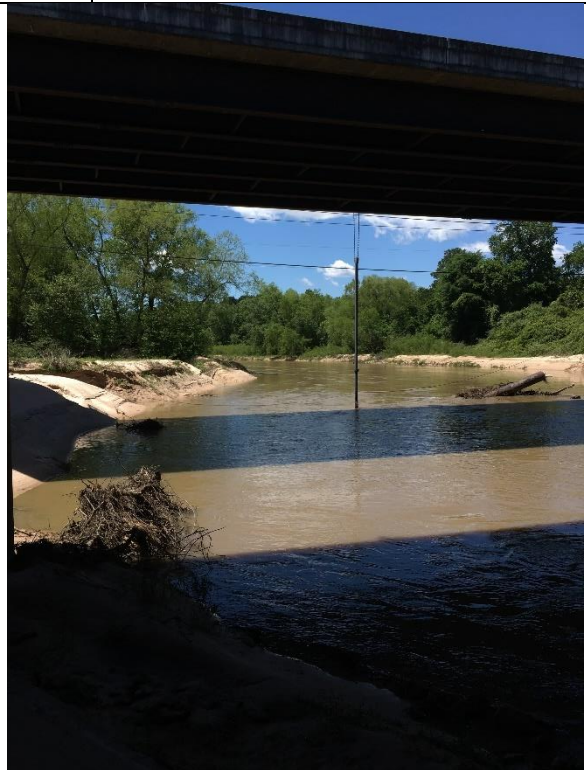
OBJECTID: 128232_a	Heavy erosion from underside of I-45 between Pruitt Rd. and Springwoods Village Pkwy.	OBJECTID: 128232_b	Evident sedimentation on abutment slopes of bridge I-45 between Pruitt Rd. and Springwoods Village Pkwy.

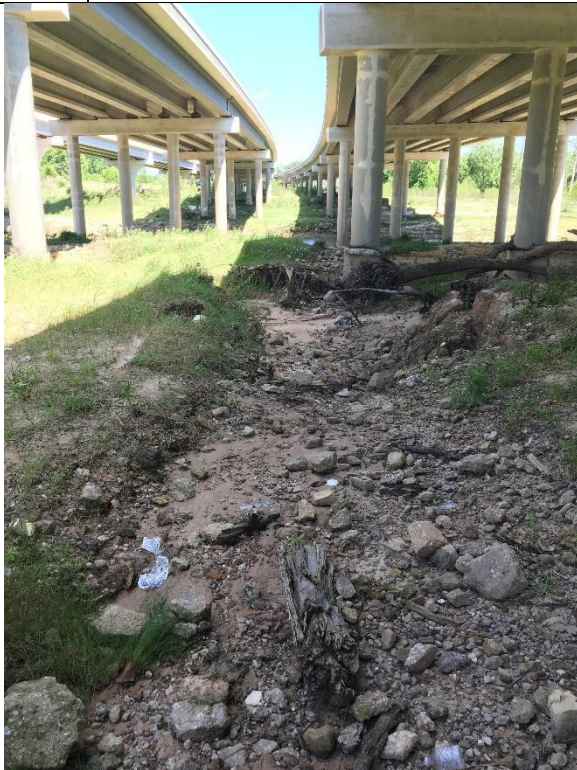
OBJECTID: 128620_b		View of channel downstream of SH-99 between Hardy Toll Rd. and Riley Fuzzell Rd. Heavy erosion on banks.		OBJECTID: 128620_c		Face of bridge on downstream side SH-99 between Hardy Toll Rd. and Riley Fuzzell Rd.

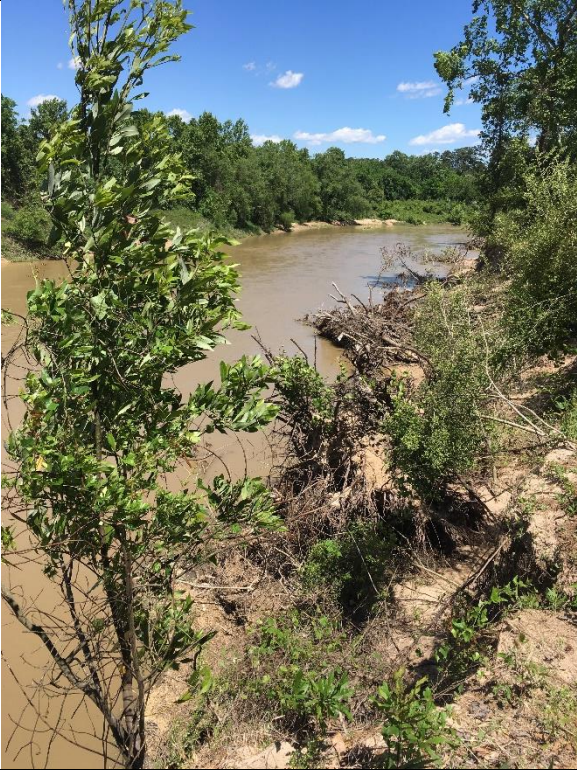
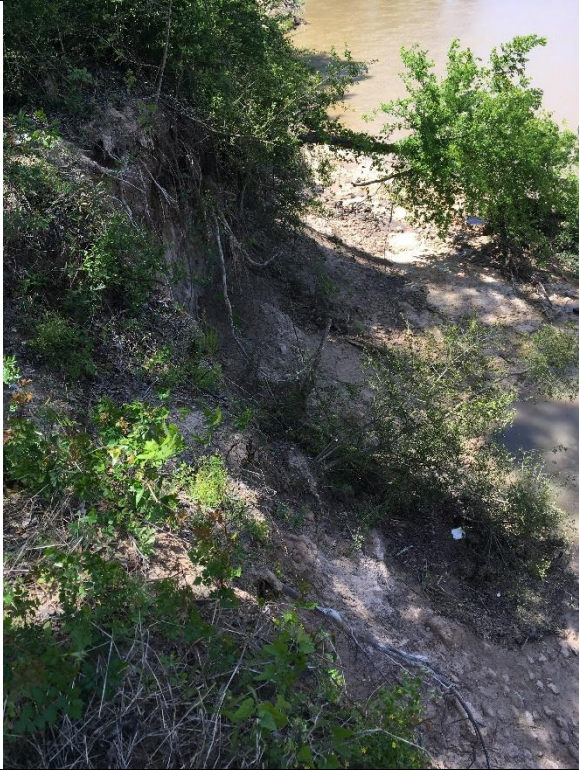
OBJECTID: 128618_a	View of channel upstream of Riley Fuzzell Rd. between Hardy Toll Rd. and SH-99. Moderate sedimentation on banks.	OBJECTID: 128618_b	Face of bridge on upstream side of Riley Fuzzell Rd. between Hardy Toll Rd. and SH-99.

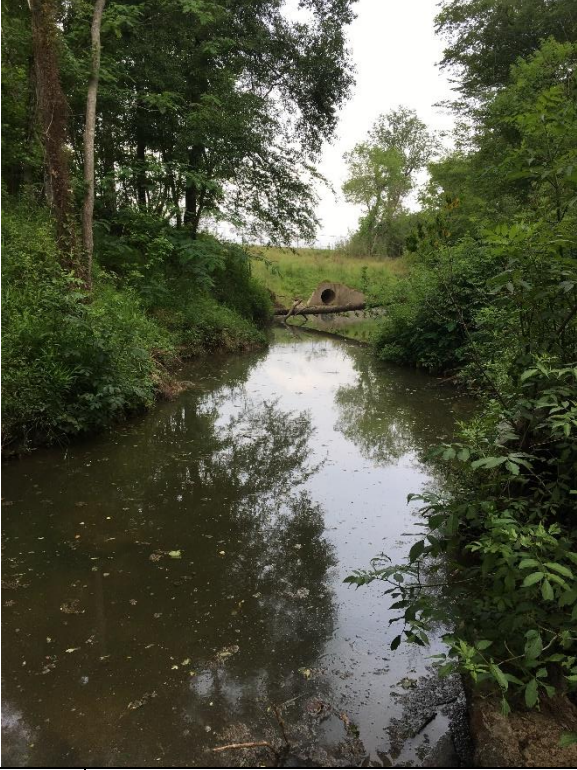
OBJECTID: 136224_d	View of channel upstream of bridge on N Diamondhead Blvd. between Port O Call St. and Yacht Ct. Substantial channel debris.	OBJECTID: 136224_e	View of upstream face of bridge on N Diamondhead Blvd. between Port O Call St. and Yacht Ct.

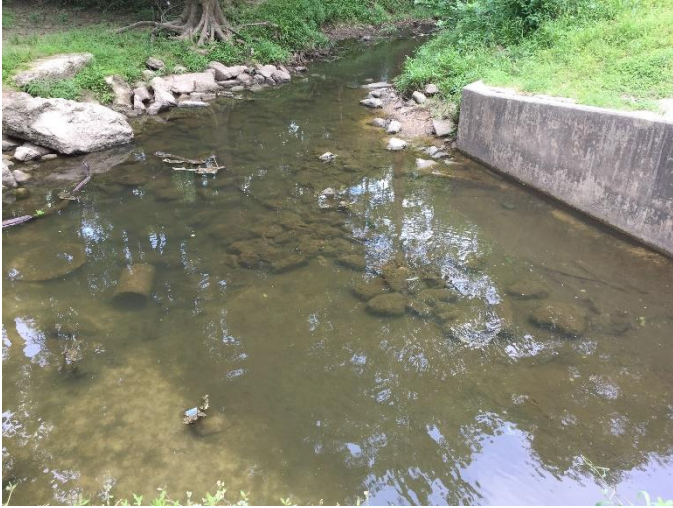
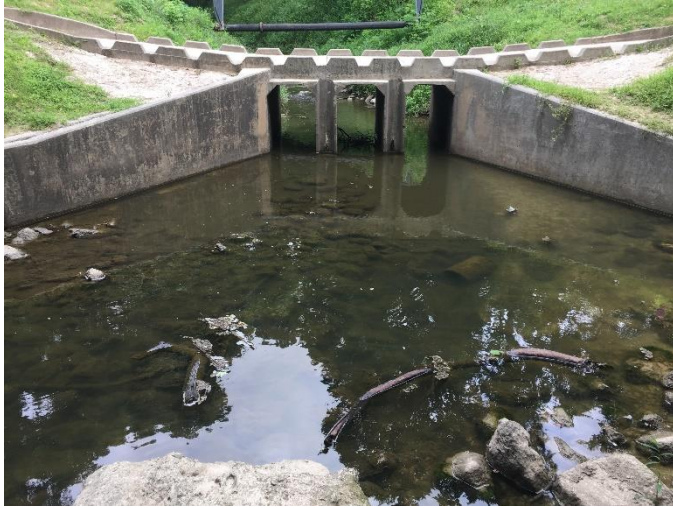
OBJECTID: 136227_c	View of channel banks downstream of culvert on Flying Bridge Way between Broken Back Dr. and Yeoman Way. Significant erosion.	OBJECTID: 136227_d	View of channel banks downstream of culvert on Flying Bridge Way between Broken Back Dr. and Yeoman Way. Significant erosion.

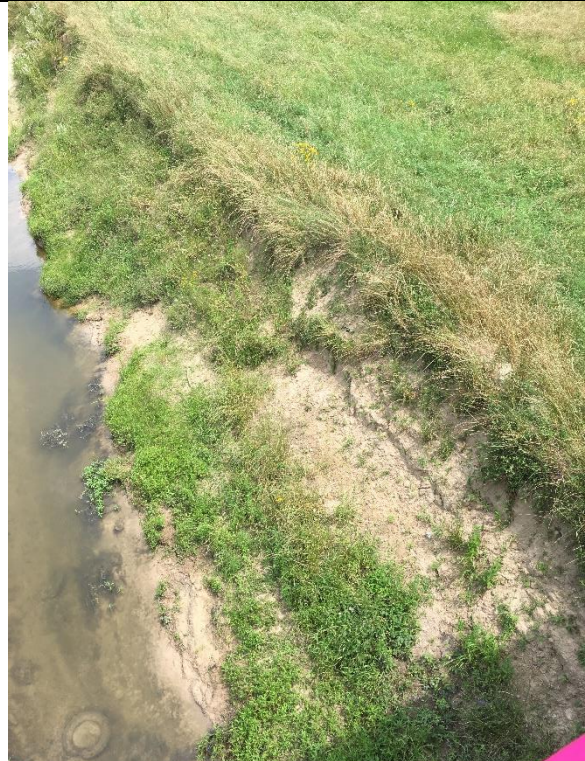
Stream: Jackson Bayou (R100-00-00)		Field Grid: N/A		HMS Subbasin:	
OBJECTID: 138631_c	View of upstream face of bridge on S Diamondhead Blvd between Golf Club Dr. and Afore Dr.	OBJECTID: 138631_d	View of channel upstream of bridge on S Diamondhead Blvd between Golf Club Dr. and Afore Dr. Evident bank erosion.

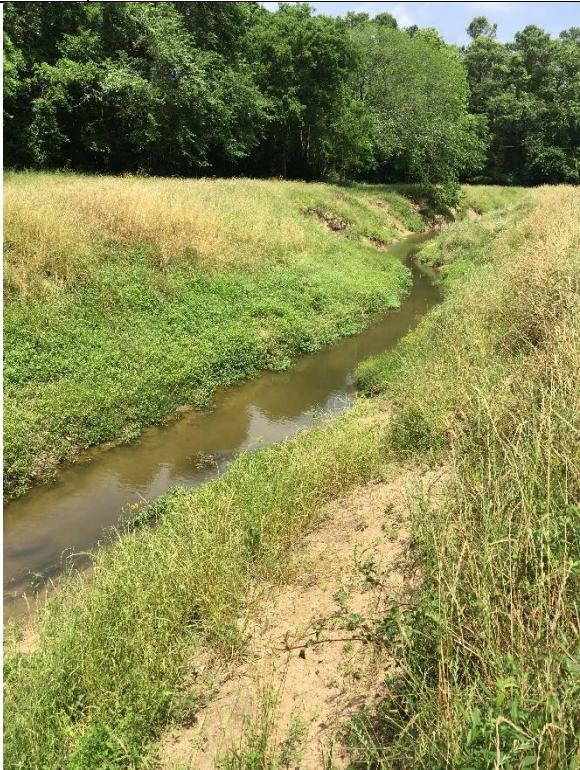
OBJECTID: 138231_a	View of channel downstream of bridge on S Diamondhead Blvd between Golf Club Dr. and Afore Dr. Evident bank erosion.	OBJECTID: 138231_b	View of downstream face of bridge on S Diamondhead Blvd between Golf Club Dr. and Afore Dr.
