REGIONAL WATERSHED MASTER DRAINAGE PLAN

APPENDIX B DATA COLLECTION AND REVIEW

**San Jacinto Regional Watershed
Master Drainage Plan**

**Halff Associates, Inc.
TBPE Firm Registration No. 312**

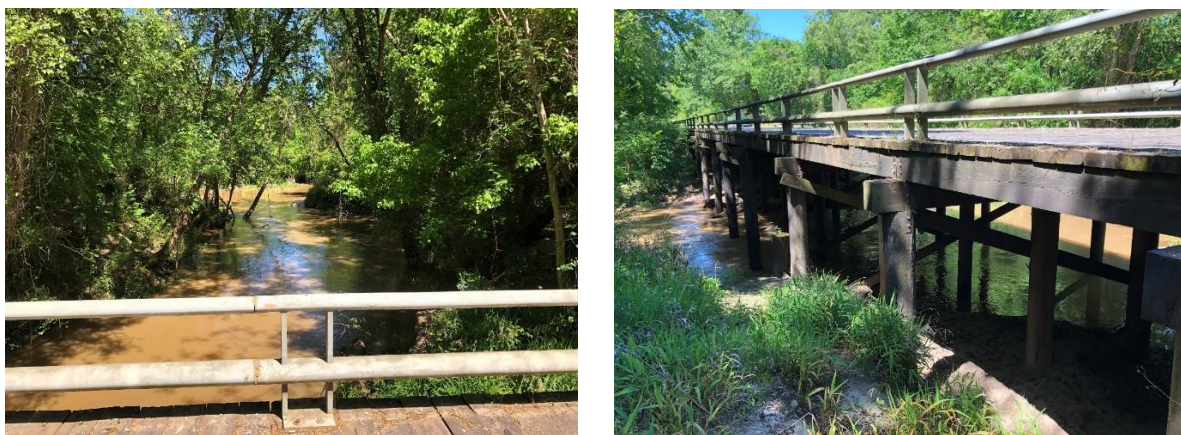
Figure 11. Structure and Channel Example Photographs

Data points were classified based on the structure type (culvert, bridge, outfall, inlet, etc.) and included notes describing the structure type, material, culvert sizes and channel conditions. **Exhibit B5** shows the location and classification of the data points collected during the field reconnaissance effort. Typical photographs taken at each structure consisted of upstream and downstream view of the channel, upstream and downstream views of the structures, and any other locations determined to be important to understanding and evaluating the streams. Photographs were linked with a specific GIS data point using the mobile Halff GIS app, which allowed for rapid documentation and organization of the data. **Figure 11** show the view of the channel and view of the structure from a wooden bridge crossing Caney Creek near Millmac Road.

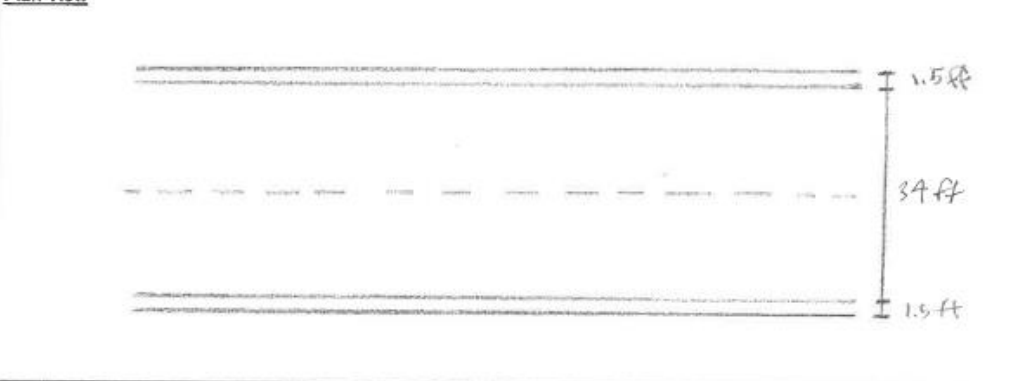
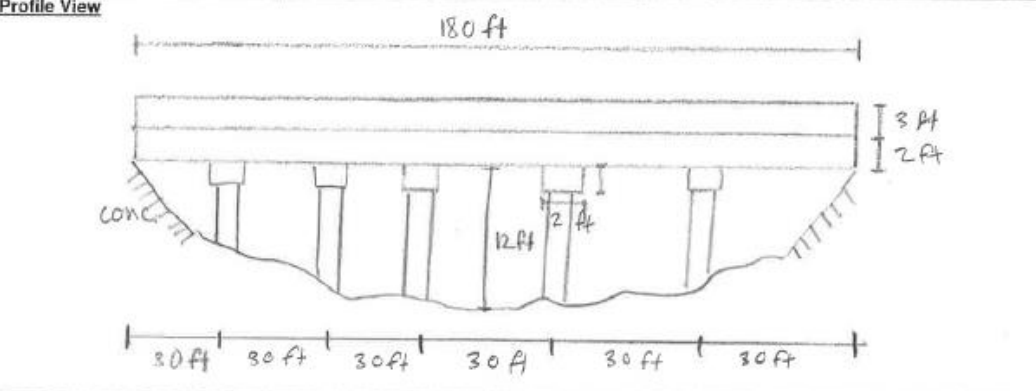
Figure 12. Survey Sketch of Lake Creek Crossing at FM 149

height of bridge deck, and the depth of the channel). A sample sketch of a bridge at the FM 149 crossing of Lake Creek is provided below as **Figure 12**.

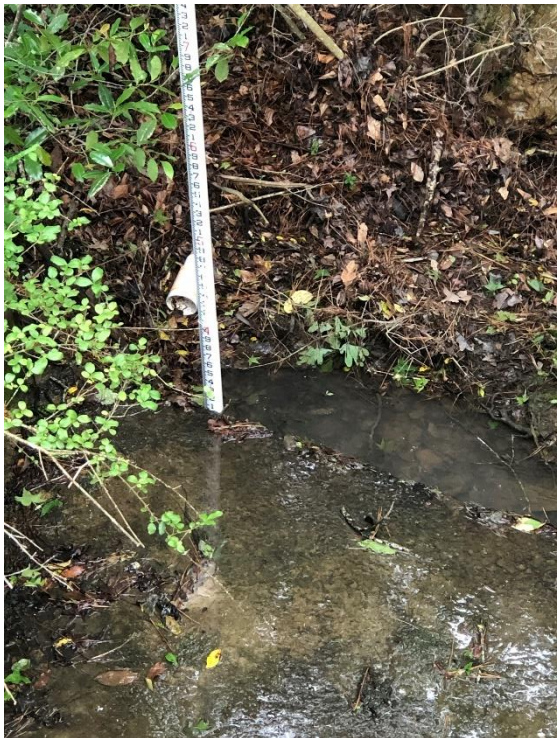
OBJECTID: 127830_c	Upstream view of Peach Creek at Jim Browder Road.	OBJECTID: 127830_d	3.0 feet of erosion on the downstream side of the culvert at Jim Browder Road.

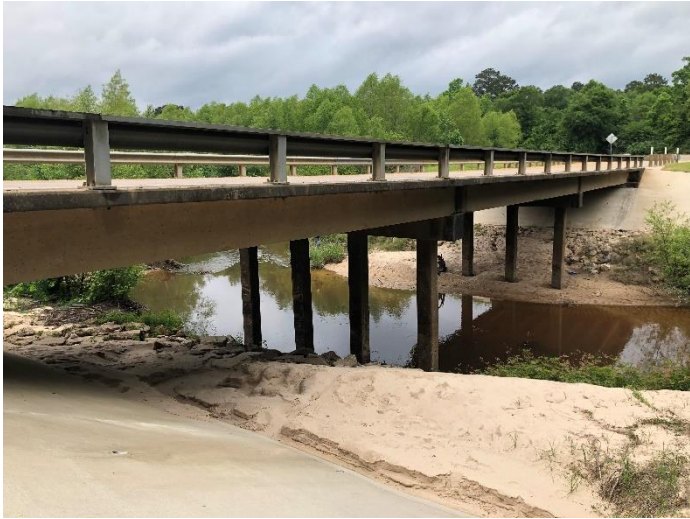
Stream: Peach Creek (GPC)		Field Grid: N/A		HMS Subbasin:	
OBJECTID: 132613_	Downstream view of Caney Creek.	OBJECTID: 132614_a	Face of bridge on upstream side of Creekwood Drive. Sandy overbanks. Light vegetation.

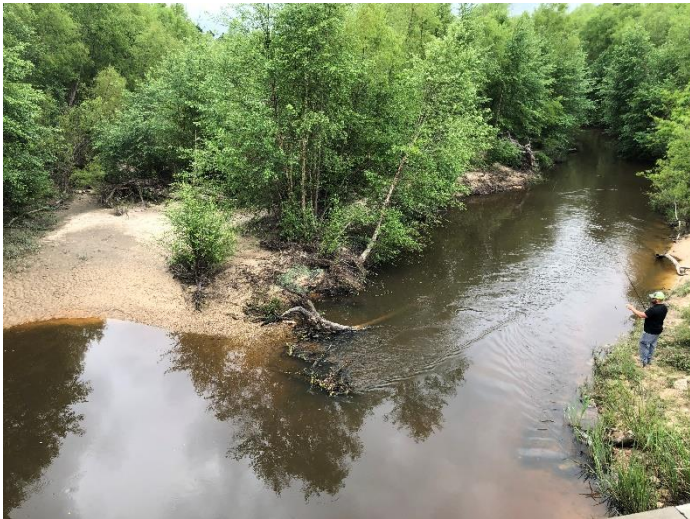
OBJECTID: 132614_b	Upstream view of Caney Creek from the bridge of Creekwood Drive.	OBJECTID: 132614_c	Downstream view of Caney Creek. Moderate vegetation.

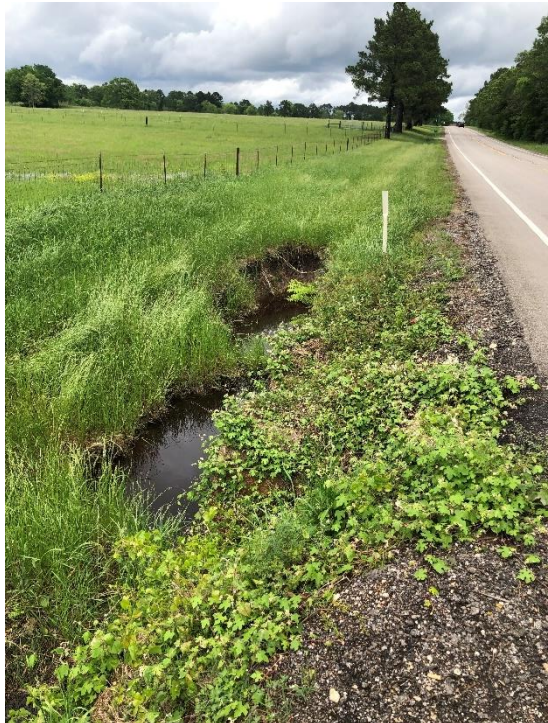
OBJECTID: 127825_c	Erosion to the east of the culvert on the upstream side at FM 1375.	OBJECTID: 127825_d	Erosion to the west of the culvert on the upstream side at FM 1375.

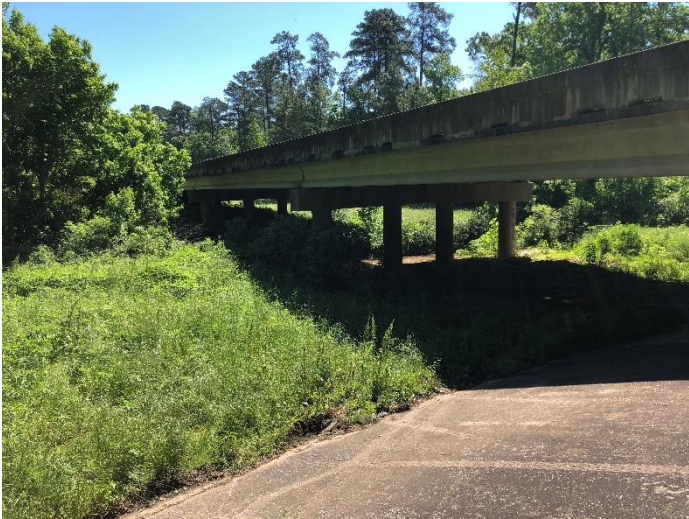
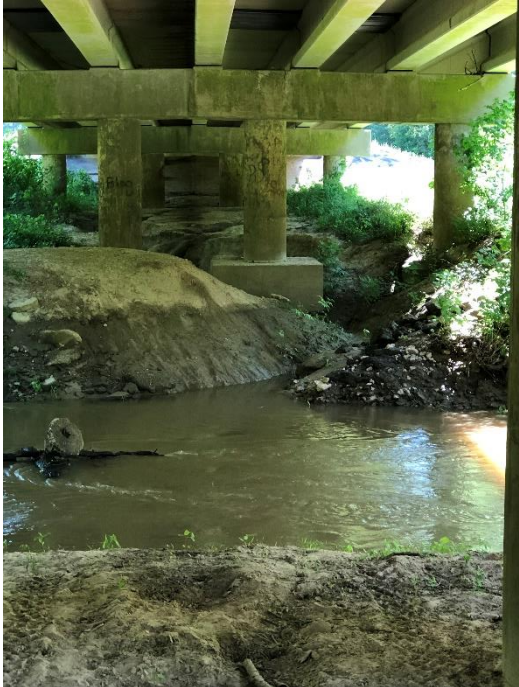
Stream: Caney Creek (GCC)		Field Grid: N/A		HMS Subbasin:	
OBJECTID: 128221_c	Downstream view of Caney Creek.	OBJECTID: 128221_d	Face of bridge on downstream side of FM 1484. Moderate vegetation.

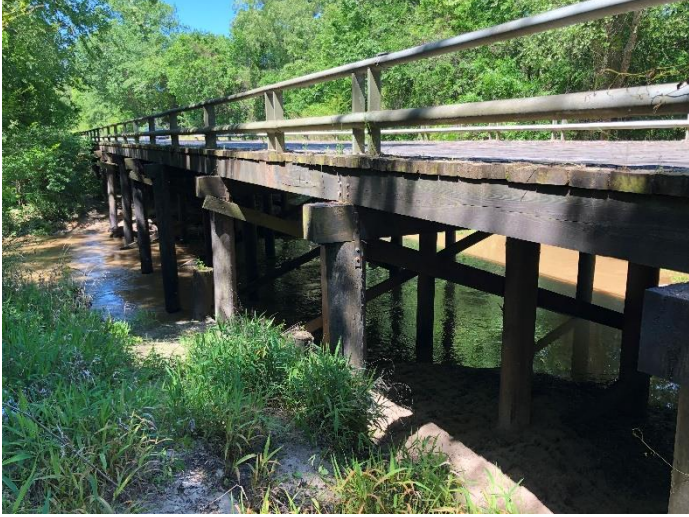
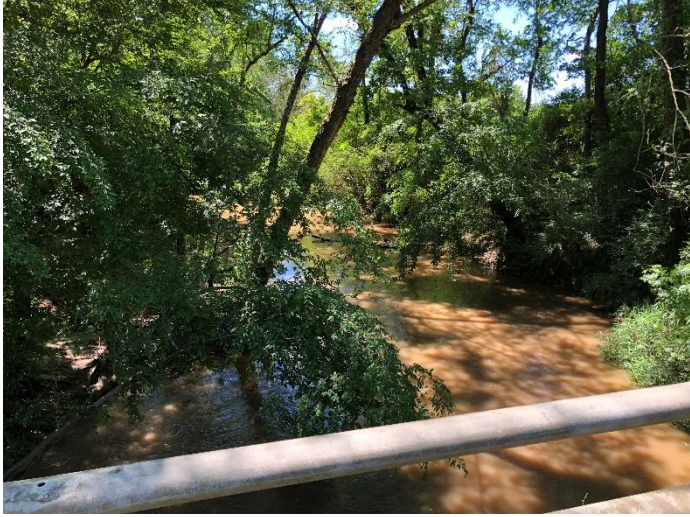
OBJECTID: 128227_a	Right overbank face of the bridge over SH 105.	OBJECTID: 128227_b	Downstream view of Caney Creek from the bridge at SH 105.

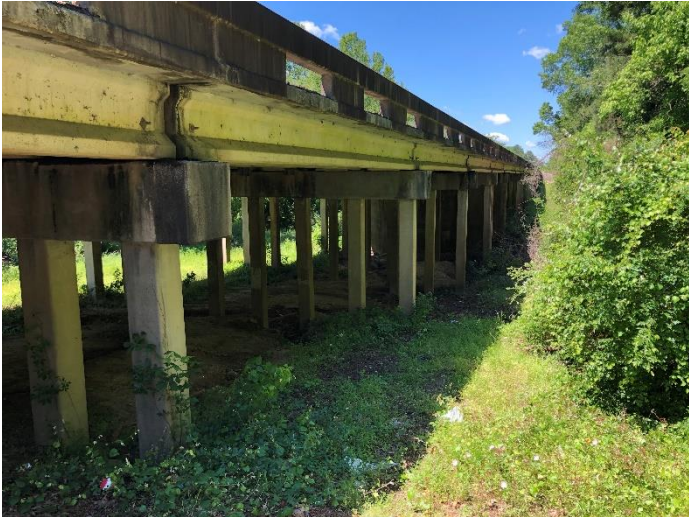
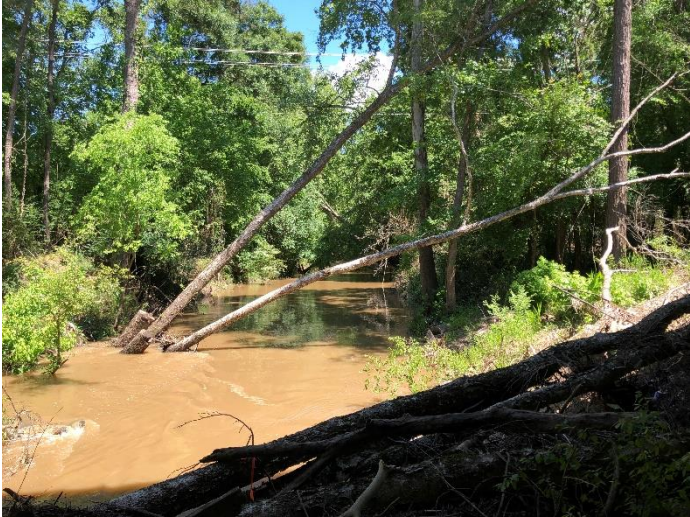
Stream: Caney Creek (GCC)		Field Grid: N/A		HMS Subbasin:	
OBJECTID: 128227_c	Upstream face of the bridge at SH 105.	OBJECTID: 128227_d	Upstream view of Caney Creek at SH 105.

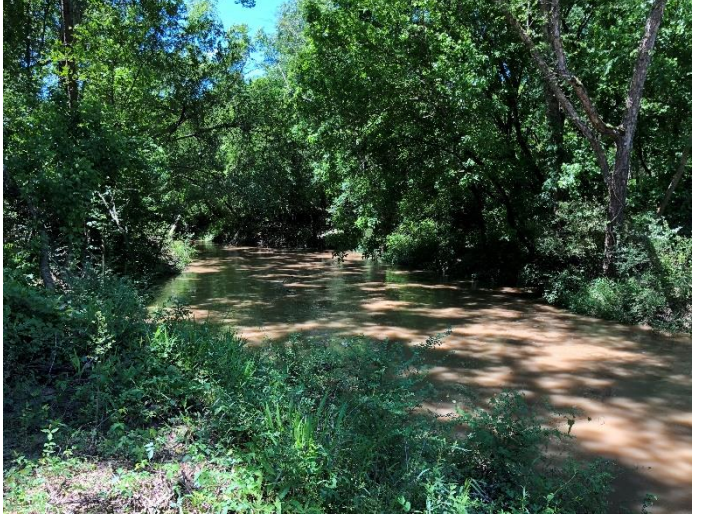
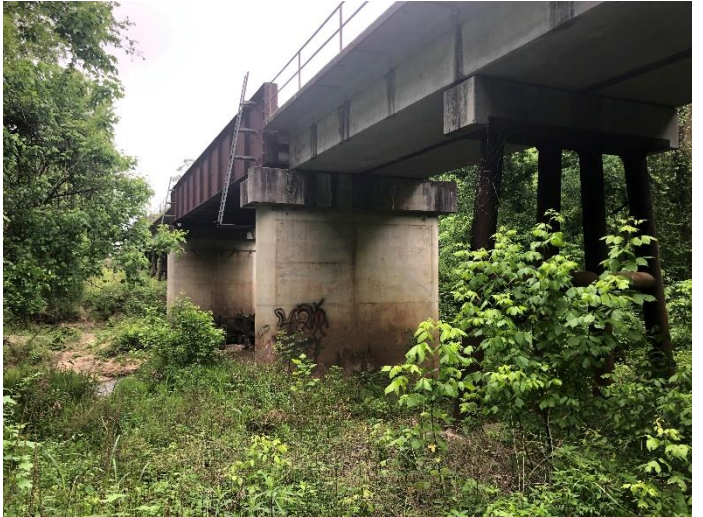
OBJECTID: 128227_e	Left overbank view of bridge at SH 105. Moderate vegetation.	OBJECTID: 131013_a	Face of railroad bridge near Crockett Martin Road.

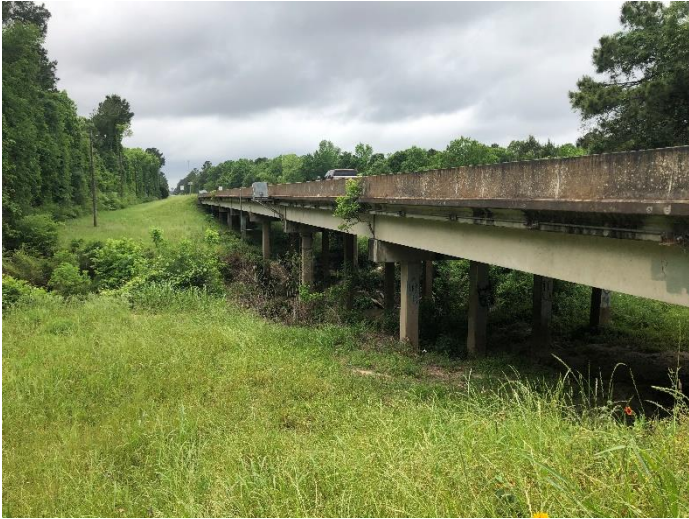
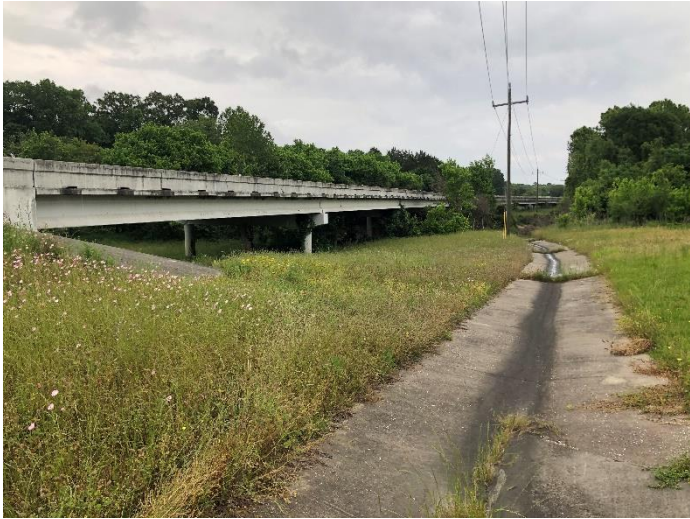
OBJECTID: 131022_b	View of erosion on downstream side of the bridge crossing at TX-242.	OBJECTID: 131022_c	Face of bridge on downstream side of TX-242.

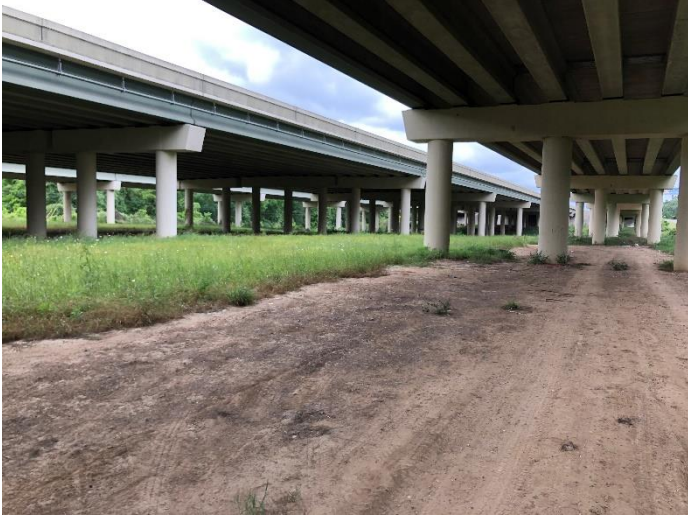
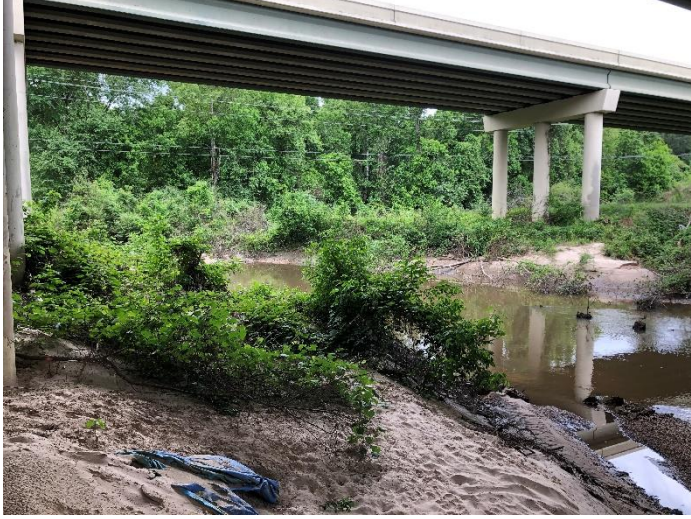
OBJECTID: 131415_c	Downstream view of Caney Creek at the US-59 crossing.	OBJECTID: 131415_d	View of erosion under the middle bridge crossing at US-59.

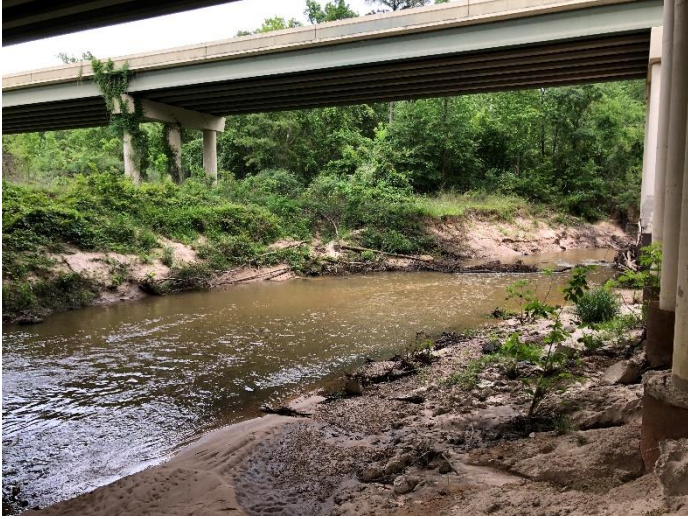
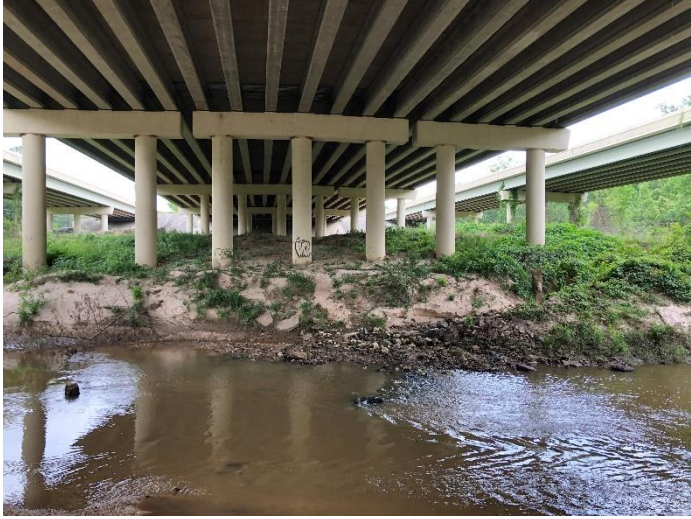
Stream: Caney Creek (GCC)		Field Grid: N/A		HMS Subbasin:	
OBJECTID: 131416_a	Upstream view of bridge at County Line Road crossing.	OBJECTID: 131416_b	View of the bridge under TX-494. Moderate vegetation.

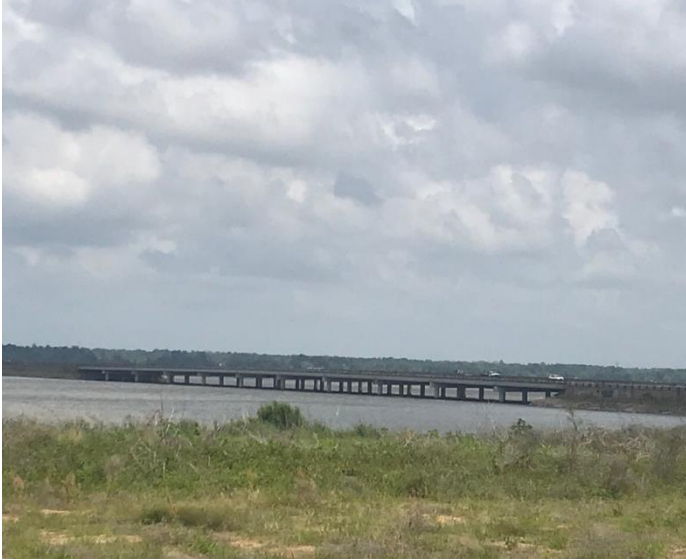
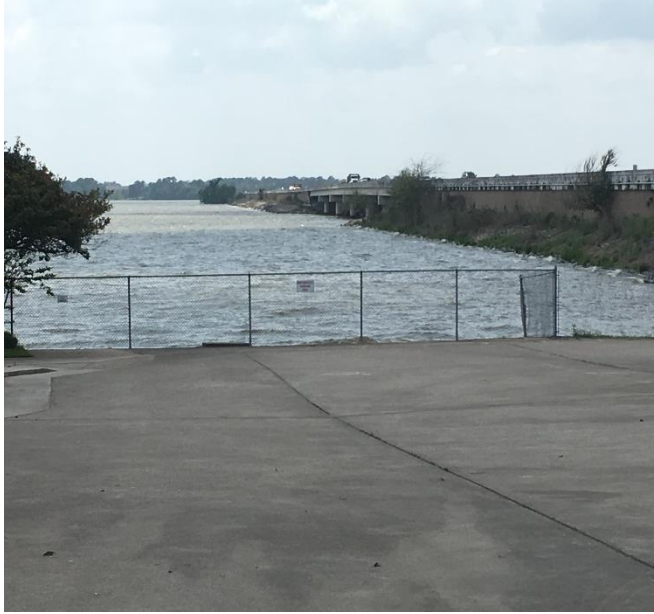
OBJECTID: 42	Bank protection on the north side of FM 1960	OBJECTID: 49	Bank protection on the south side of FM 1960

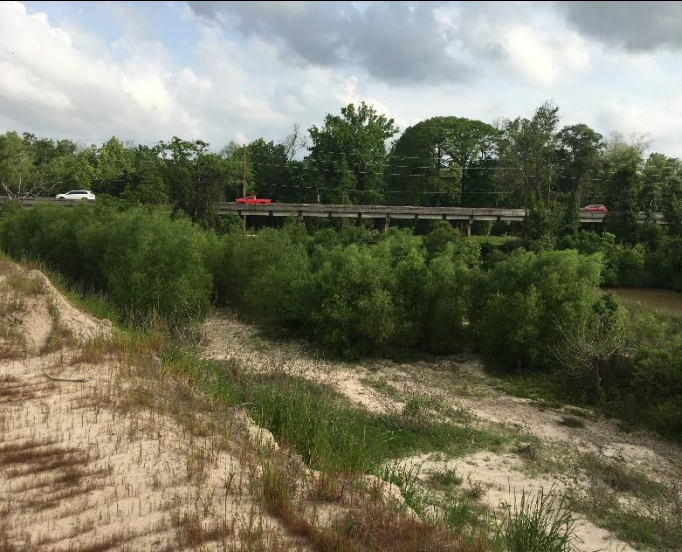
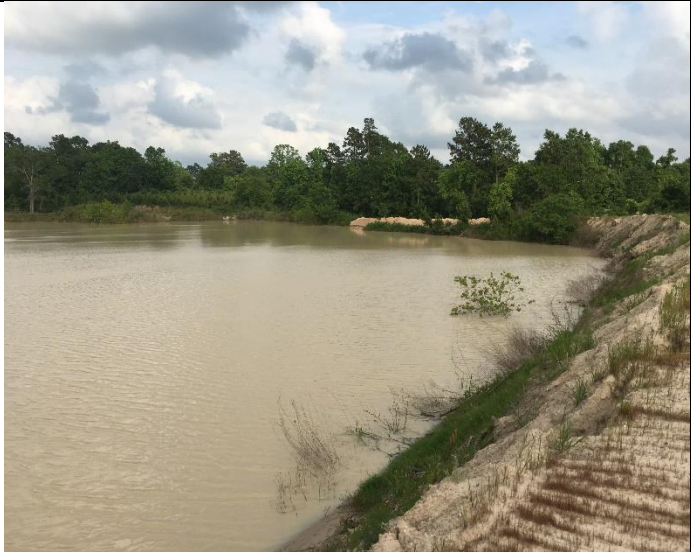
OBJECTID: 37	Facing upstream end of bridge at FM 2090.	OBJECTID: 35	Water northeast of the channel crossing.

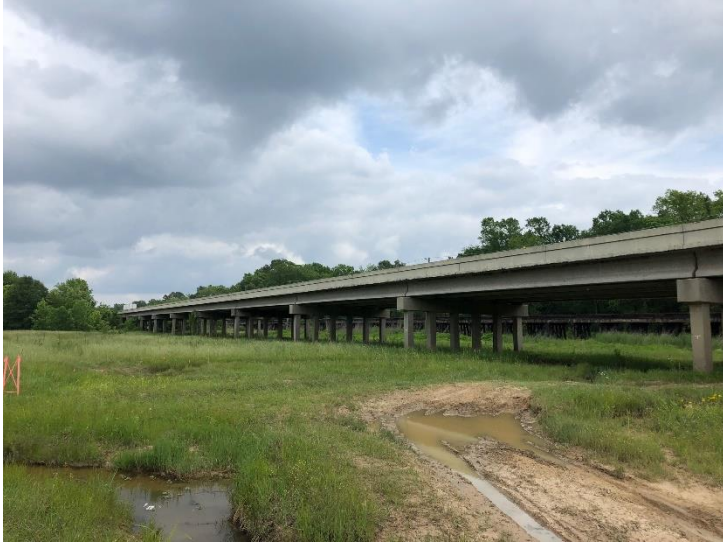
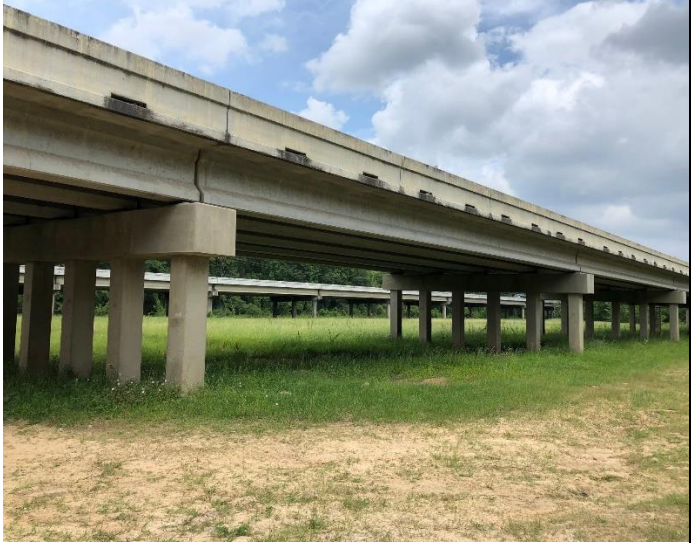
Stream: GEF_100		Field Grid: EF-5	HMS Subbasin:
OBJECTID: 90	Upstream bridge face at US 59.	OBJECTID: 91	Downstream bridge face at US 59.

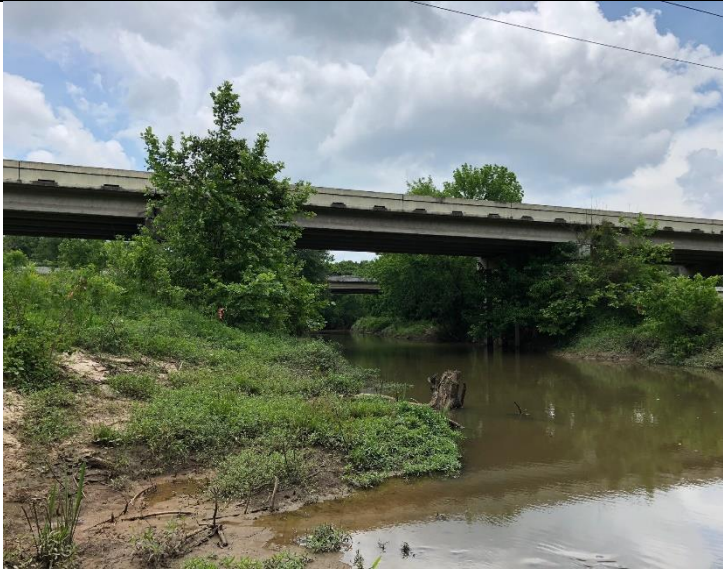
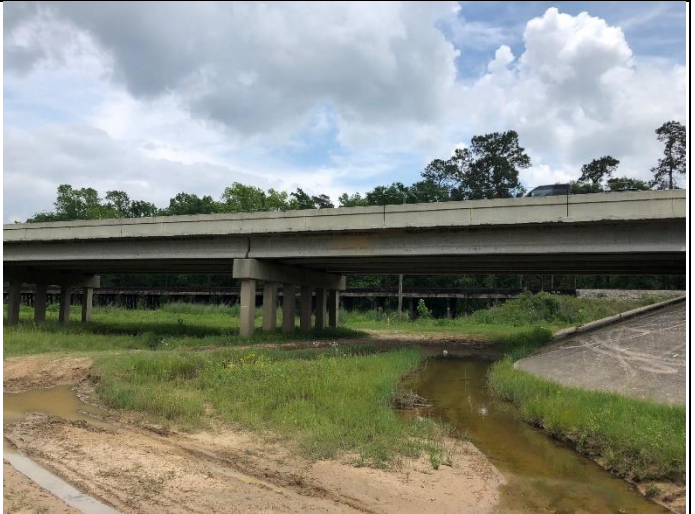
OBJECTID: 83	Channel at US 59 from downstream end facing the bridge crossing.	OBJECTID: 89	Upstream face of bridge with abutment.

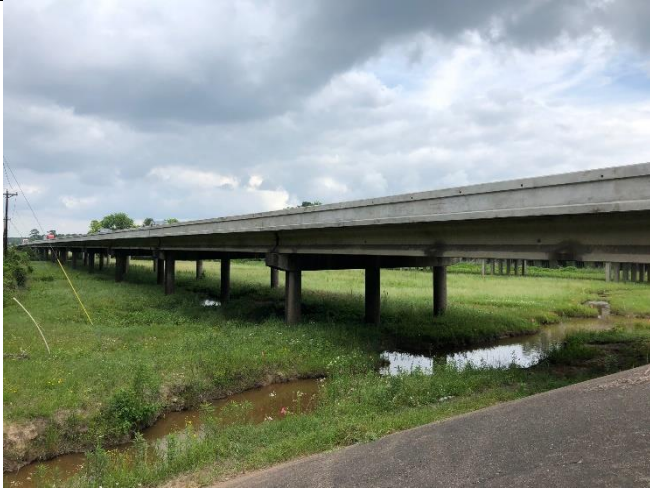
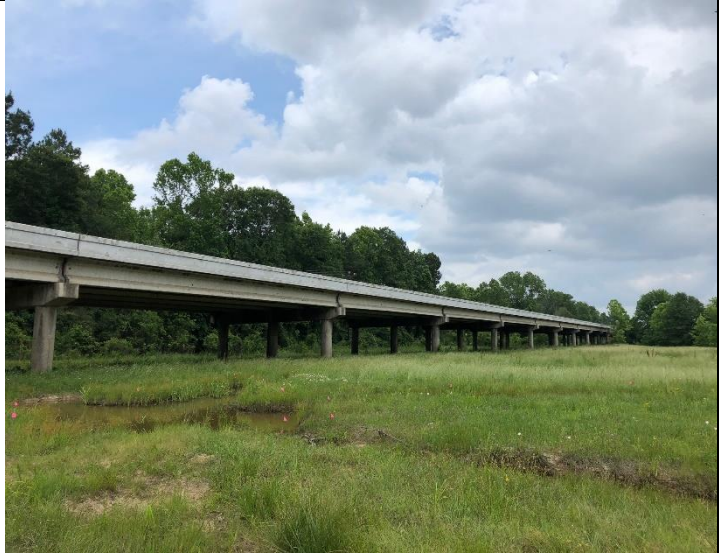
Stream: GEF_100		Field Grid: EF-6		HMS Subbasin: Q100E, Q100F1	
OBJECTID: 94		Channel upstream US 59.		OBJECTID: 96

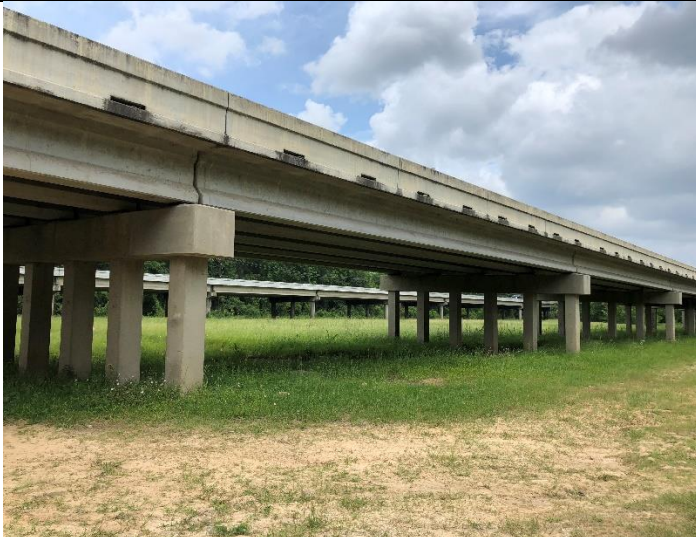
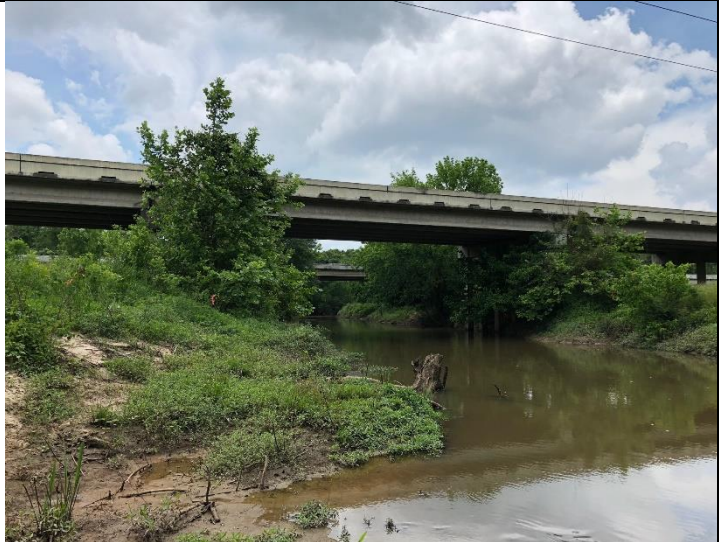
OBJECTID:		Upstream face of the bridge at US 59.		OBJECTID: 83

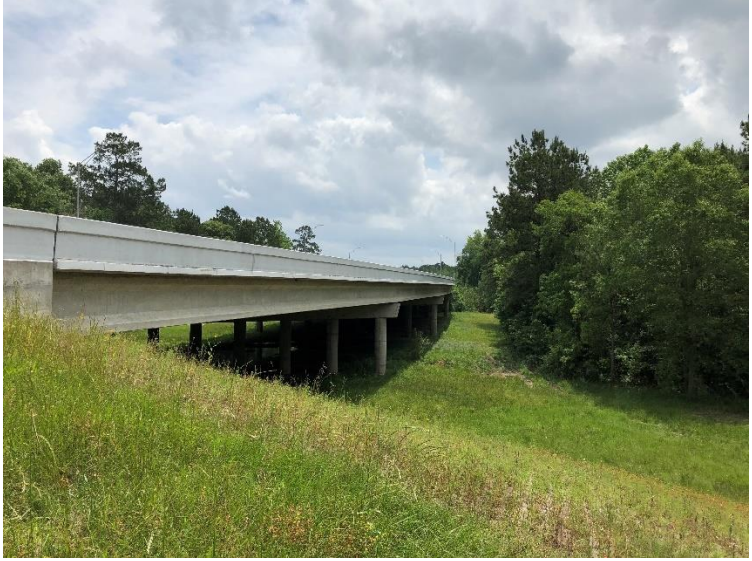
Stream: GEF_100		Field Grid: EF-7		HMS Subbasin:	
OBJECTID: 104	Upstream face of bridge on north west side of TX-105.	OBJECTID: 102	Downstream face of bridge on north west side of TX-105.

OBJECTID: 106	Upstream face of bridge on east side of TX-105.	OBJECTID: 108	Channel upstream of TX-105.

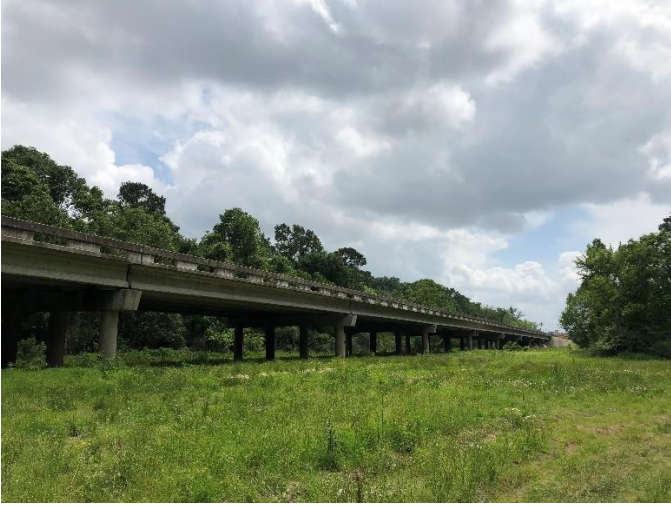
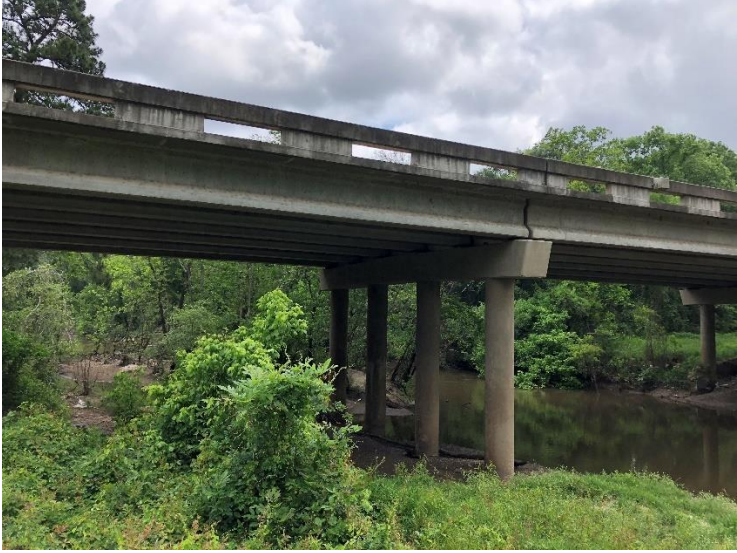
Stream: GEF_100		Field Grid: EF-8	HMS Subbasin:
OBJECTID: 113	Downstream face of the crossing.	OBJECTID: 116	Main channel under the bridge crossing.

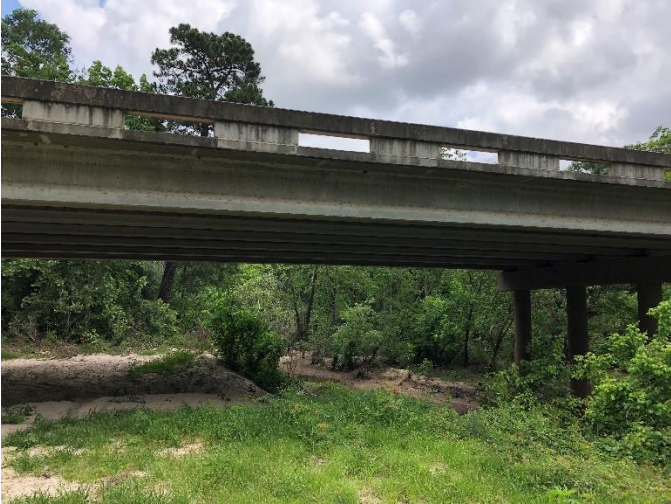
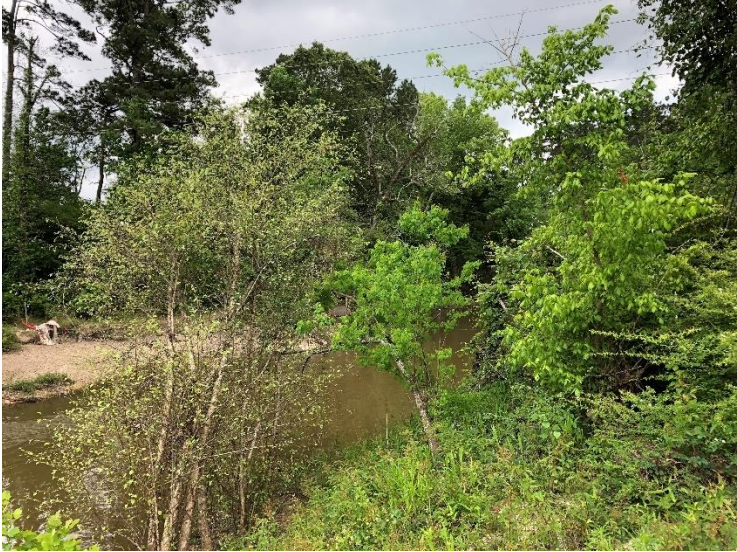
OBJECTID: 114	Facing upstream channel from the downstream end.	OBJECTID: 118	Channel downstream of TX-105.

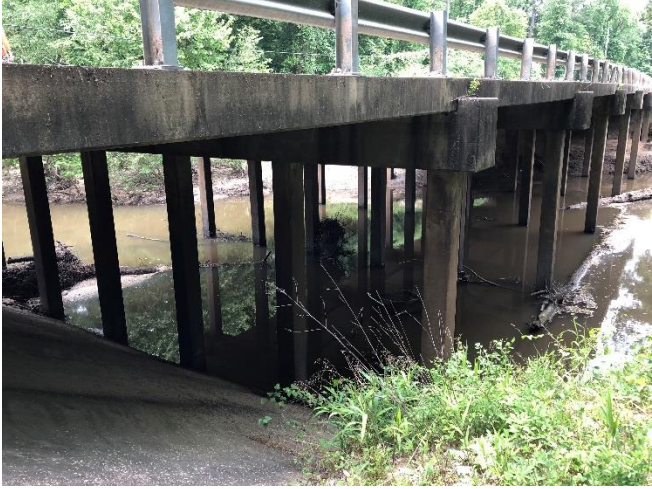
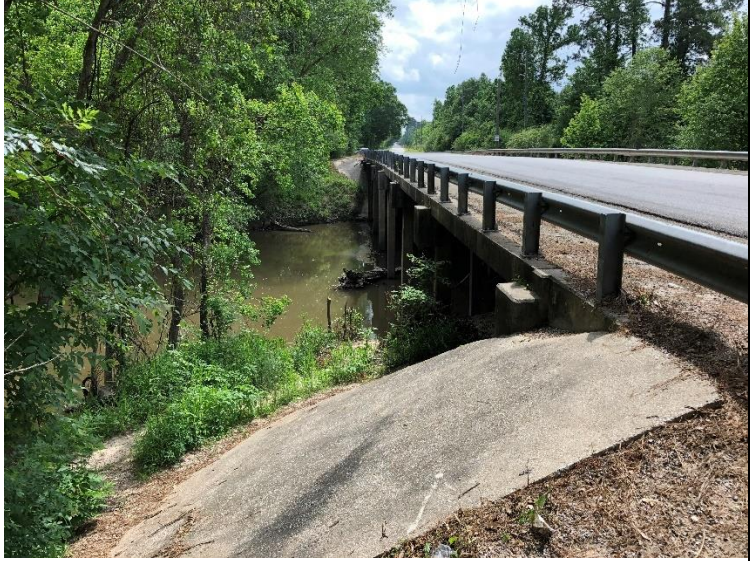
Stream: GEF_100		Field Grid: EF-10	HMS Subbasin:
OBJECTID: 3	Crossing at the main channel.	OBJECTID: 4	Upstream face of crossing at CR 388.

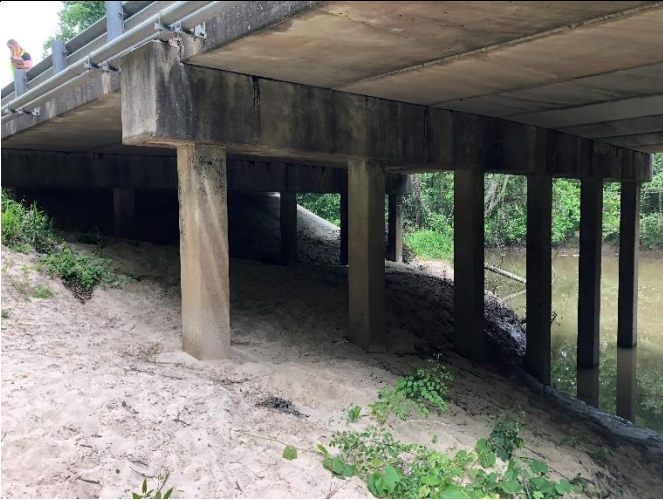
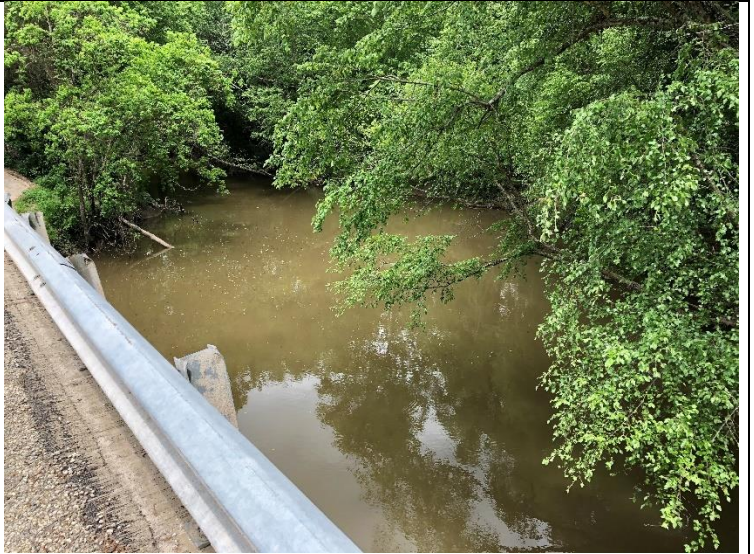
OBJECTID: 7	Sediment buildup on downstream side of the crossing.	OBJECTID: 11	Channel upstream of CR 388.

Channel Depth: _____ Additional Info: Very sandy channel, lots of debris, DS right lots of sediment buildup

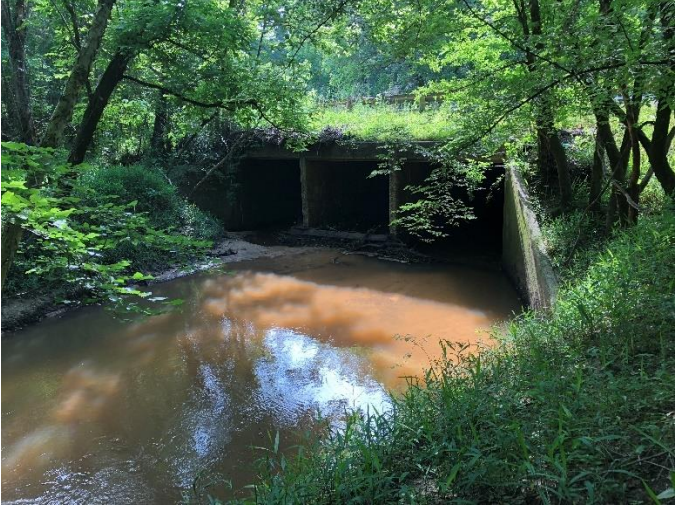
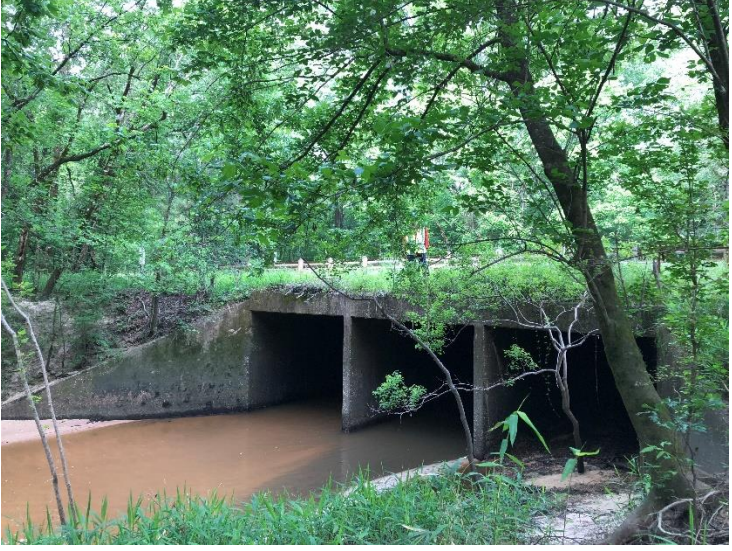
Stream: GEF_100		Field Grid: EF-15	HMS Subbasin:
OBJECTID: 15	Upstream face of crossing at Lower Vann Rd.	OBJECTID: 18	Downstream face of crossing at Lower Vann Rd.

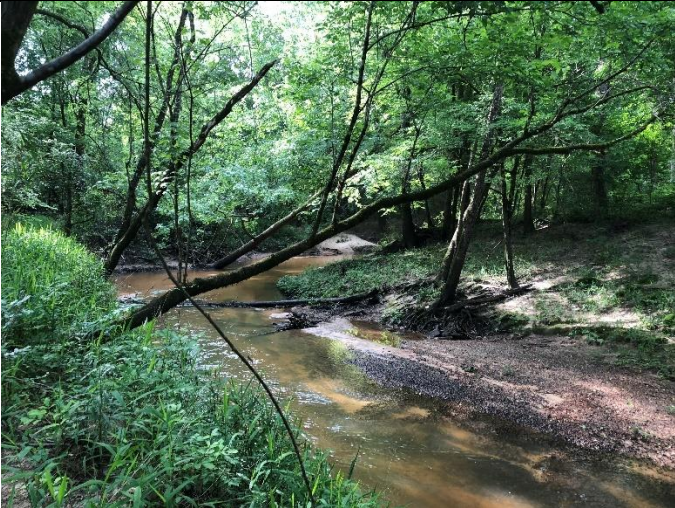
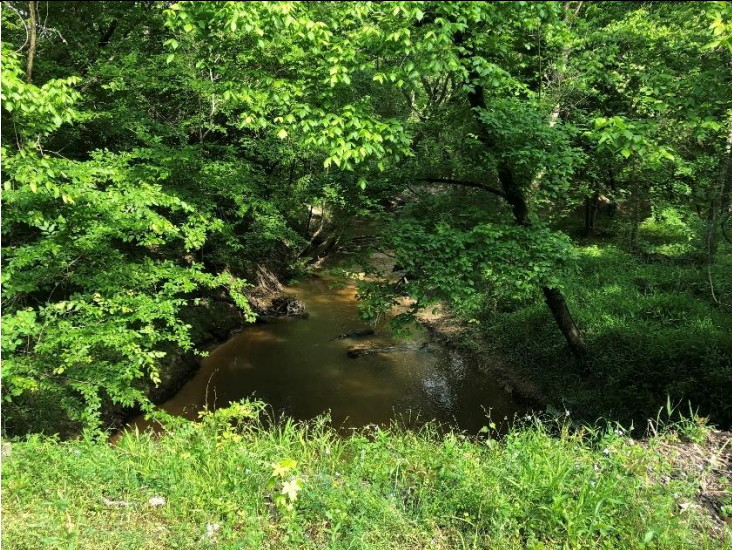
OBJECTID: 20	Channel downstream of Lower Vann Rd.	OBJECTID: 14	Channel upstream of Lower Vann Rd.

Channel Depth: _____ Additional Info: Channel sandy, some debris is
blocking opening

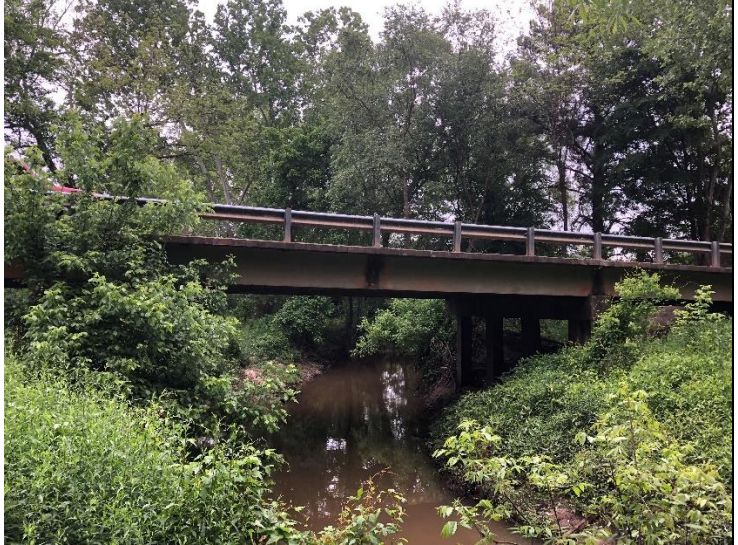
Stream: GEF_100		Field Grid: EF-16	HMS Subbasin:
OBJECTID: 22	Upstream face of crossing at S Butch Arthur Rd.	OBJECTID: 27	Downstream face of crossing at S Butch Arthur Rd.

OBJECTID: 25	Main channel facing downstream of the crossing.	OBJECTID: 23	Channel upstream of S Butch Arthur Rd.

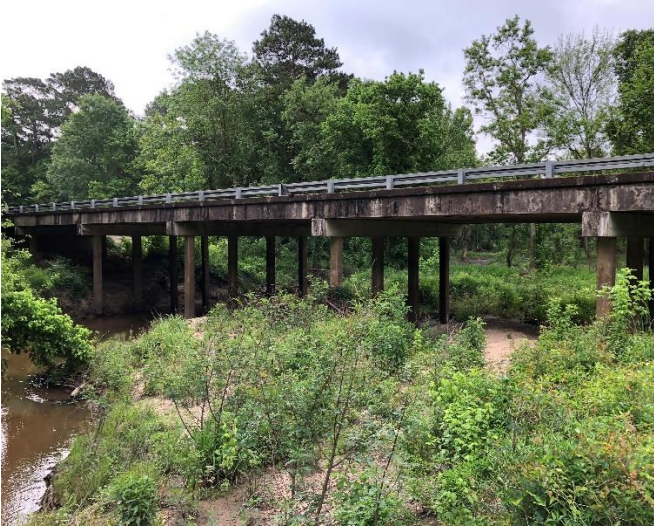
Stream: GEF_100		Field Grid: EF-17	HMS Subbasin:
OBJECTID: 35	Upstream face of crossing at TX-150	OBJECTID: 39	Downstream face of crossing at TX-150.

OBJECTID: 38	Sediment buildup on the west side on the crossing.	OBJECTID: 41	Main channel under the crossing.

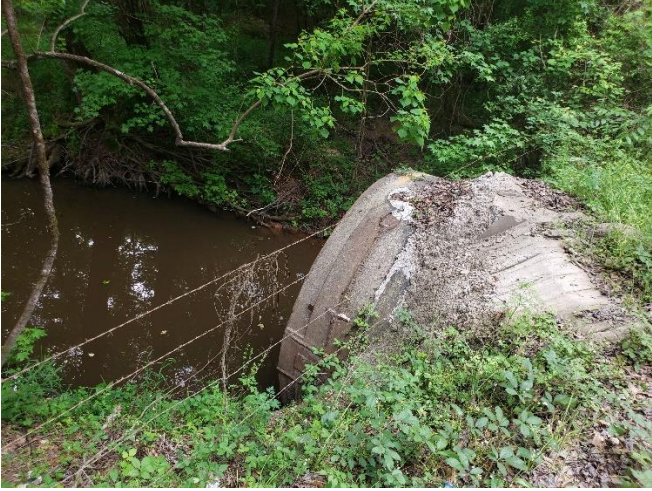
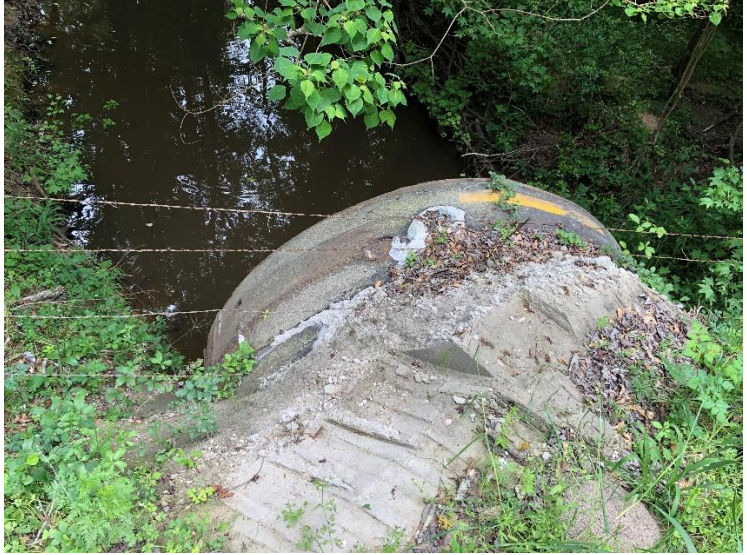
Stream: GEF_100		Field Grid: EF-27	HMS Subbasin:
OBJECTID: 236	Upstream face of crossing at Stanley Rd.	OBJECTID: 227	Downstream face of crossing at Stanley Rd.

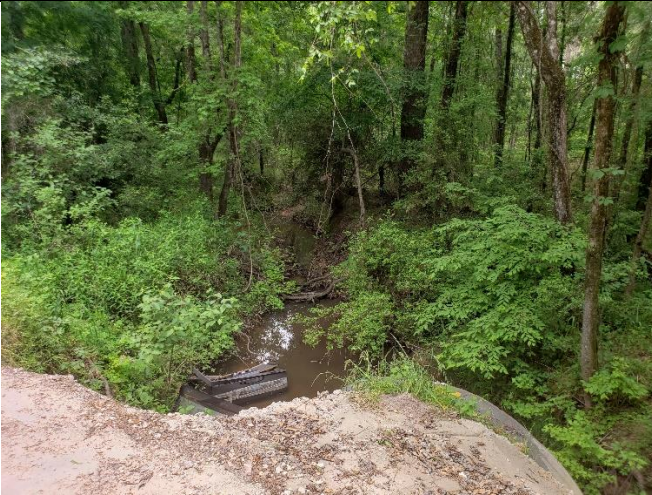
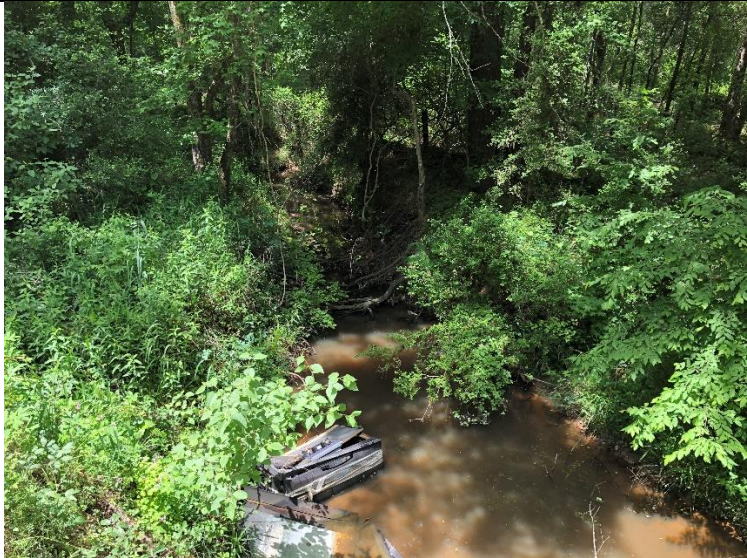
OBJECTID: 128	Channel downstream of crossing.	OBJECTID: 233	Channel upstream of crossing.

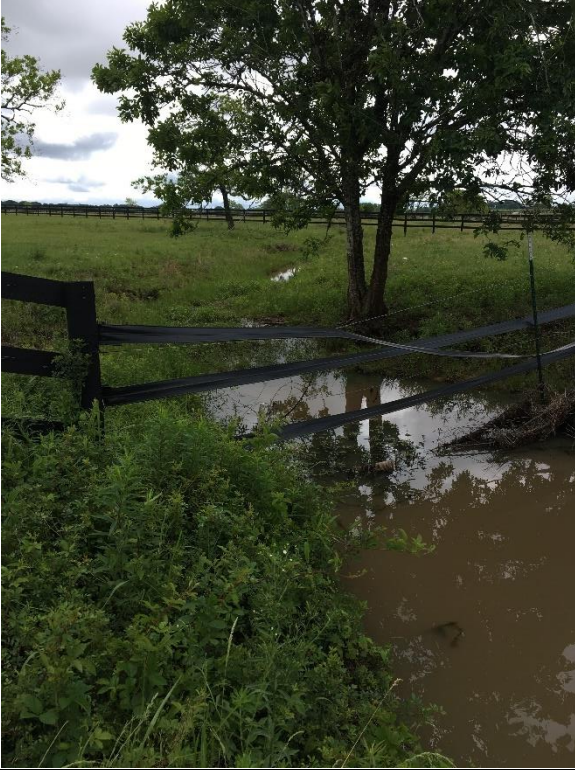
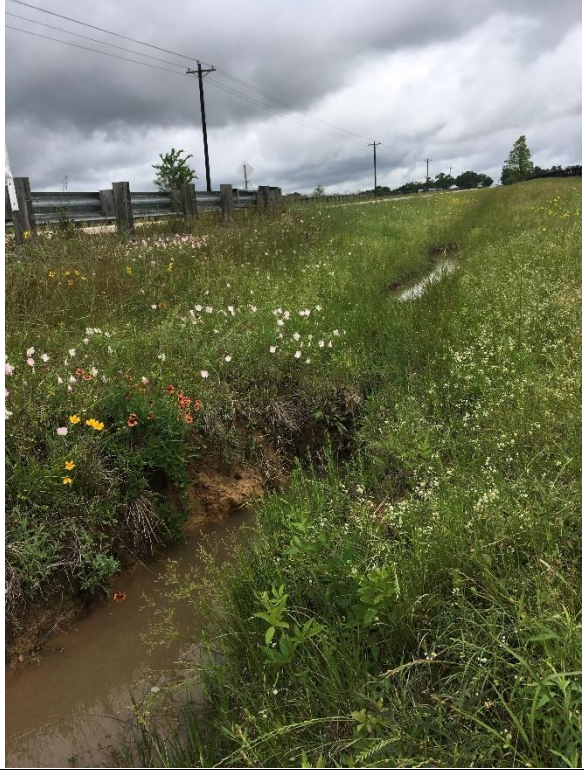
Stream: Spring Creek (J100-00-00)		Field Grid: N/A		HMS Subbasin:	
OBJECTID: 127813_b	View of channel downstream of FM 1736 between Waller Gladish Rd. and Mitchell Rd.	OBJECTID: 127813_c	Roadside ditch along FM 1736 between Waller Gladish Rd. and Mitchell Rd. with noticeable erosion.

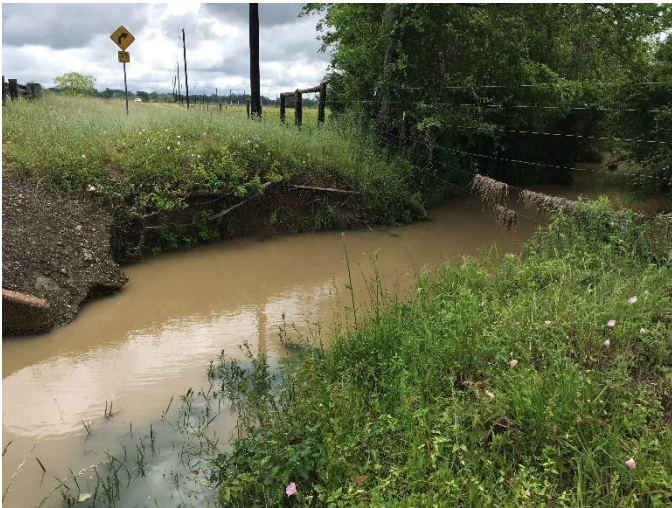
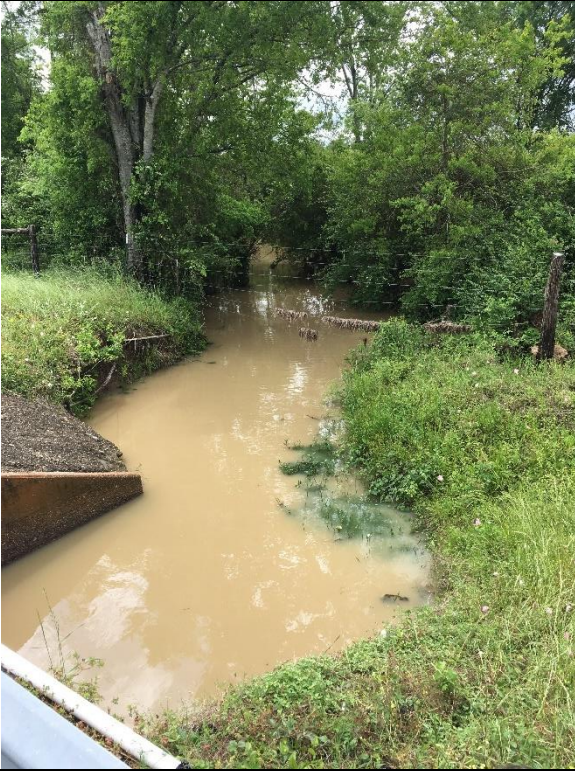
Stream: Spring Creek (J100-00-00)		Field Grid: N/A		HMS Subbasin:	
OBJECTID: 127815_a	View of channel upstream of FM 1736 between Mitchell Rd. and FM 1488.	OBJECTID: 127815_b	Face of 6' W x 5' H double barrel culvert on downstream side of FM 1736 between Mitchell Rd. and FM 1488.	 	
OBJECTID: 127815_c	View of channel upstream of FM 1736 between Mitchell Rd. and FM 1488 with noticeable bank erosion.	OBJECTID: 127816_a	Roadside ditch on upstream side of FM 1736 between Mitchell Rd. and FM 1488 with noticeable bank erosion. Facing South.
