REGIONAL WATERSHED MASTER DRAINAGE PLAN

APPENDIX B DATA COLLECTION AND REVIEW

**San Jacinto Regional Watershed
Master Drainage Plan**

**Halff Associates, Inc.
TBPE Firm Registration No. 312**

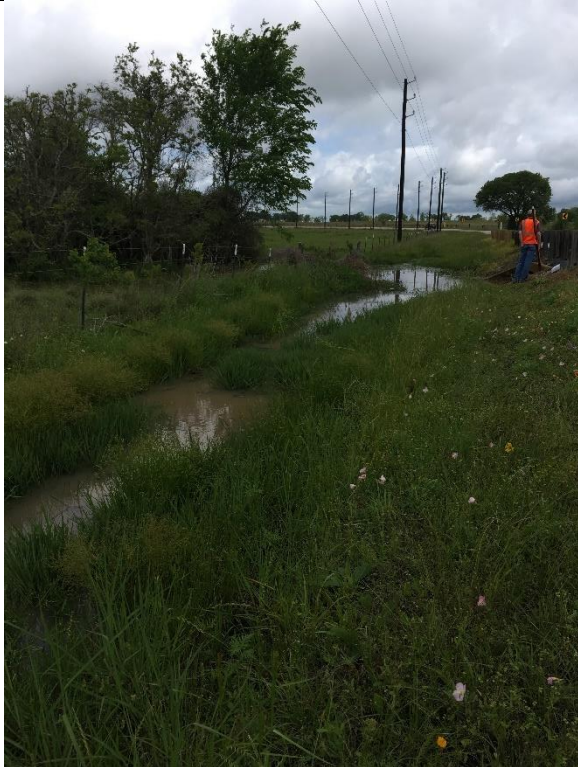
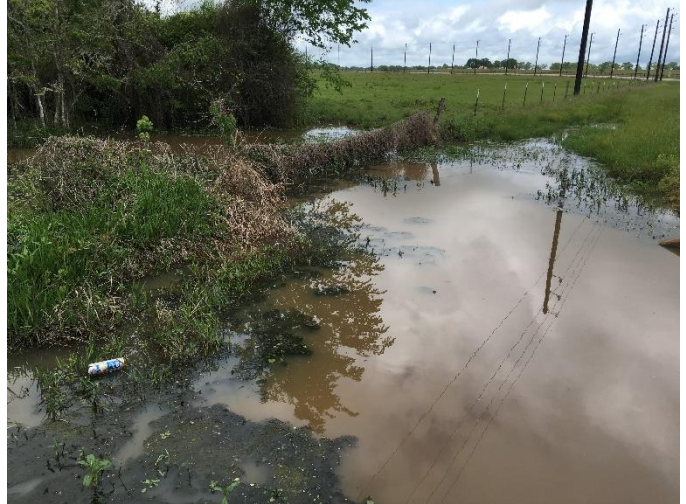
Stream: Spring Creek (J100-00-00)		Field Grid: N/A		HMS Subbasin:	
OBJECTID: 127816_b	Roadside ditch on upstream side of FM 1736 between Mitchell Rd. and FM 1488 with noticeable bank erosion. Facing North.	OBJECTID: 127816_c	View of channel upstream of FM 1736 between Mitchell Rd. and FM 1488. Large amounts of ponding in front of culvert.

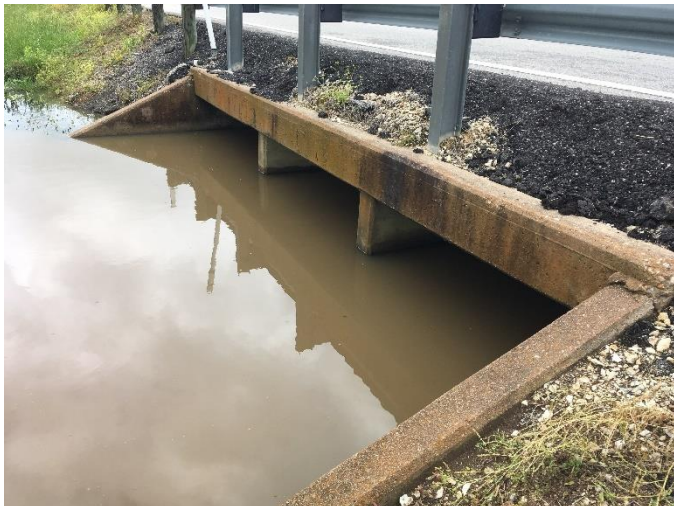
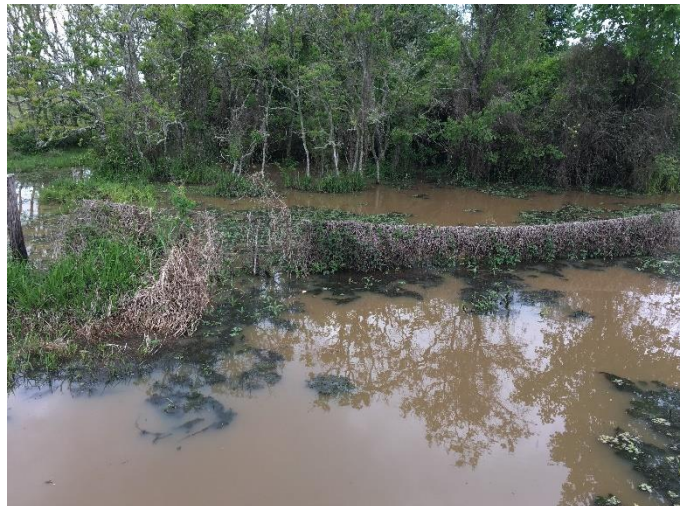
OBJECTID: 127816_d	Face of 5.5' W x 5' H triple barrel culvert on upstream side of FM 1736 between Mitchell Rd. and FM 1488.	OBJECTID: 127816_e	View of channel upstream of FM 1736 between Mitchell Rd. and FM 1488. Large amounts of ponding in front of culvert.

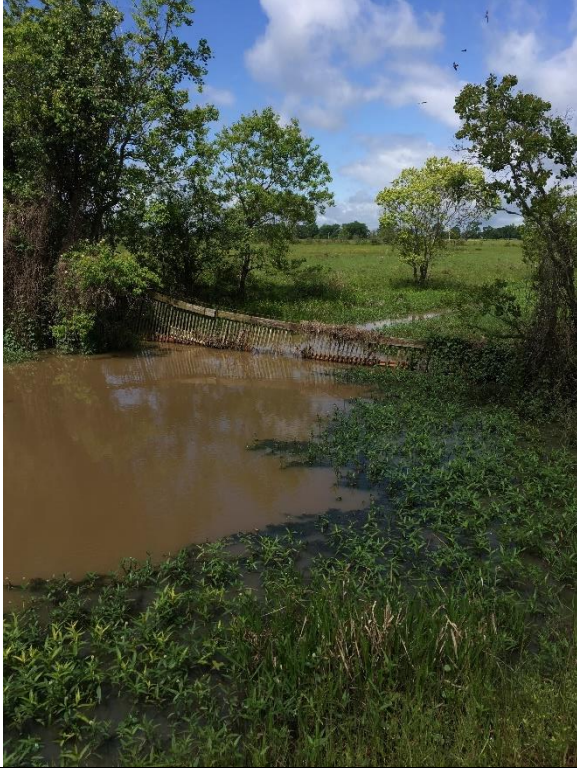
Stream: Spring Creek (J100-00-00)		Field Grid: N/A		HMS Subbasin:	
OBJECTID: 127819_b	View of channel downstream of FM 1488 between FM 1736 and Joseph Rd. High levels of ponding in front of culvert. Evident erosion.	OBJECTID: 127818_a	View of channel upstream of FM 1488 between FM 1736 and Joseph Rd. High levels of ponding in front of bridge.

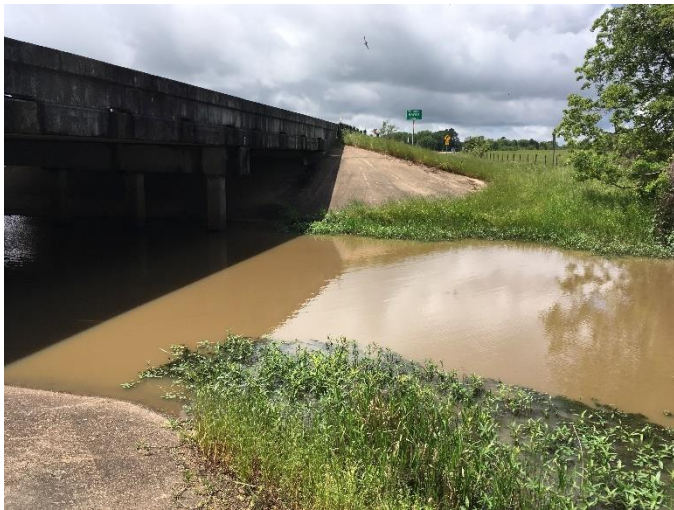
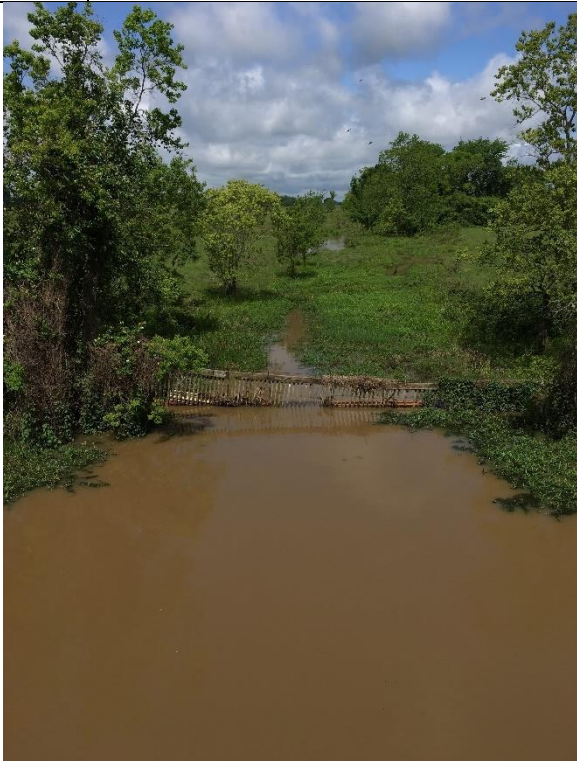
OBJECTID: 127818_b	Face of bridge on upstream side of FM 1736 between Mitchell Rd. and FM 1488.	OBJECTID: 127818_c	View of channel upstream of FM 1488 between FM 1736 and Joseph Rd. High levels of ponding in front of bridge.

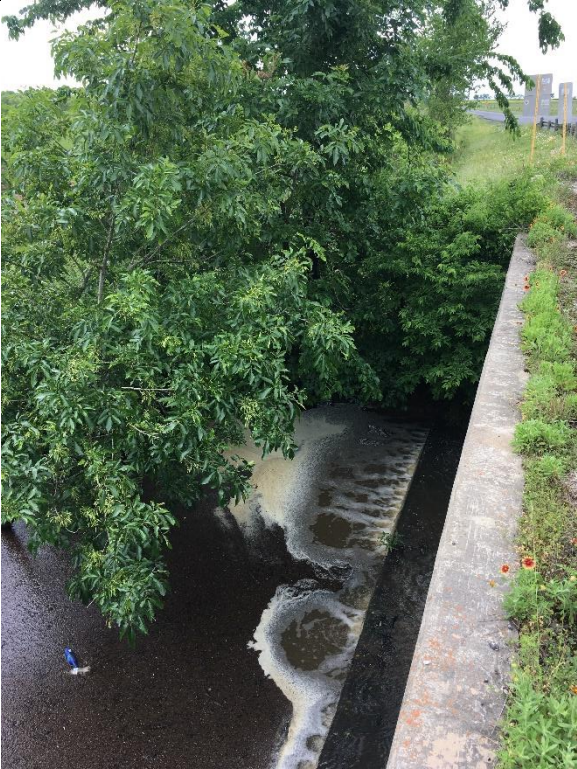
Stream: Spring Creek (J100-00-00)		Field Grid: N/A		HMS Subbasin:	
OBJECTID: 127821_c	View of channel downstream of Fields Store Rd. between Mayer Rd. and Joseph Rd. High amounts of collected debris.	OBJECTID: 127821_d	Culvert intake on upstream side of Fields Store Rd.

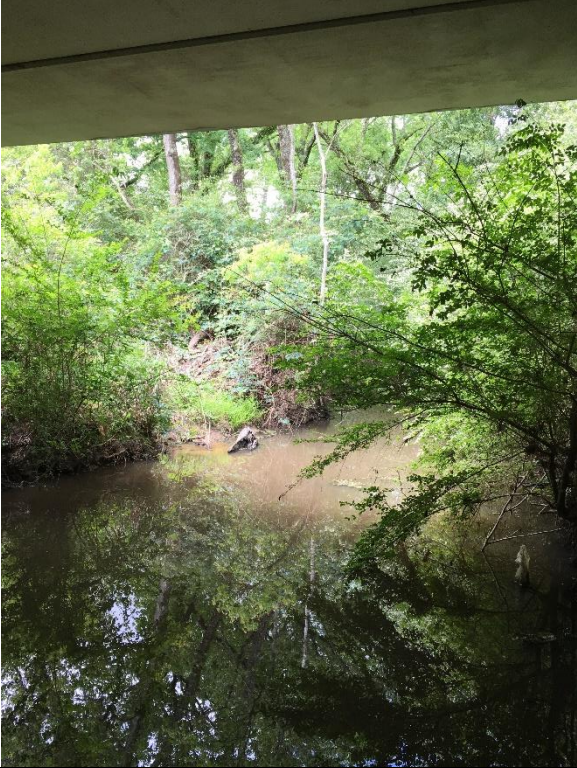
Stream: Spring Creek (J100-00-00)		Field Grid: N/A		HMS Subbasin:	
OBJECTID: 127823_d	View of channel downstream of Kickapoo Rd. between Castle Rd. and Joseph Rd. from below bridge.	OBJECTID: 127829_a	View of channel downstream of Margerstadt Rd. between Kickapoo Rd. and Hegar Rd. Defunct outfall pipe.

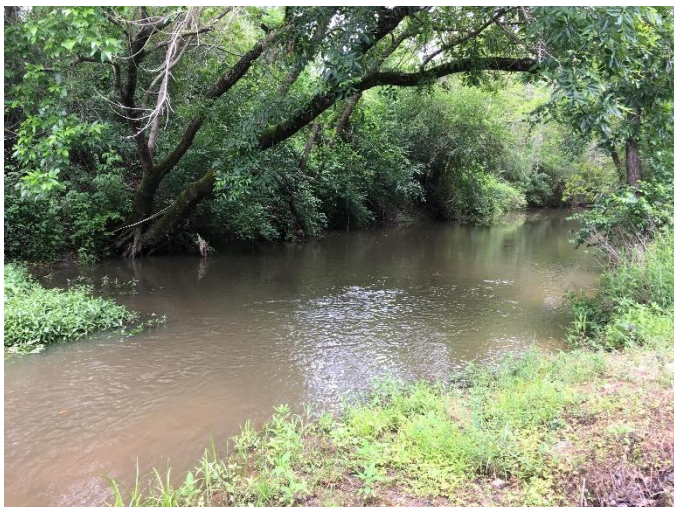
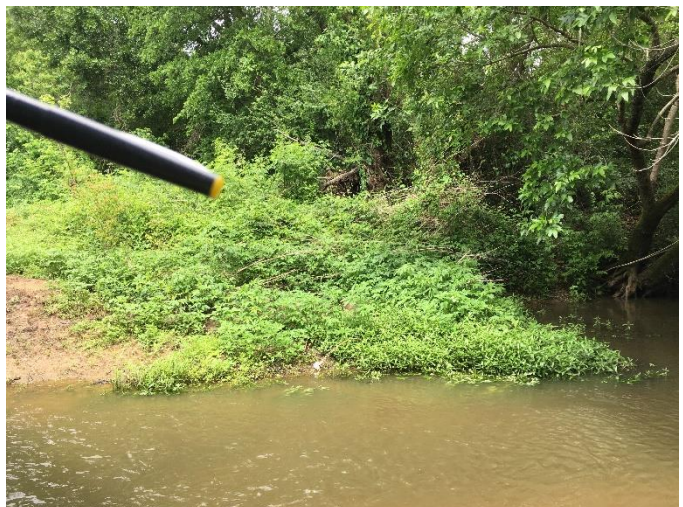
OBJECTID: 127831_f	View of channel downstream of Hegar Rd. between Waller Spring Creek Rd. and Magnolia Rd.	OBJECTID: 127831_g	High water mark visible in crushed vegetation.

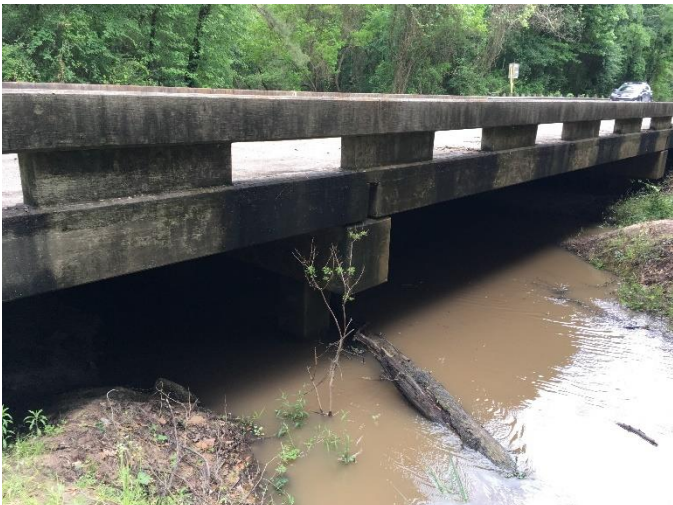
OBJECTID: 127836_b	Face of bridge on upstream side of Roberts Cemetery Rd. between FM 2920 and Michael Ln.	OBJECTID: 127838_a	View of channel downstream of Roberts Cemetery Rd. between FM 2920 and Michael Ln. Moderate bank vegetation.

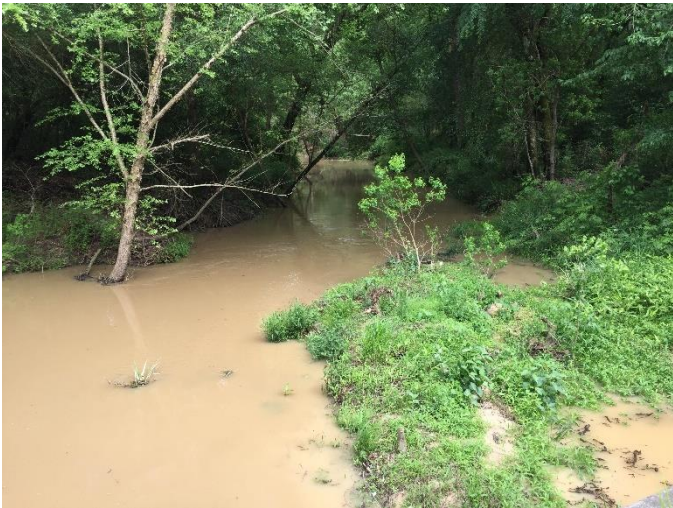
OBJECTID: 127842_a	View of channel downstream of Mueschke Rd. between Sanders Cemetery Rd. and FM 2920.	OBJECTID: 127842_b	View of channel downstream of Mueschke Rd. between Sanders Cemetery Rd. and FM 2920. Channel geometry narrows downstream of bridge.

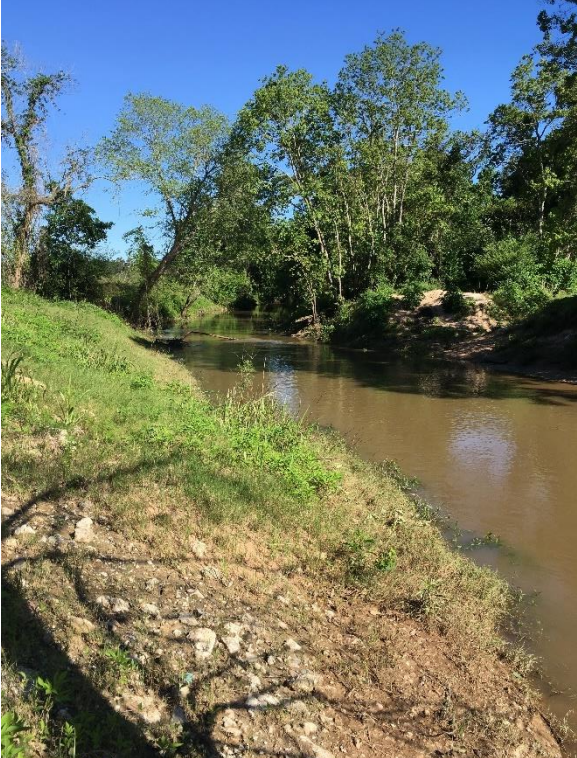
OBJECTID: 128214_a	View of channel upstream of Decker Prairie Rosehill Rd between FM2920 and Coe Loop. Good channel conditions.	OBJECTID: 128214_b	Face of bridge on upstream side of Decker Prairie Rosehill Rd between FM2920 and Coe Loop.

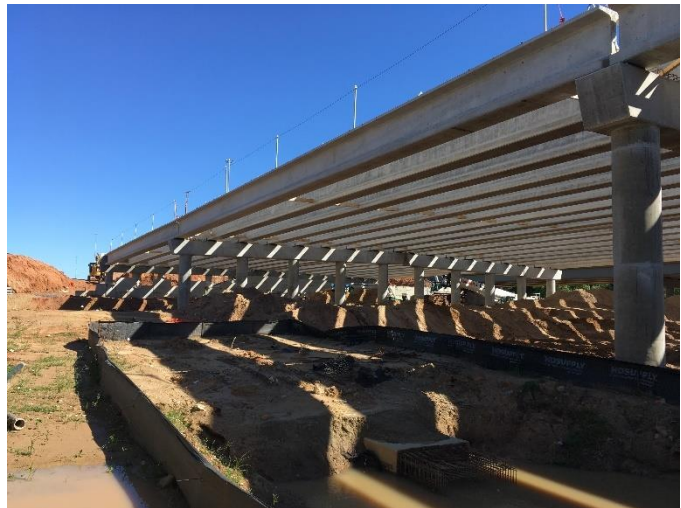
OBJECTID: 128219_b	Face of bridge on upstream of 249 between Sentinel Oaks and Zion Rd.		OBJECTID: 128219_c	Face of bridge on upstream of 249 between Sentinel Oaks and Zion Rd. Outfall culvert under construction.

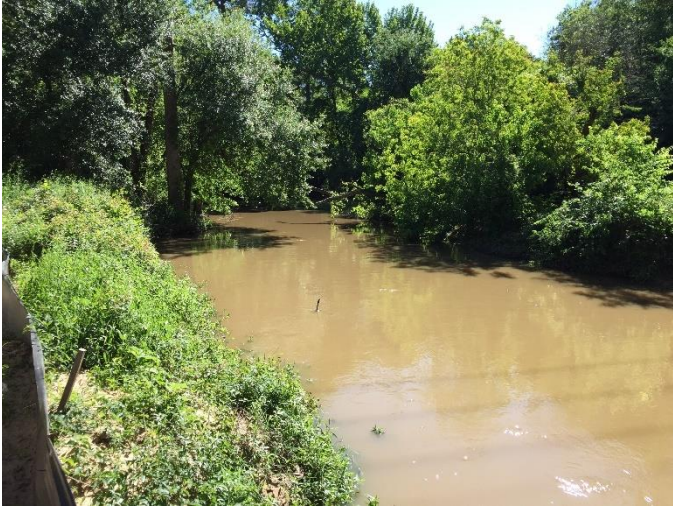
OBJECTID: 128217_a	Face of bridge on downstream of 249 between Sentinel Oaks and Zion Rd.	OBJECTID: 128217_b	View of channel downstream of 249 between Sentinel Oaks and Zion Rd. Some channel debris and moderate bank vegetation.

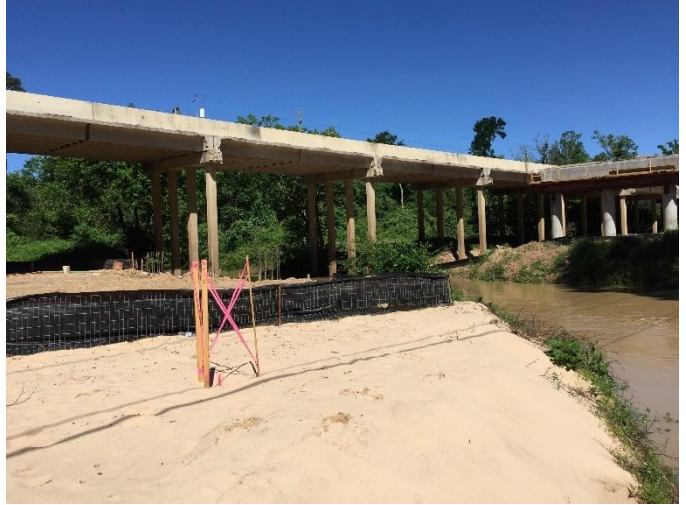
Stream: Spring Creek (J100-00-00)		Field Grid: N/A	HMS Subbasin:
OBJECTID: 128222_b	View of channel upstream of Huffsmith Kohrville Rd. between Dobbin Hufsmith Rd. and Bogs Rd. Some channel debris.	OBJECTID: 128222_c	Face of bridge on downstream of Huffsmith Kohrville Rd. between Dobbin Hufsmith Rd. and Bogs Rd. Currently under construction.

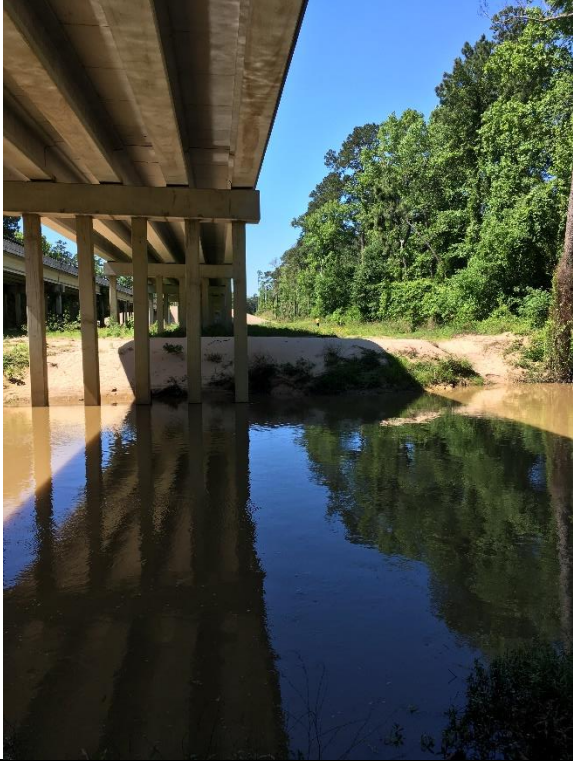
Stream: Spring Creek (J100-00-00)		Field Grid: N/A		HMS Subbasin:	
OBJECTID: 128223_c	Underside of bridge on upstream side of Kuykendahl Rd. between Flintridge Dr. and Carlton Woods Creekside Dr. Evident sedimentation.	OBJECTID: 128223_d	Underside of bridge on upstream side of Kuykendahl Rd. between Flintridge Dr. and Carlton Woods Creekside Dr. Evident erosion.

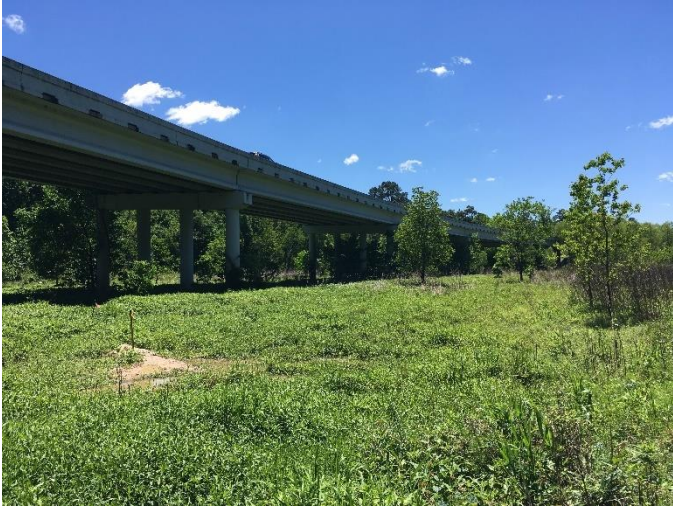
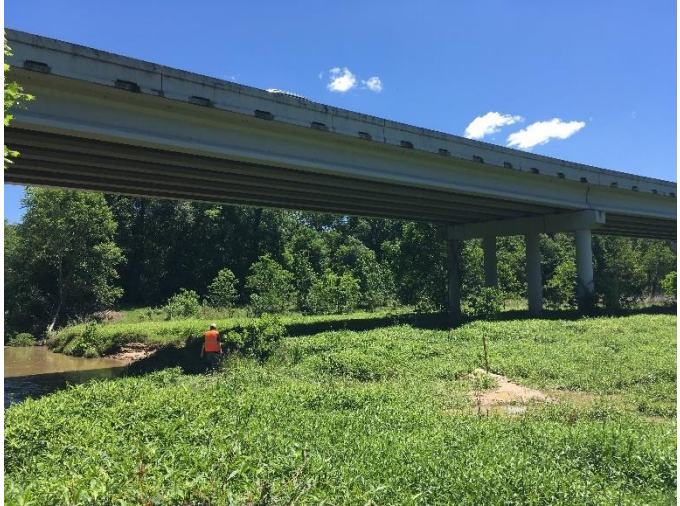
OBJECTID: 128229_b	Face of bridge on upstream side of Gosling Rd. between Flintridge Dr. and Creekside Forest Dr. Highly vegetated overbanks.	OBJECTID: 128229_c	Face of bridge on upstream side of Gosling Rd. between Flintridge Dr. and Creekside Forest Dr. Highly vegetated overbanks.

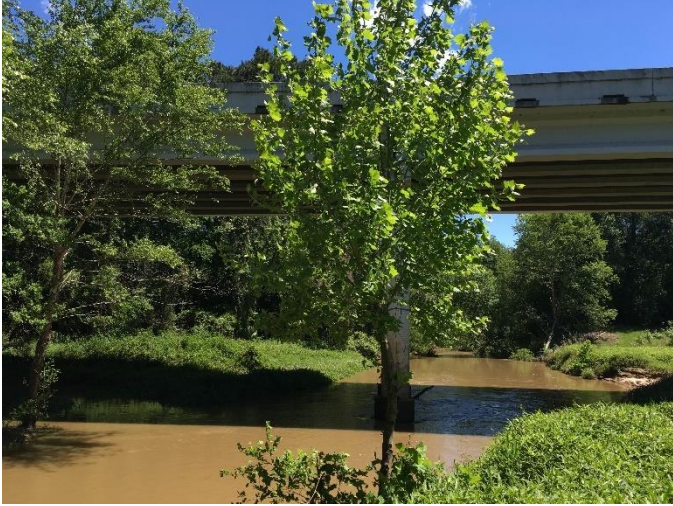
Stream: Spring Creek (J100-00-00)		Field Grid: N/A	HMS Subbasin:
OBJECTID: 128229_d	Face of bridge on upstream side of Gosling Rd. between Flintridge Dr. and Creekside Forest Dr.	OBJECTID: 128230_a	View of channel upstream side of Gosling Rd. between Flintridge Dr. and Creekside Forest Dr. Light sedimentation. Vegetation growing into channel.

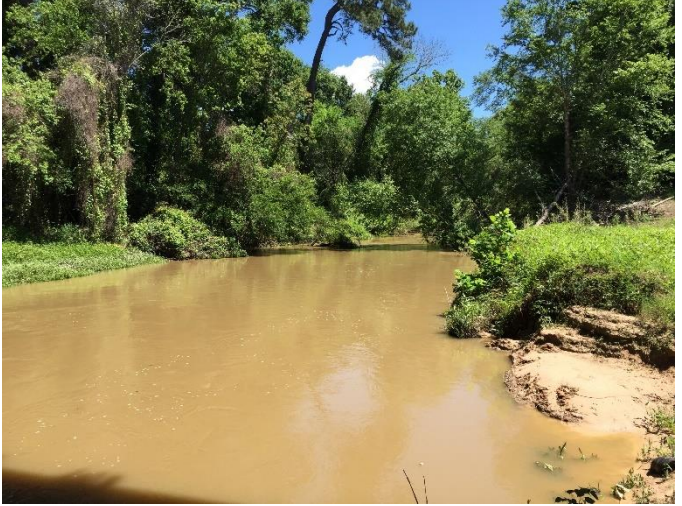
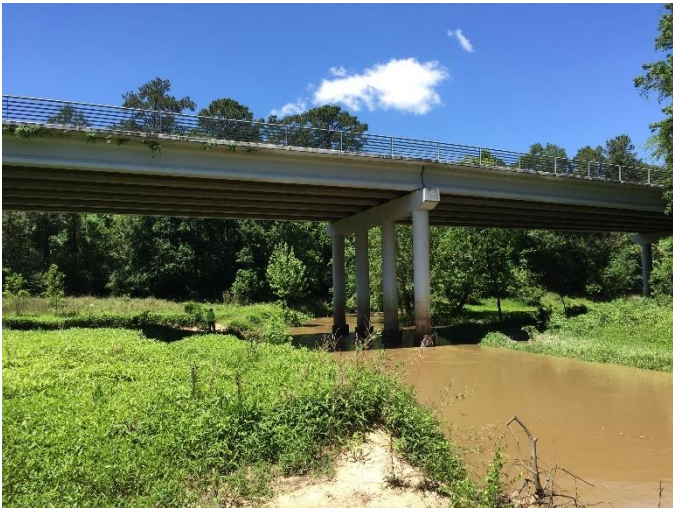
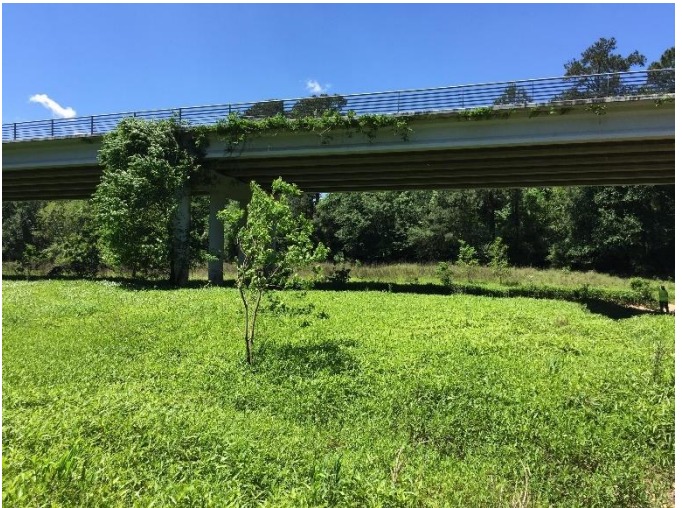
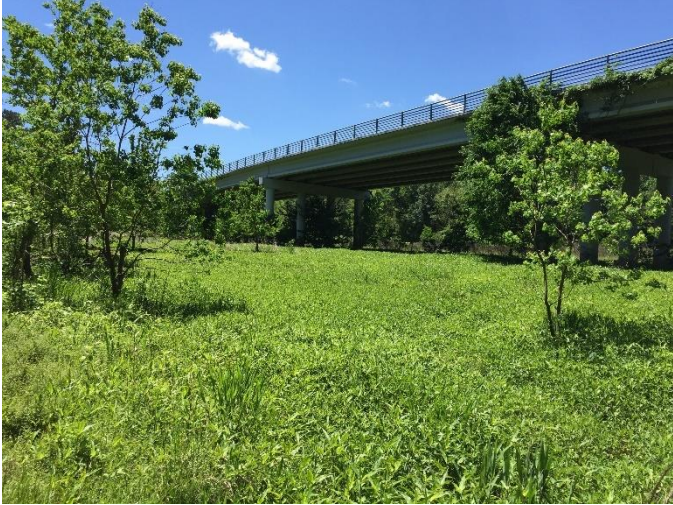
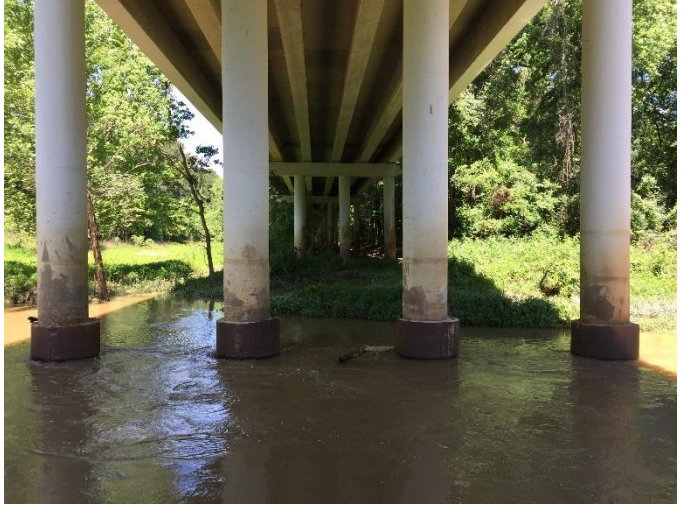
OBJECTID: 128230_b	Face of bridge on downstream side of Gosling Rd. between Flintridge Dr. and Creekside Forest Dr. Highly vegetated overbanks.	OBJECTID: 128230_c	Face of bridge on downstream side of Gosling Rd. between Flintridge Dr. and Creekside Forest Dr. Highly vegetated overbanks.

Stream: Spring Creek (J100-00-00)		Field Grid: N/A	HMS Subbasin:
OBJECTID: 128230_d	Face of bridge on downstream side of Gosling Rd. between Flintridge Dr. and Creekside Forest Dr. Highly vegetated overbanks.	OBJECTID: 128230_e	Underside of bridge on Gosling Rd. between Flintridge Dr. and Creekside Forest Dr. Highly vegetated overbanks.

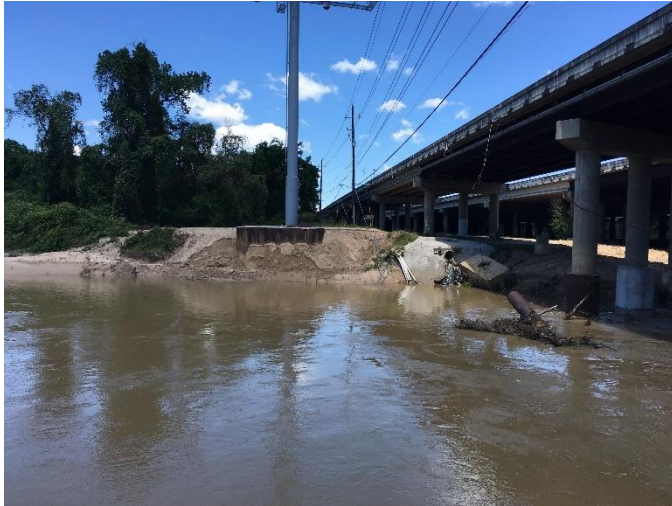
Stream: Spring Creek (J100-00-00)		Field Grid: N/A		HMS Subbasin:	
OBJECTID: 128231_c	Heavy erosion on upstream side of I-45 between Pruitt Rd. and Springwoods Village Pkwy.	OBJECTID: 128231_d	View of channel looking upstream from underneath I-45 between Pruitt Rd. and Springwoods Village Pkwy.

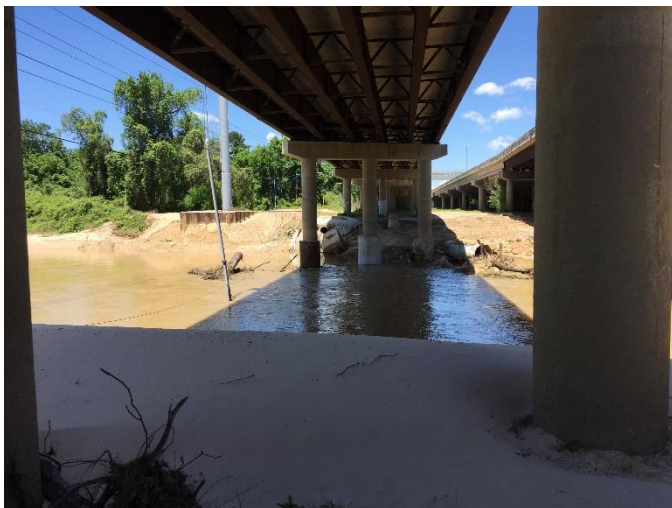
OBJECTID: 128232_a	Heavy erosion from underside of I-45 between Pruitt Rd. and Springwoods Village Pkwy.	OBJECTID: 128232_b	Evident sedimentation on abutment slopes of bridge I-45 between Pruitt Rd. and Springwoods Village Pkwy.

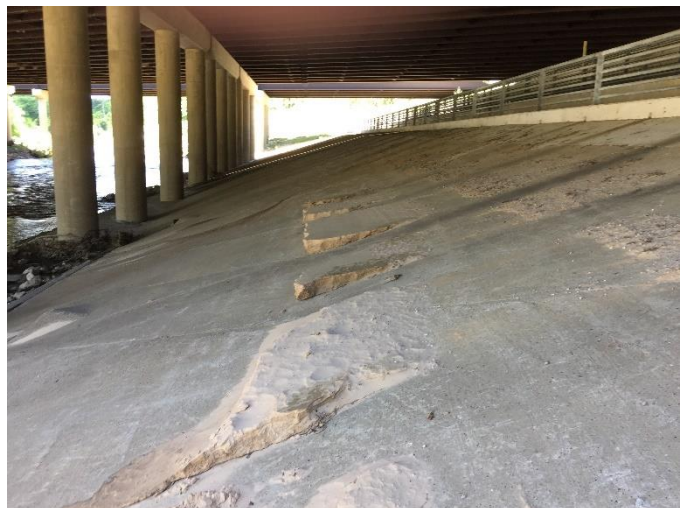
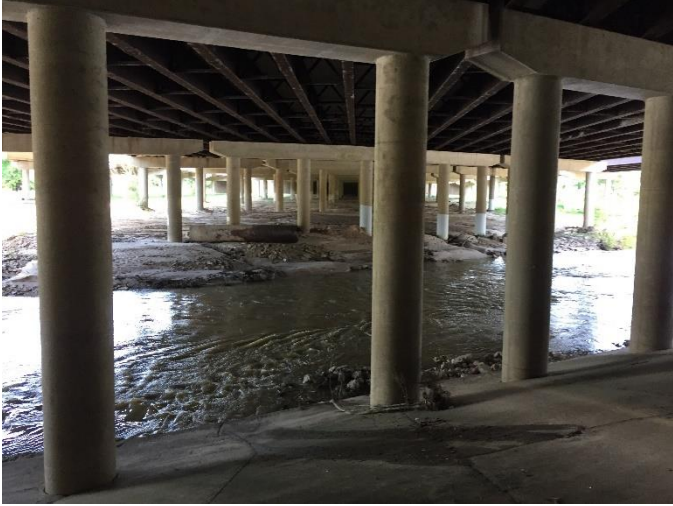
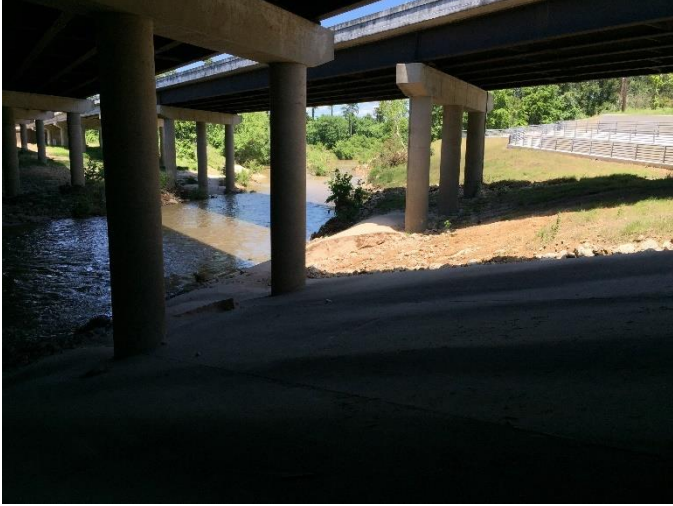
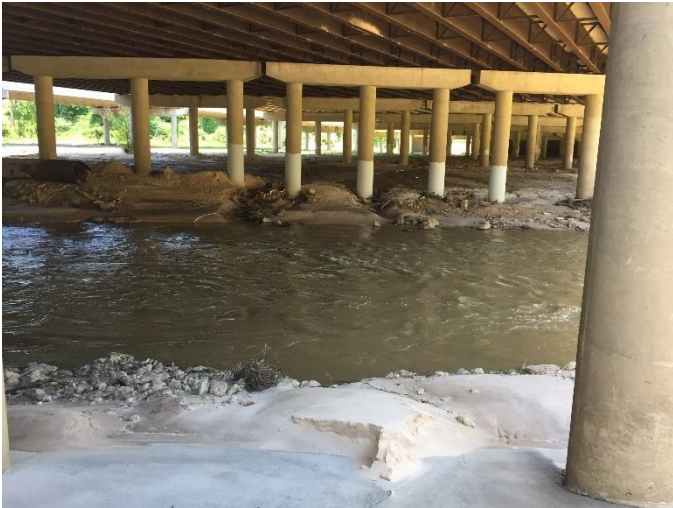
Stream: Spring Creek (J100-00-00)		Field Grid: N/A		HMS Subbasin:	
OBJECTID: 128232_c	Evident sedimentation and erosion on abutment slopes of bridge I-45 between Pruitt Rd. and Springwoods Village Pkwy.	OBJECTID: 128232_d	Evident sedimentation on abutment slopes of bridge I-45 between Pruitt Rd. and Springwoods Village Pkwy.

OBJECTID: 128232_e	Evident sedimentation and erosion on abutment slopes of bridge I-45 between Pruitt Rd. and Springwoods Village Pkwy.	OBJECTID: 128232_f	Evident erosion on abutment slopes of bridge I-45 between Pruitt Rd. and Springwoods Village Pkwy. Originate from sidewalk drainage outfalls.

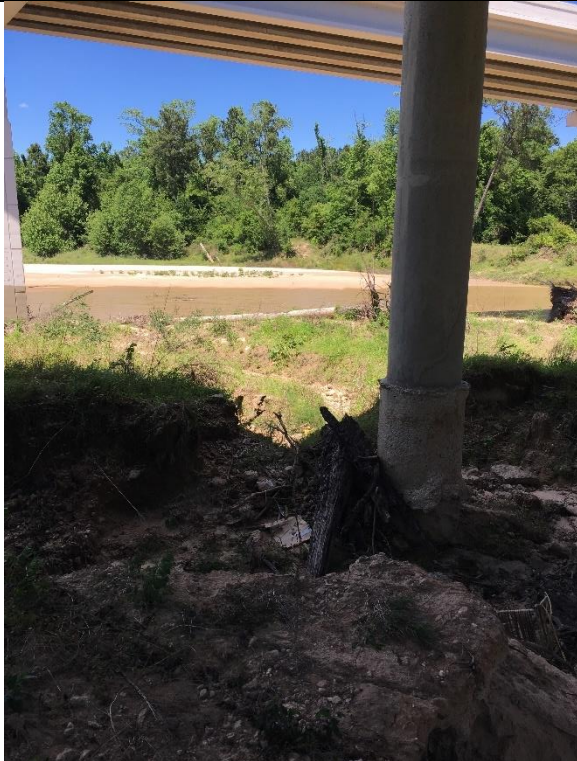
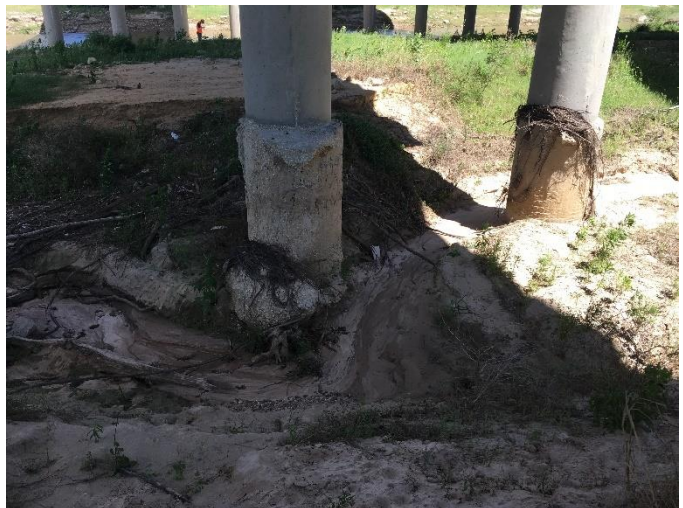
OBJECTID: 128621_a		Erosion by piers on upstream end of SH-99 between Hardy Toll Rd. and Riley Fuzzell Rd.		OBJECTID: 128621_b		Erosion by piers on underneath SH-99 between Hardy Toll Rd. and Riley Fuzzell Rd.

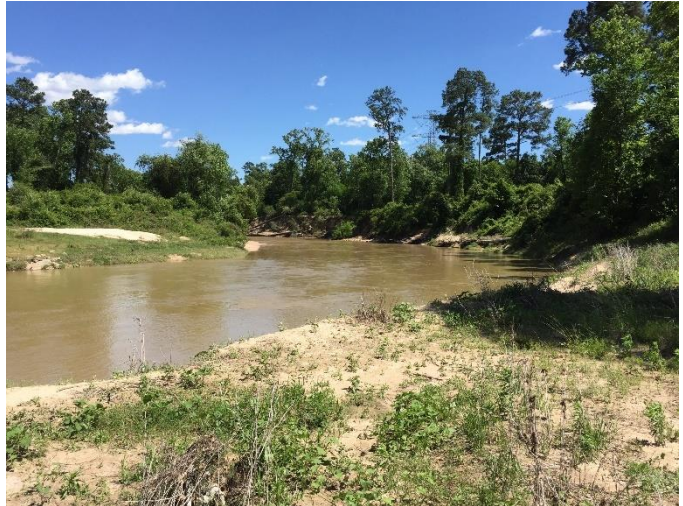
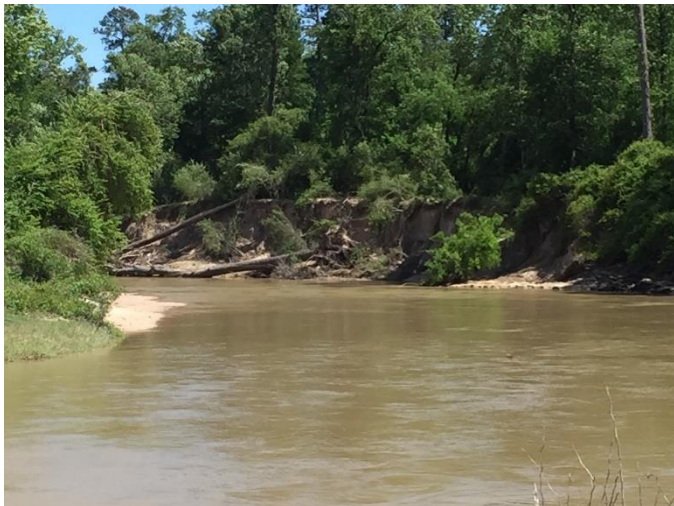
Stream: Spring Creek (J100-00-00)		Field Grid: N/A		HMS Subbasin:			
OBJECTID: 128621_c		Erosion underneath SH-99 between Hardy Toll Rd. and Riley Fuzzell Rd.		OBJECTID: 128620_a		View of channel downstream of SH-99 between Hardy Toll Rd. and Riley Fuzzell Rd. Heavy erosion on banks.

OBJECTID: 128620_b		View of channel downstream of SH-99 between Hardy Toll Rd. and Riley Fuzzell Rd. Heavy erosion on banks.		OBJECTID: 128620_c		Face of bridge on downstream side SH-99 between Hardy Toll Rd. and Riley Fuzzell Rd.

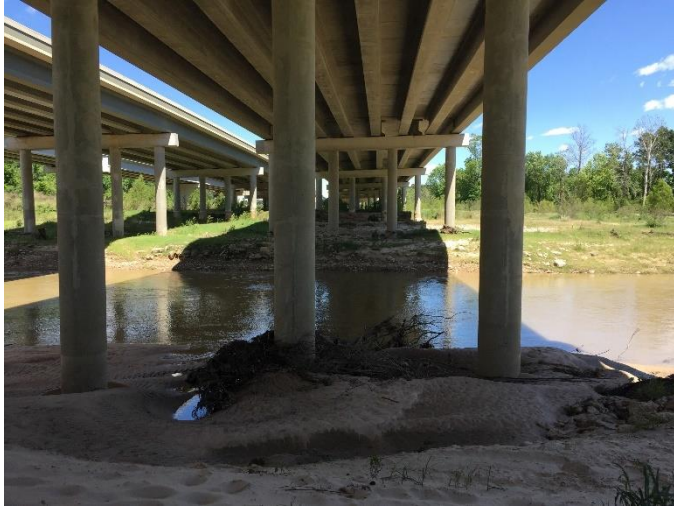
Stream: Spring Creek (J100-00-00)		Field Grid: N/A		HMS Subbasin:	
OBJECTID: 128620_d	Sedimentation under bridge on downstream side SH-99 between Hardy Toll Rd. and Riley Fuzzell Rd.	OBJECTID: 128615_a	Face of bridge on downstream side SH-99 between Hardy Toll Rd. and Riley Fuzzell Rd.

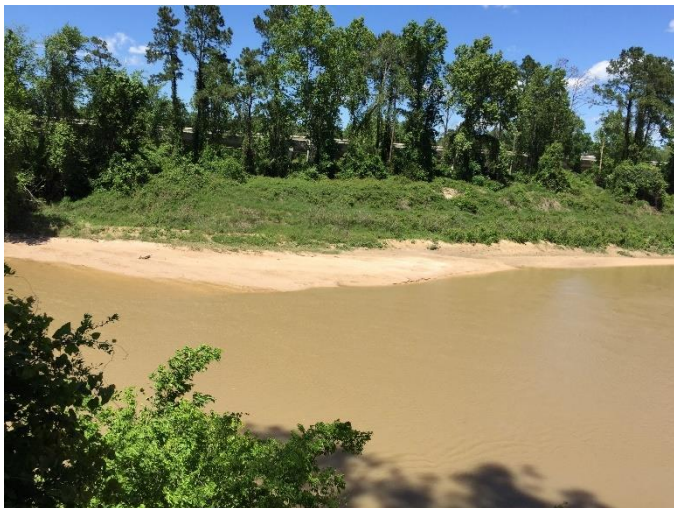
OBJECTID: 128615_b	Sedimentation downstream of SH-99 between Hardy Toll Rd. and Riley Fuzzell Rd.	OBJECTID: 128616_a	Face of bridge on downstream side SH-99 between Hardy Toll Rd. and Riley Fuzzell Rd.

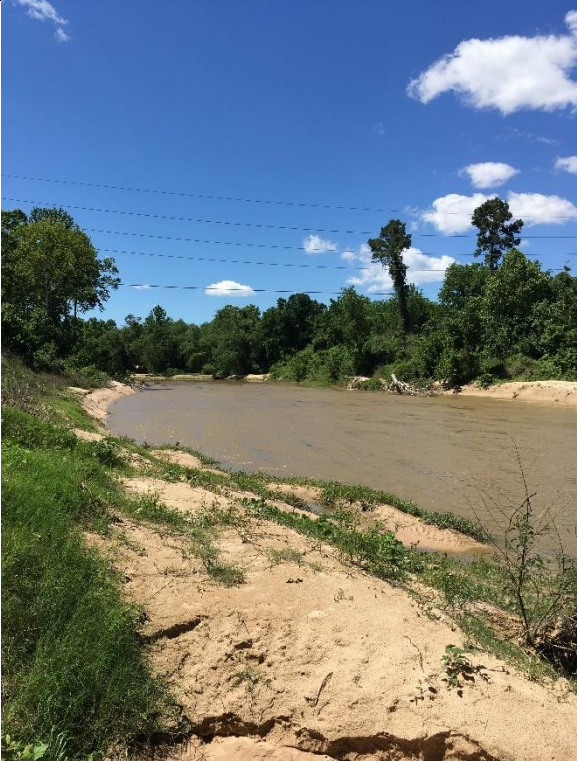
OBJECTID: 128618_a	View of channel upstream of Riley Fuzzell Rd. between Hardy Toll Rd. and SH-99. Moderate sedimentation on banks.	OBJECTID: 128618_b	Face of bridge on upstream side of Riley Fuzzell Rd. between Hardy Toll Rd. and SH-99.

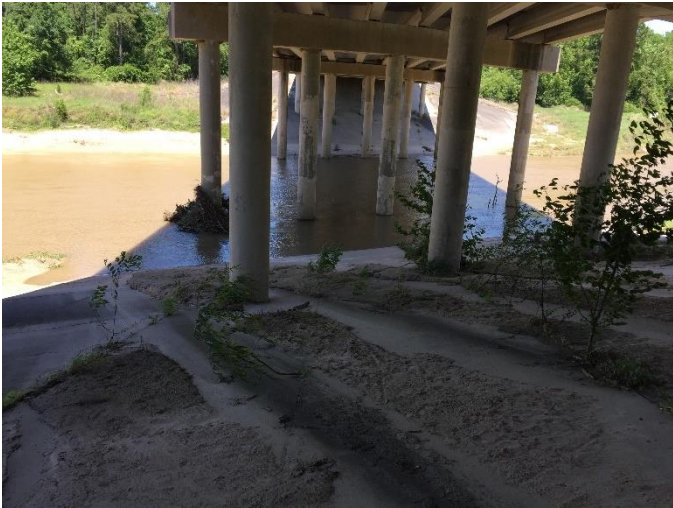
OBJECTID: 128617_c	Sedimentation under bridge of Riley Fuzzell Rd. between Hardy Toll Rd. and SH-99.	OBJECTID: 130620_a	Detention pond off channel between I-45 and SH-99. Upstream of pump station.

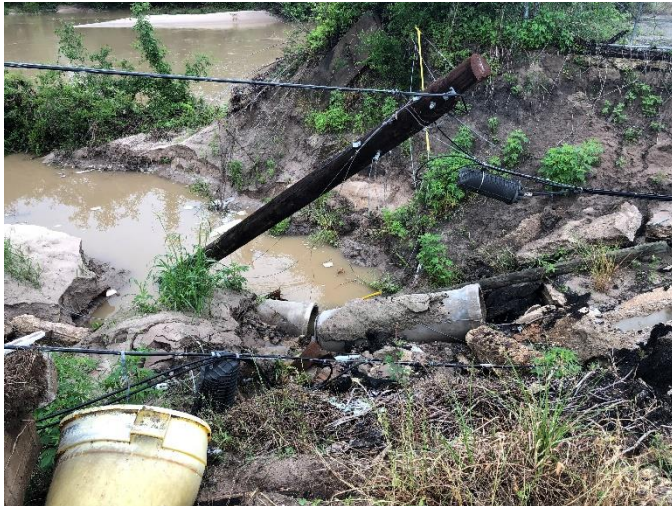
Stream: San Jacinto River (G103WFSJ)		Field Grid: N/A		HMS Subbasin:			
OBJECTID: 137830_a		View of channel upstream of bridge on I-45 between FM 1488 and South Loop 336 W. Heavy bank erosion.		OBJECTID: 137830_b		View of channel upstream of bridge on I-45 between FM 1488 and South Loop 336 W.

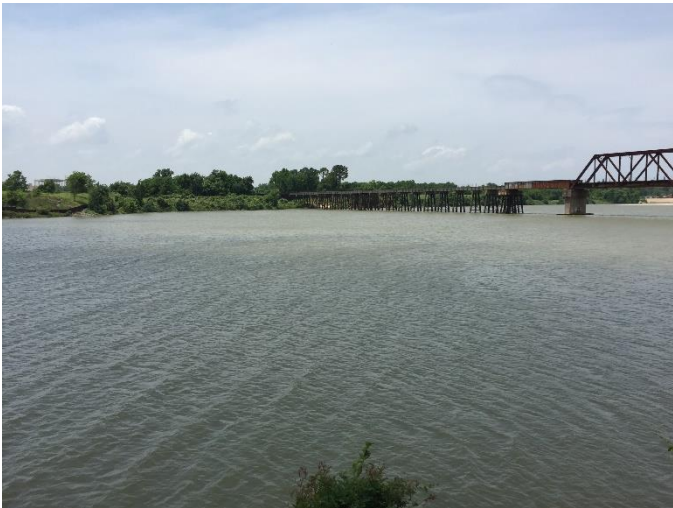
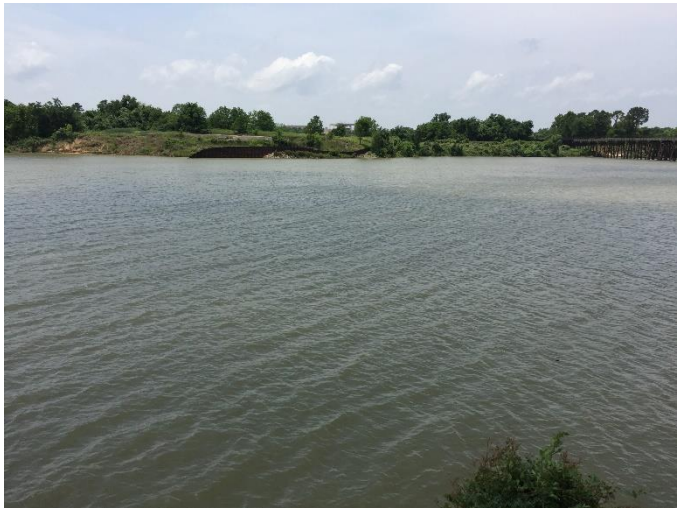
OBJECTID: 138632_c	View of downstream face of railroad bridge upstream of Beaumont Hwy.	OBJECTID: 138632_d	View of channel downstream of railroad bridge upstream of Beaumont Hwy. Evident erosion on banks.

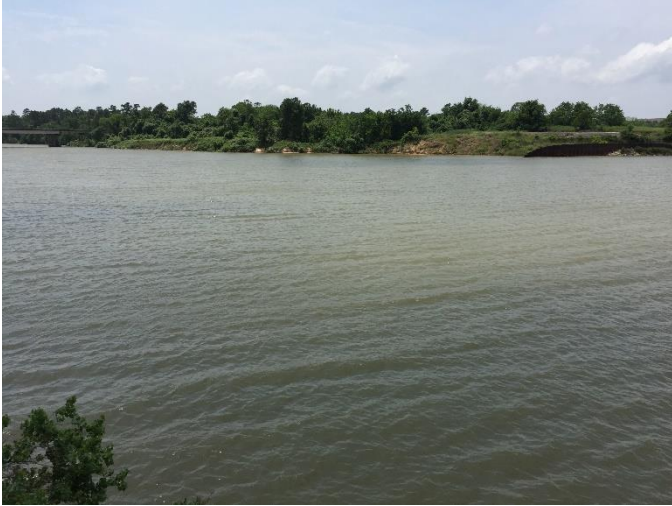
Stream: San Jacinto River (G103)		Field Grid: N/A		HMS Subbasin:	
OBJECTID: 138632_e	View of channel downstream of railroad bridge upstream of Beaumont Hwy. Evident erosion on banks.	OBJECTID: 138232_a	View of upstream face of bridge on Beaumont Hwy.

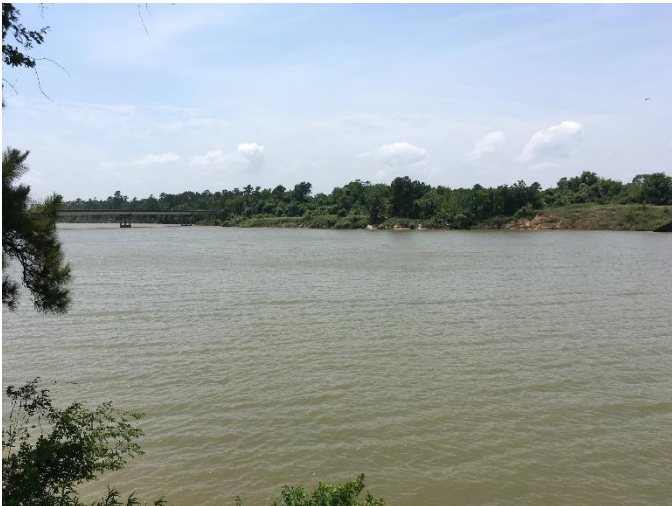
OBJECTID: 138232_b	View of channel upstream of bridge on Beaumont Hwy. Evident bank erosion.	OBJECTID: 138234_a	View of downstream face of Beaumont Hwy. between FM 2100 and Sheldon Rd.

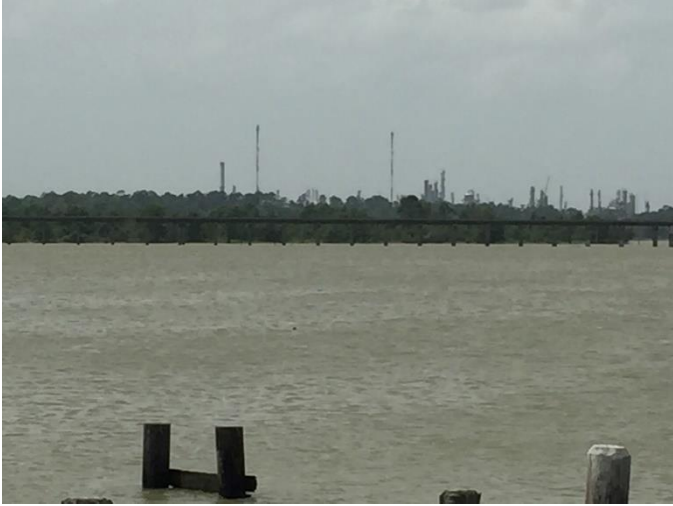
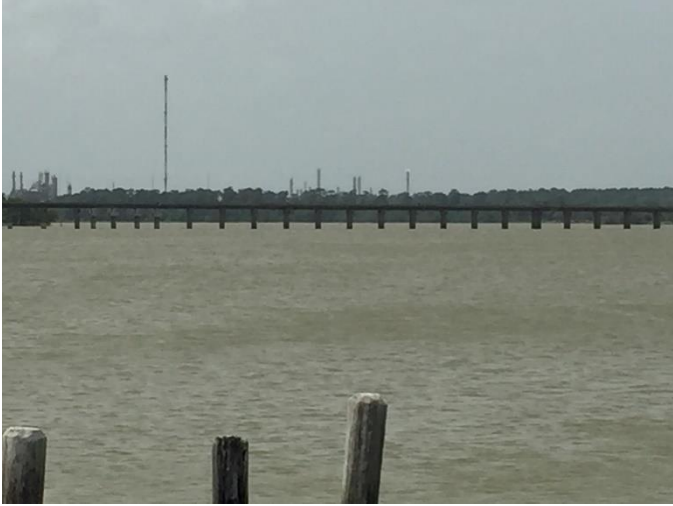
Stream: San Jacinto River (G103)		Field Grid: N/A		HMS Subbasin:	
OBJECTID: 138235_c	View of downstream face of railroad bridge upstream of SH-10.	OBJECTID: 138235_d	View of downstream face of railroad bridge upstream of SH-10.

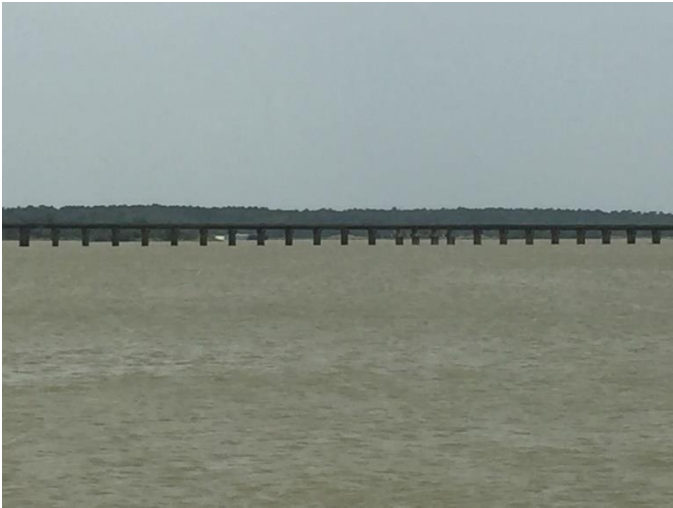
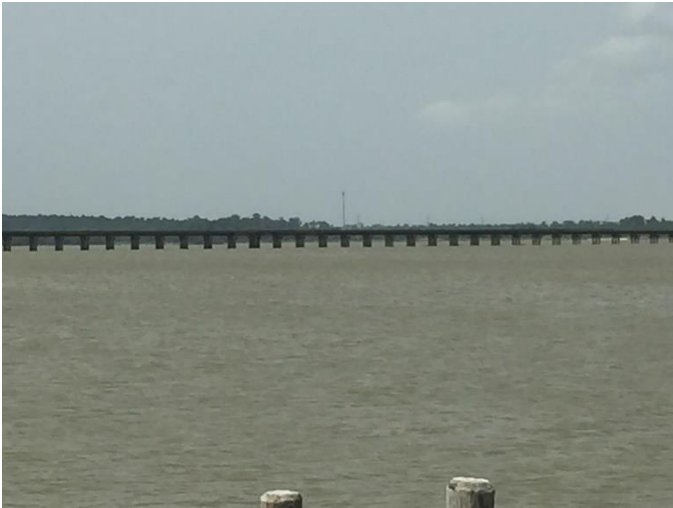
OBJECTID: 138235_e	View of downstream face of railroad bridge upstream of SH-10.	OBJECTID: 138235_f	View of downstream face of railroad bridge upstream of SH-10.

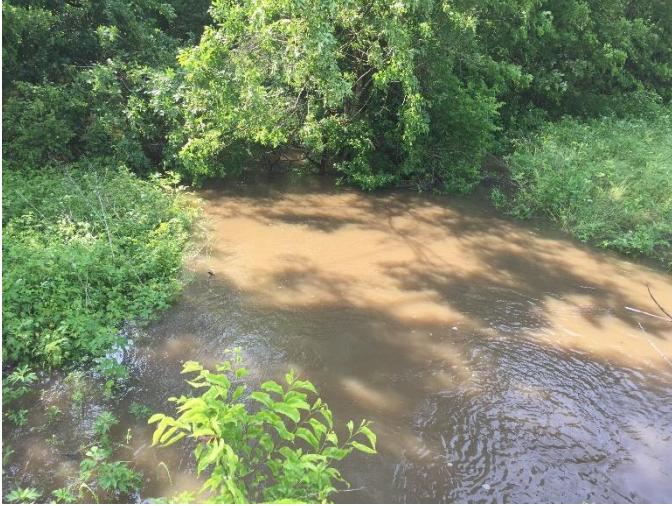
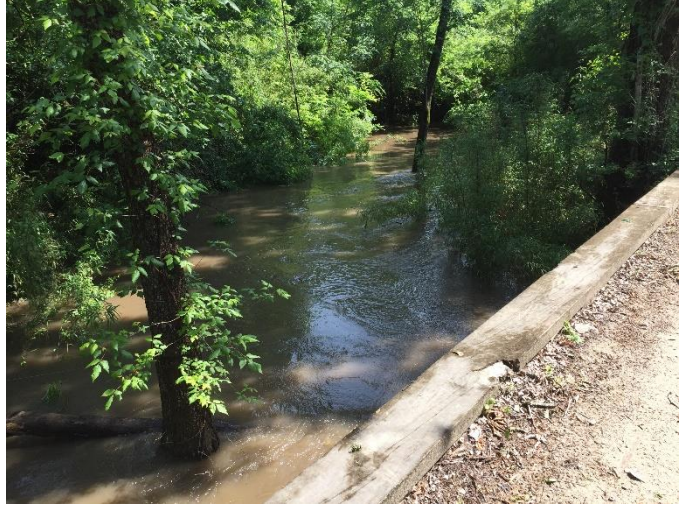
Stream: Lake Creek (GLC)		Field Grid: N/A		HMS Subbasin:	
OBJECTID: 137430_b	View of channel downstream of bridge on TX-30 between CR 233 and FM 2620. Moderate bank vegetation.	OBJECTID: 137033_a	View of channel upstream of bridge on CR 233 between TX-30 and CR 231. Moderate bank vegetation.

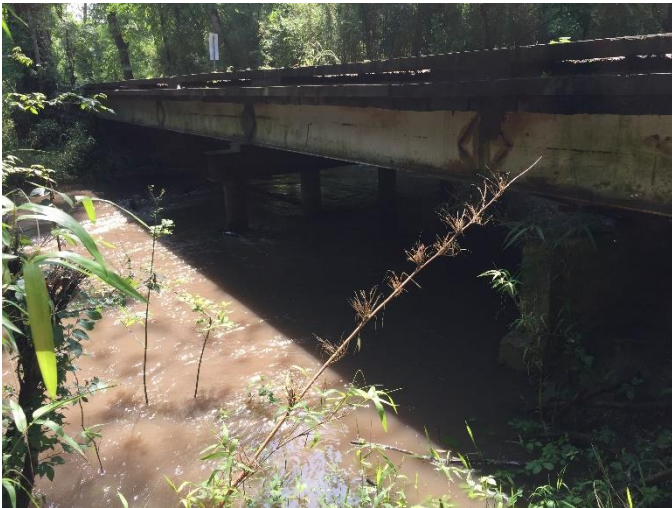
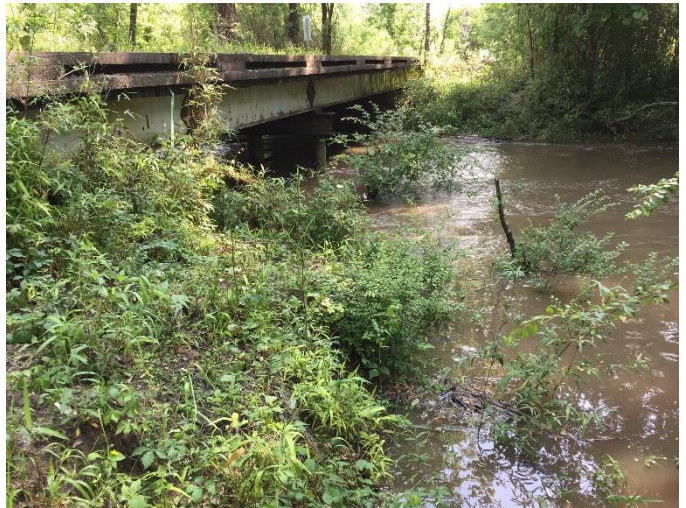
OBJECTID: 137033_b	Face of bridge on upstream side of CR 233 between TX-30 and CR 231.	OBJECTID: 137034_a	Face of bridge on downstream side of CR 233 between TX-30 and CR 231.

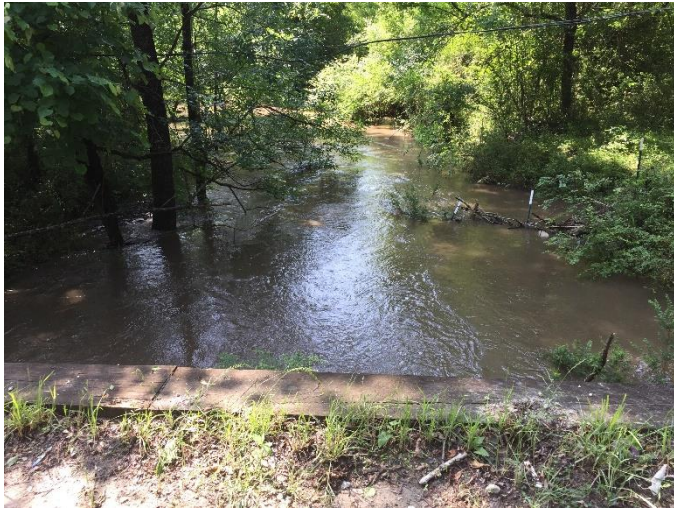
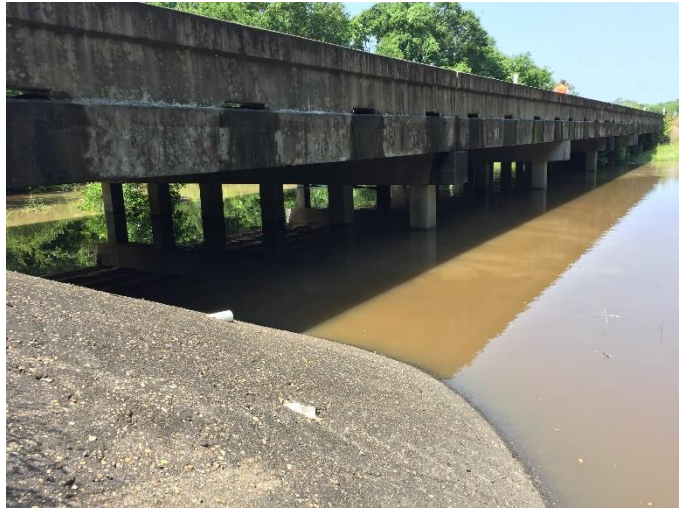
Stream: Lake Creek (GLC)		Field Grid: N/A		HMS Subbasin:	
OBJECTID: 137034_b	View of channel downstream of bridge on CR 233 between TX-30 and CR 231. Moderate bank vegetation.	OBJECTID: 137035_a	Face of bridge on upstream side of FM 149 between CR 216 and Lynn St.
