REGIONAL WATERSHED MASTER DRAINAGE PLAN

APPENDIX B DATA COLLECTION AND REVIEW

**San Jacinto Regional Watershed
Master Drainage Plan**

**Halff Associates, Inc.
TBPE Firm Registration No. 312**

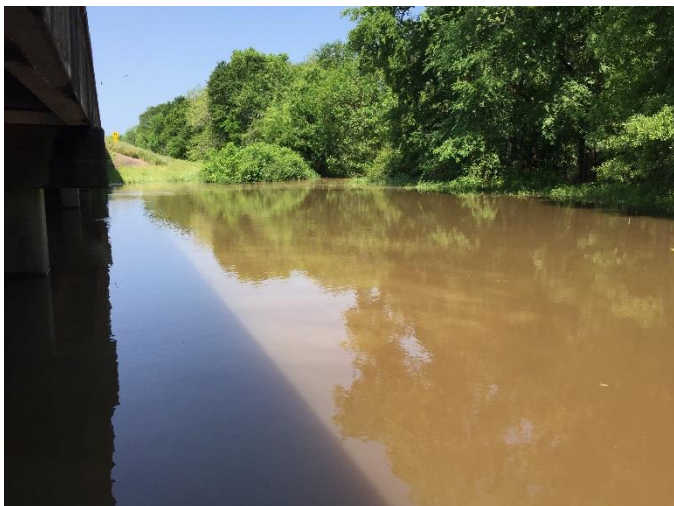
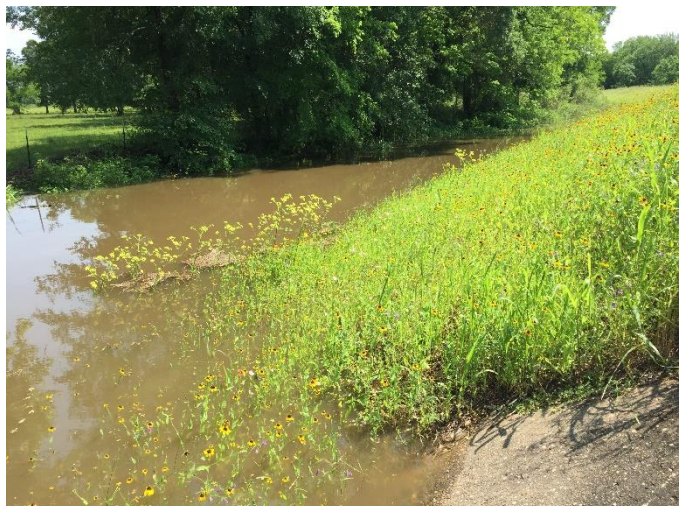
OBJECTID: 137035_b	View of channel upstream of bridge FM 149 between CR 216 and Lynn St. Heavy ponding.	OBJECTID: 137035_c	View of roadside drainage ditch upstream of bridge FM 149 between CR 216 and Lynn St. Heavy ponding.

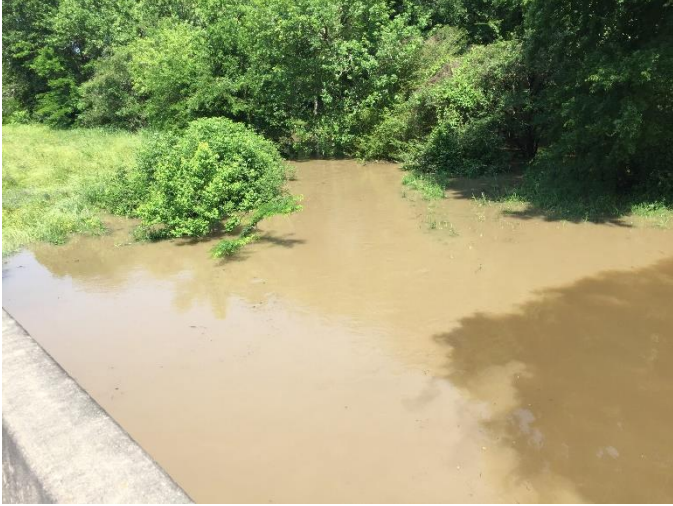
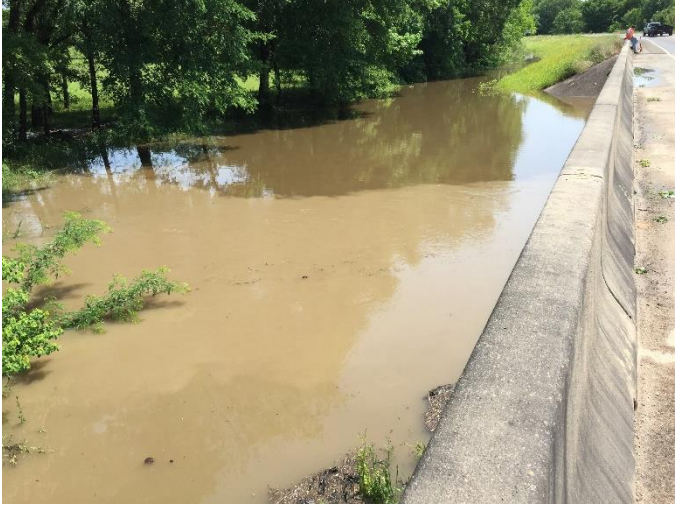
Stream: Lake Creek (GLC)		Field Grid: N/A		HMS Subbasin:	
OBJECTID: 137035_d	View of channel upstream of bridge FM 149 between CR 216 and Lynn St. Heavy ponding.	OBJECTID: 137035_e	View of roadside drainage ditch upstream of bridge FM 149 between CR 216 and Lynn St. Heavy ponding.

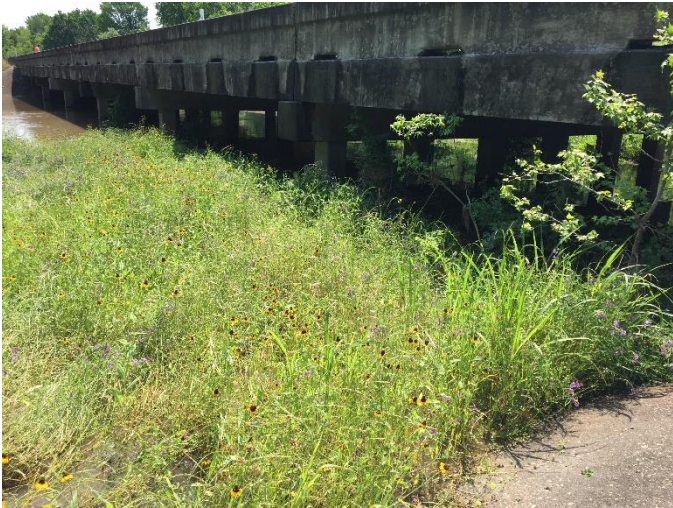
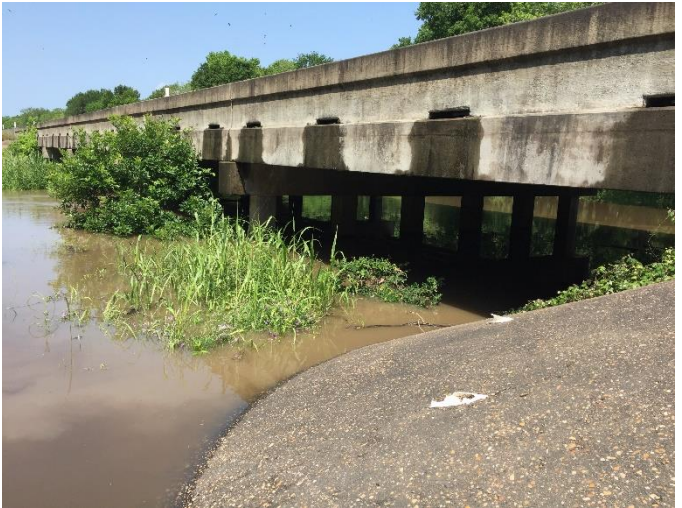
OBJECTID: 137035_f	Face of bridge on upstream side of FM 149 between CR 216 and Lynn St.	OBJECTID: 137036_a	Face of bridge on downstream side of FM 149 between CR 216 and Lynn St.

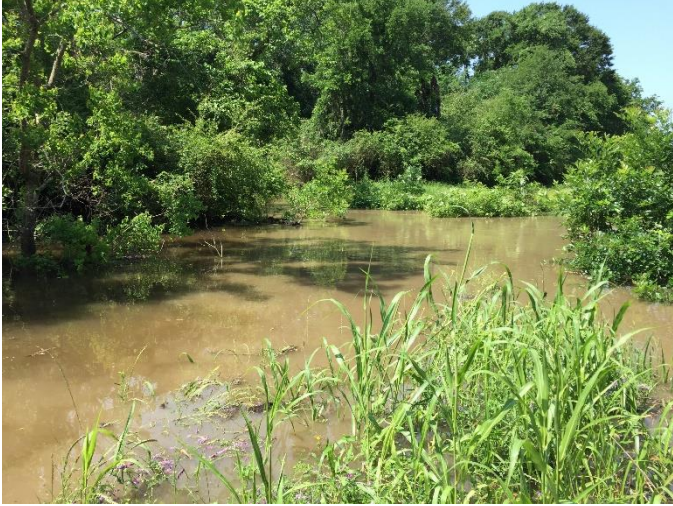
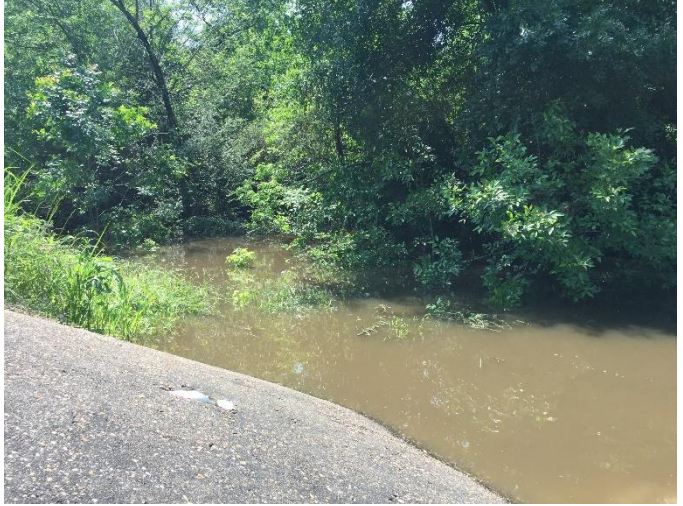
Stream: Lake Creek (GLC)		Field Grid: N/A		HMS Subbasin:	
OBJECTID: 137036_b	View of channel downstream of bridge FM 149 between CR 216 and Lynn St. Heavy ponding.	OBJECTID: 137036_c	View of roadside ditch downstream of bridge FM 149 between CR 216 and Lynn St. Heavy ponding.

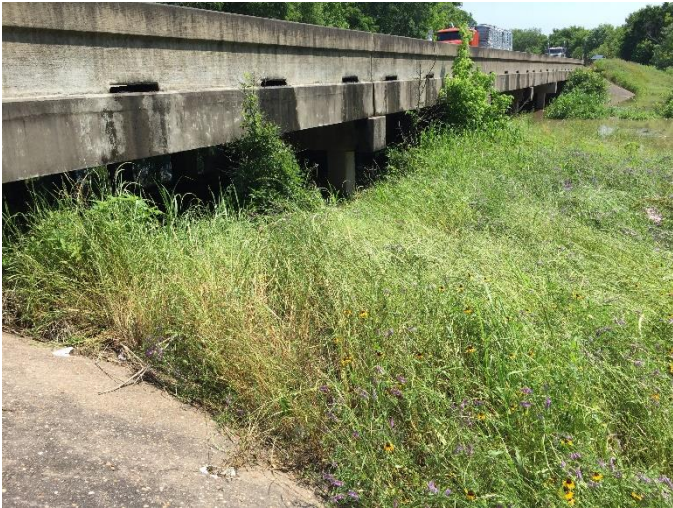
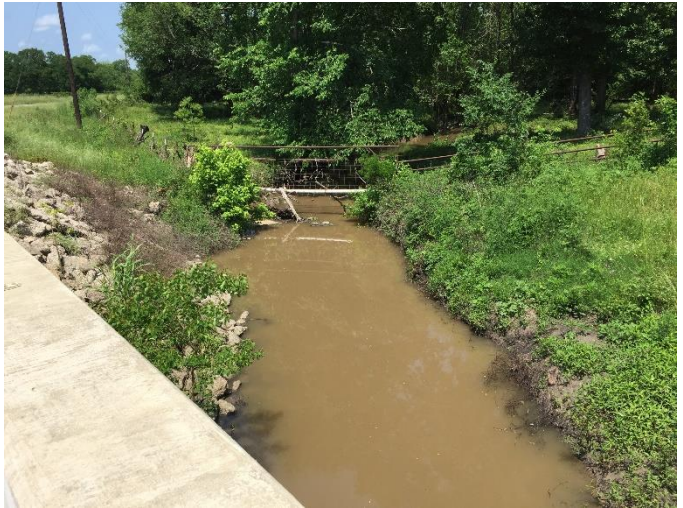
OBJECTID: 137036_d	Face of bridge on downstream side of FM 149 between CR 216 and Lynn St.	OBJECTID: 137037_a	View of channel upstream of bridge Johnson Rd. between FM1486 and Bethel Rd.

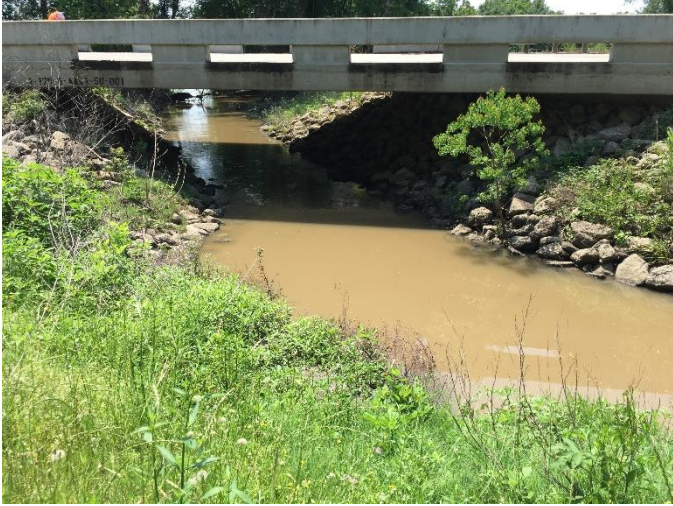
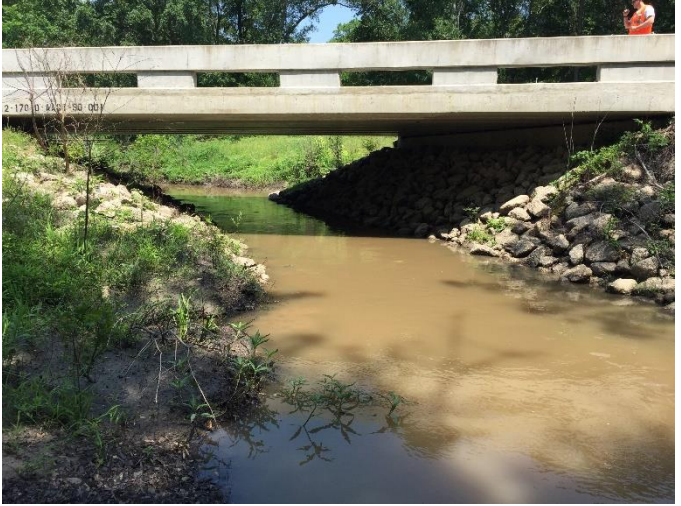
Stream: Lake Creek (GLC)		Field Grid: N/A		HMS Subbasin:	
OBJECTID: 137037_b	Face of bridge on upstream side of Johnson Rd. between FM1486 and Bethel Rd.	OBJECTID: 137431_a	Face of bridge on downstream side of Johnson Rd. between FM1486 and Bethel Rd.

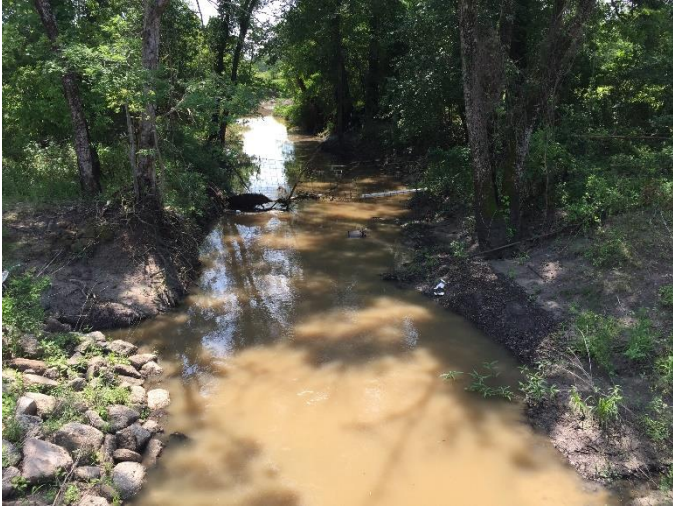
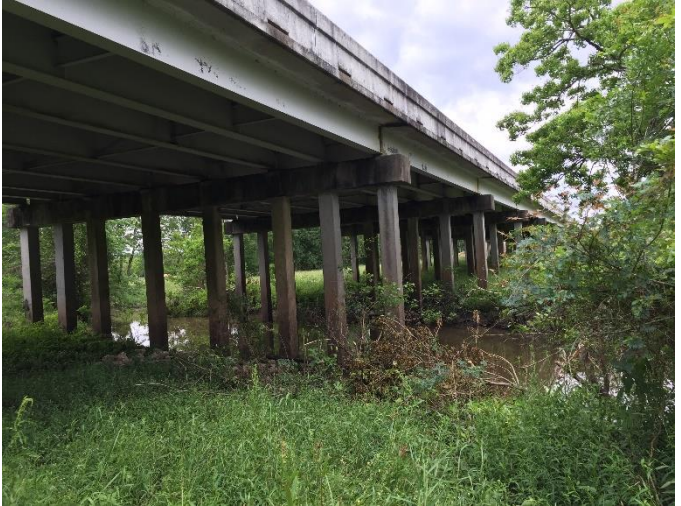
OBJECTID: 137431_b	View of channel downstream of bridge Johnson Rd. between FM1486 and Bethel Rd.	OBJECTID: 137038_a	Face of bridge on downstream side of TX-105 between FM1486 and Pooles Rd.

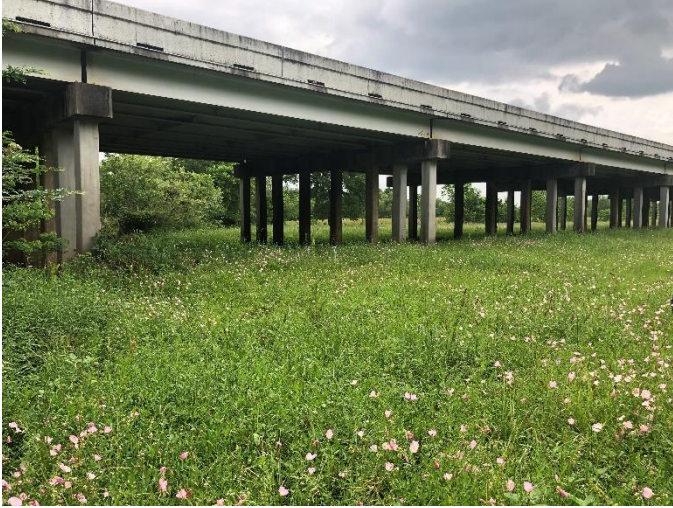
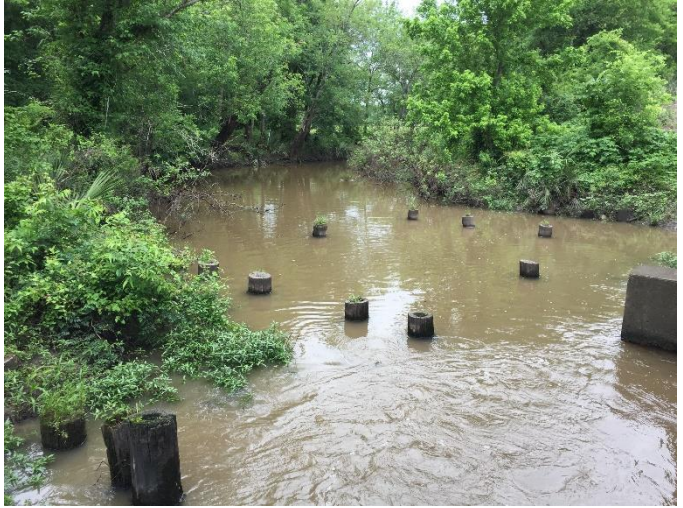
Stream: Lake Creek (GLC)		Field Grid: N/A		HMS Subbasin:	
OBJECTID: 137436_c	Face of bridge on upstream side of TX-105 between FM1486 and Pooles Rd.	OBJECTID: 137432_a	View of channel upstream of railroad bridge, upstream of Old Dobbin Rd.

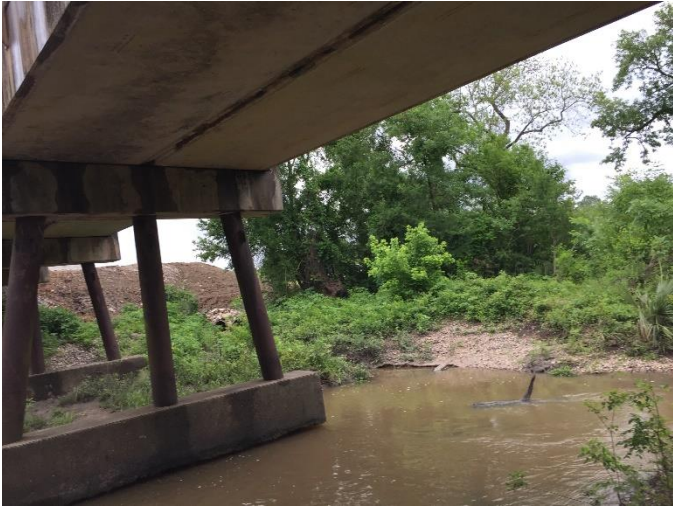
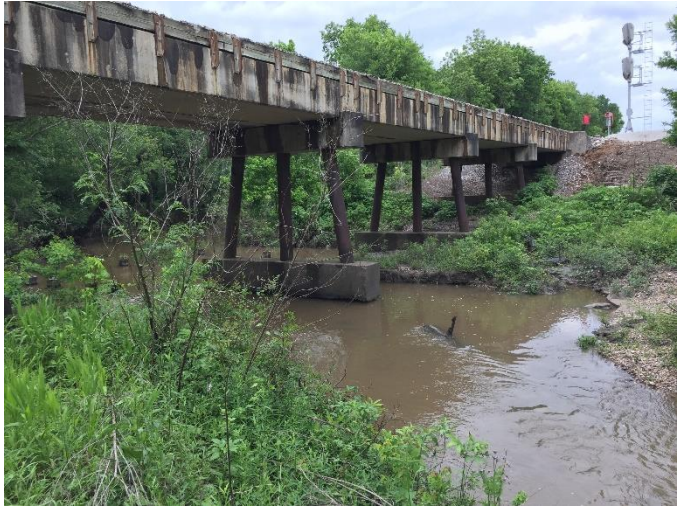
OBJECTID: 137432_b	Face of bridge on upstream side of railroad bridge, upstream of Old Dobbin Rd.	OBJECTID: 137039_a	Face of bridge on downstream side of railroad bridge, upstream of Old Dobbin Rd.

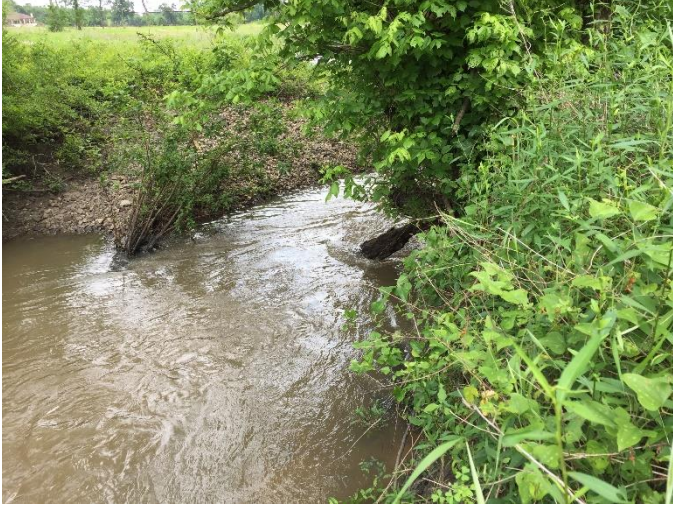
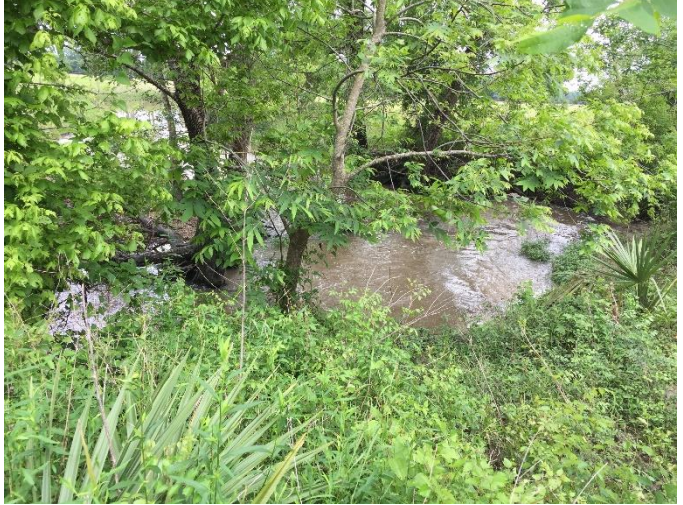
Stream: Lake Creek (GLC)		Field Grid: N/A		HMS Subbasin:	
OBJECTID: 137039_b	View of channel upstream of railroad bridge, downstream of Old Dobbin Rd.	OBJECTID: 137039_c	View of channel upstream of railroad bridge, downstream of Old Dobbin Rd.

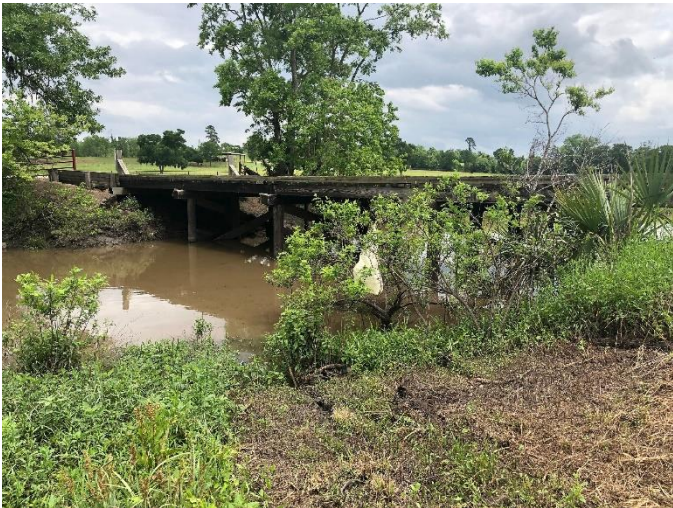
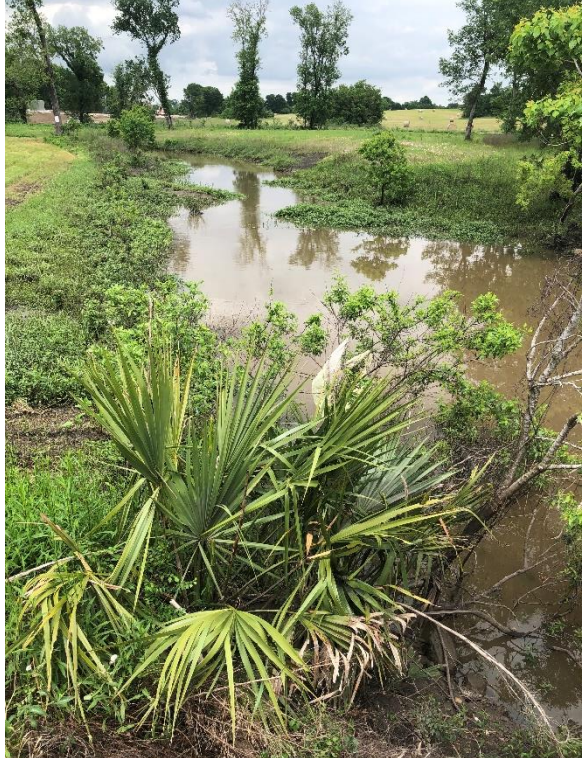
OBJECTID: 137829_a	Face of bridge on upstream side of Old Dobbin Rd. between Dobbin Rd. and St. Beulah Chapel Rd.	OBJECTID: 137829_b	View of channel upstream of railroad bridge, downstream of Old Dobbin Rd. between Dobbin Rd. and St. Beulah Chapel Rd.

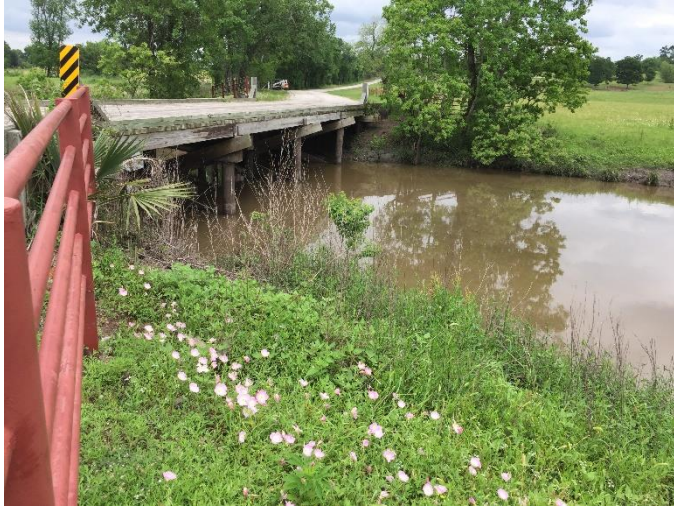
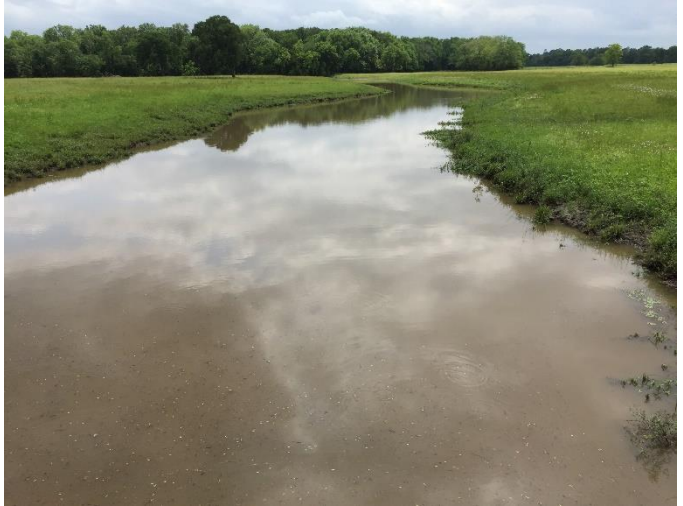
Stream: Lake Creek (GLC)		Field Grid: N/A		HMS Subbasin:	
OBJECTID: 137433_a	Face of bridge on downstream side of Old Dobbin Rd. between Dobbin Rd. and St. Beulah Chapel Rd.	OBJECTID: 137433_b	View of channel downstream of Old Dobbin Rd. between Dobbin Rd. and St. Beulah Chapel Rd.

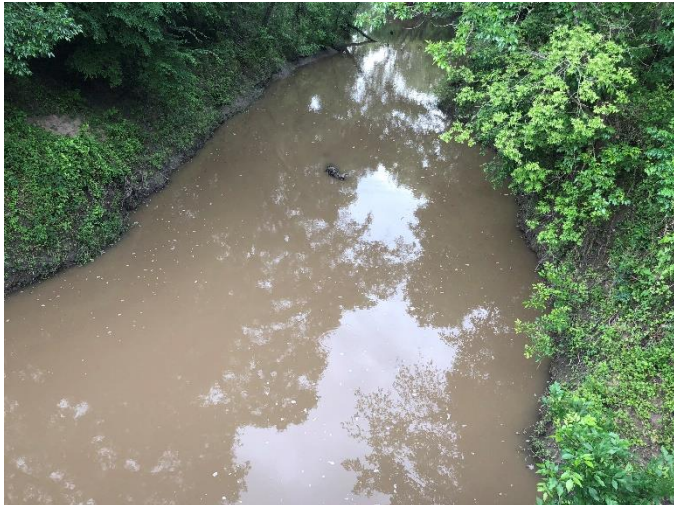
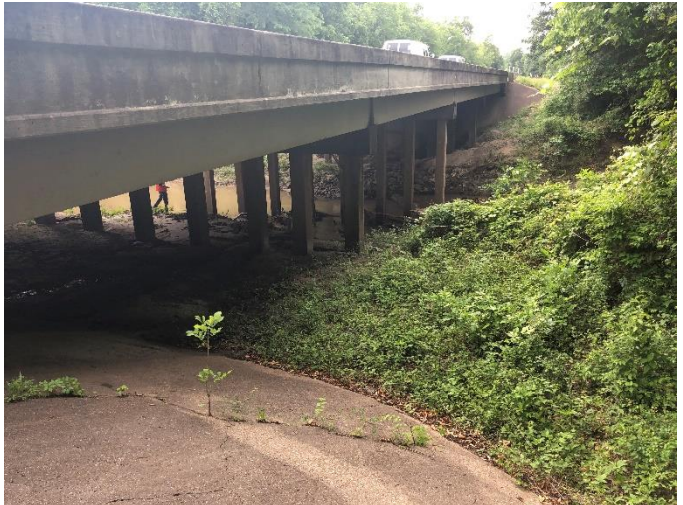
OBJECTID: 137437_a	View of channel downstream of FM 149 between Stillwater Ct. and Mitchell Rd.	OBJECTID: 137437_b	Face of bridge on downstream side of FM 149 between Stillwater Ct. and Mitchell Rd.

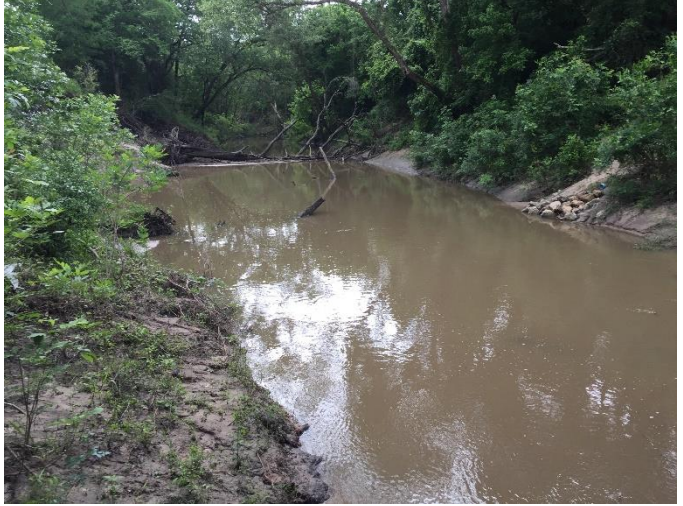
OBJECTID: 137040_c	View of channel beneath FM 149 between Stillwater Ct. and Mitchell Rd. Evident sedimentation and erosion.	OBJECTID: 137041_a	View of channel upstream of Superior Rd between Corporate Wood Dr. and Pal Metta Ln.

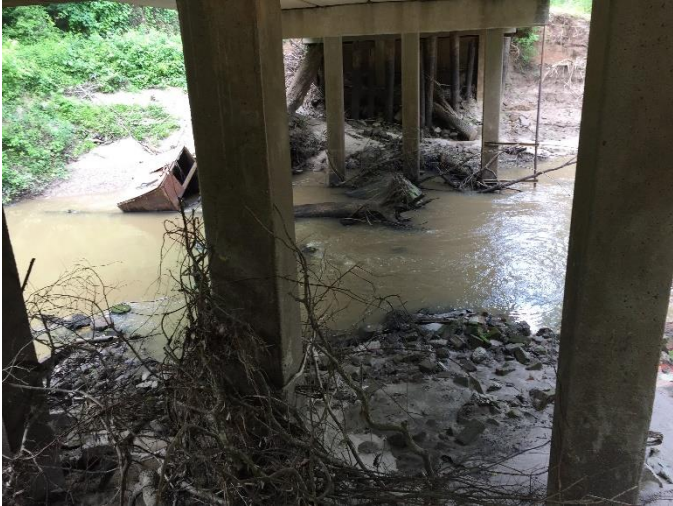
OBJECTID: 137434_c	View of channel beneath Honea Egypt Rd. between S Trace Dr. and Mulligan Dr.	OBJECTID: 137438_a	Face of bridge on downstream side of Honea Egypt Rd. between S Trace Dr. and Mulligan Dr.

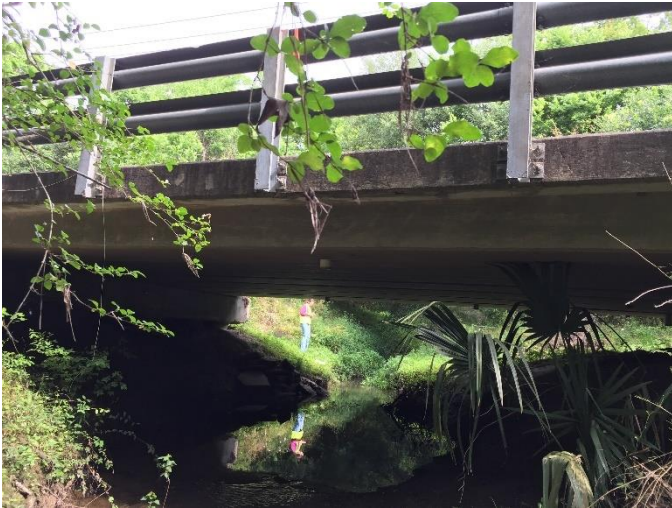
Stream: Jackson Bayou (R100-00-00)		Field Grid: N/A	HMS Subbasin:
OBJECTID: 136217_b	View of downstream face of bridge on E Stroker Rd. between Crosby Huffman Rd. and Miller Wilson Rd.	OBJECTID: 136218_a	View of upstream face of culvert on south side of E Stroker Rd. between Crosby Huffman Rd. and Miller Wilson Rd. 7' diameter non corrugated metal pipe.

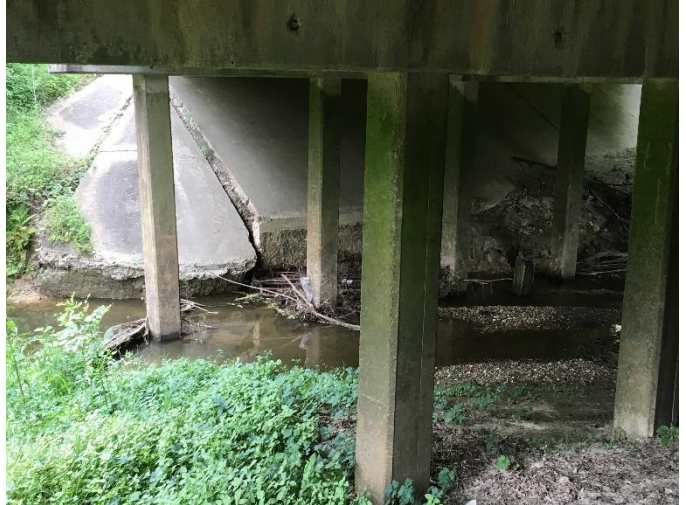
OBJECTID: 135814_b	View of channel upstream of bridge on Crosby Huffman Rd. between Gum Gully Rd and Reidland Rd.	OBJECTID: 135814_c	View of underside of bridge on Crosby Huffman Rd. between Gum Gully Rd and Reidland Rd. Evident erosion and uneven settling of abutments.

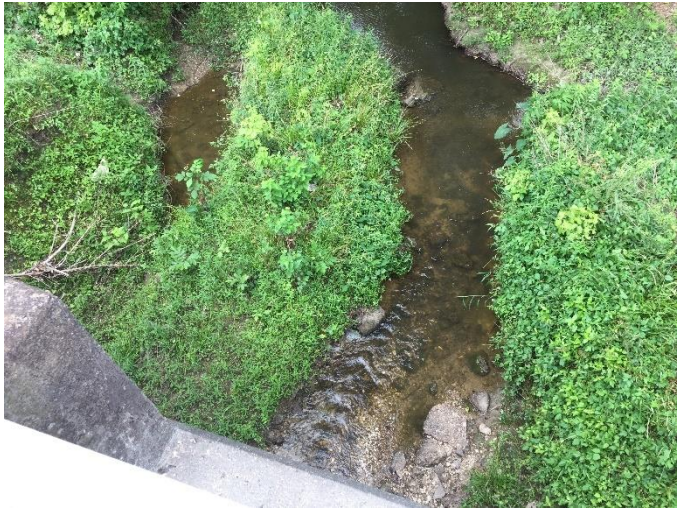
OBJECTID: 135815_c	View of downstream face of bridge on Crosby Huffman Rd. between Gum Gully Rd and Reidland Rd.	OBJECTID: 135815_d	View of channel downstream of bridge on Crosby Huffman Rd. between Gum Gully Rd and Reidland Rd. Light channel vegetation and sedimentation.

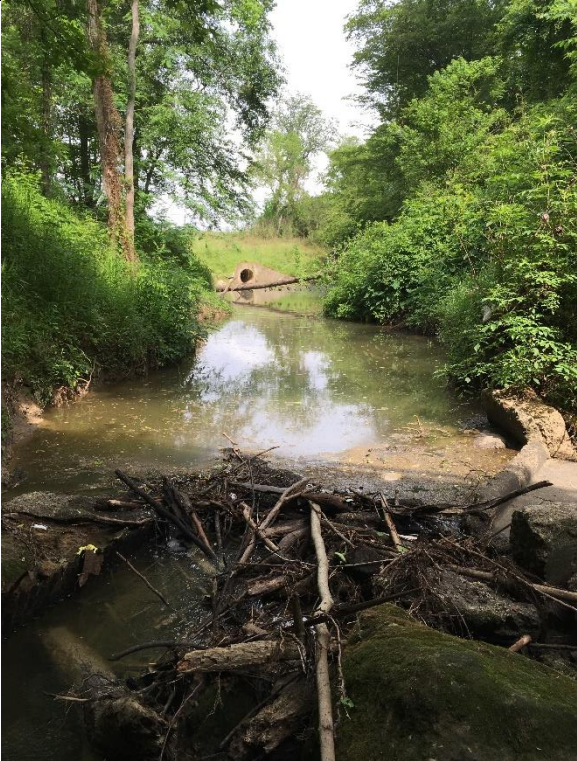
OBJECTID: 136224_d	View of channel upstream of bridge on N Diamondhead Blvd. between Port O Call St. and Yacht Ct. Substantial channel debris.	OBJECTID: 136224_e	View of upstream face of bridge on N Diamondhead Blvd. between Port O Call St. and Yacht Ct.

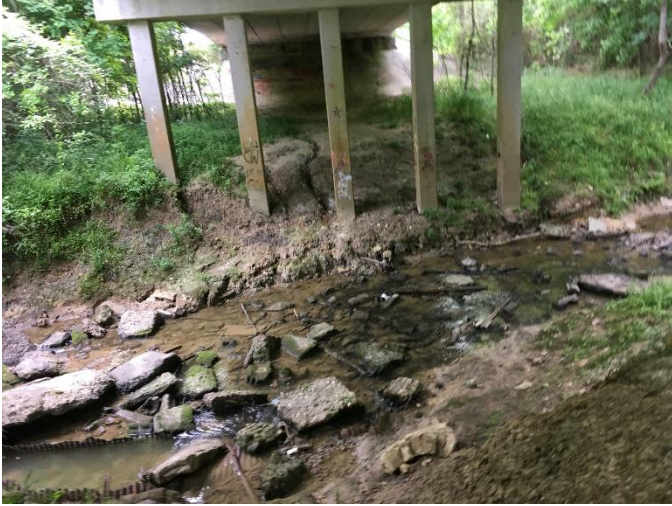
Stream: Jackson Bayou (R100-00-00)		Field Grid: N/A	HMS Subbasin:
OBJECTID: 136224_f	View of underside of bridge on N Diamondhead Blvd. between Port O Call St. and Yacht Ct. Evident erosion along banks.	OBJECTID: 136223_a	View of channel downstream of bridge on N Diamondhead Blvd. between Port O Call St. and Yacht Ct.

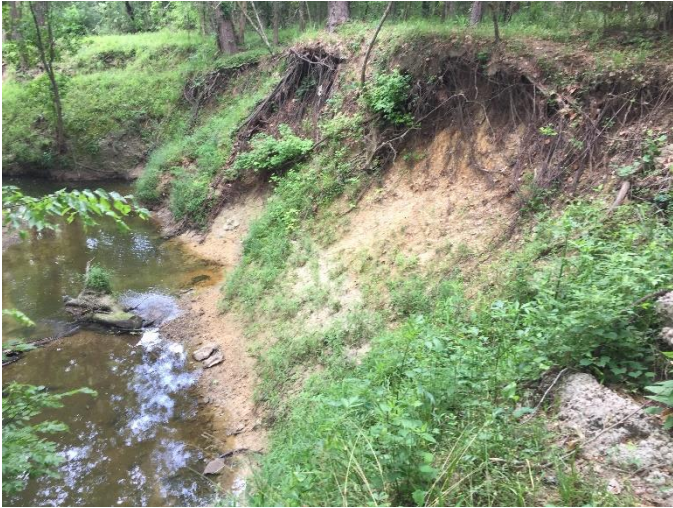
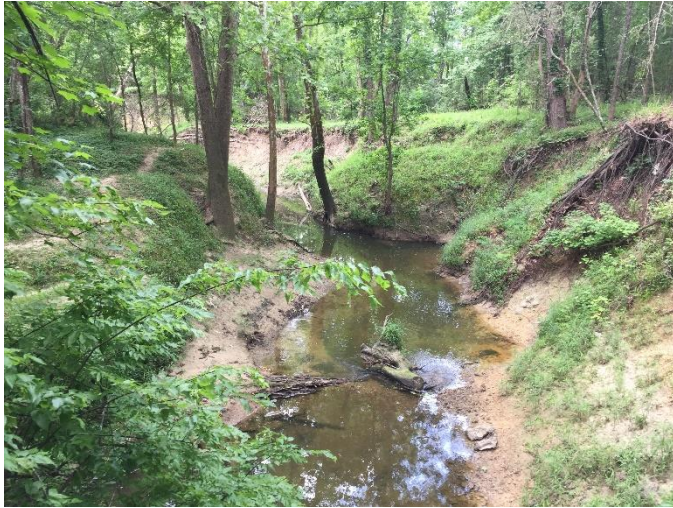
OBJECTID: 136227_c	View of channel banks downstream of culvert on Flying Bridge Way between Broken Back Dr. and Yeoman Way. Significant erosion.	OBJECTID: 136227_d	View of channel banks downstream of culvert on Flying Bridge Way between Broken Back Dr. and Yeoman Way. Significant erosion.

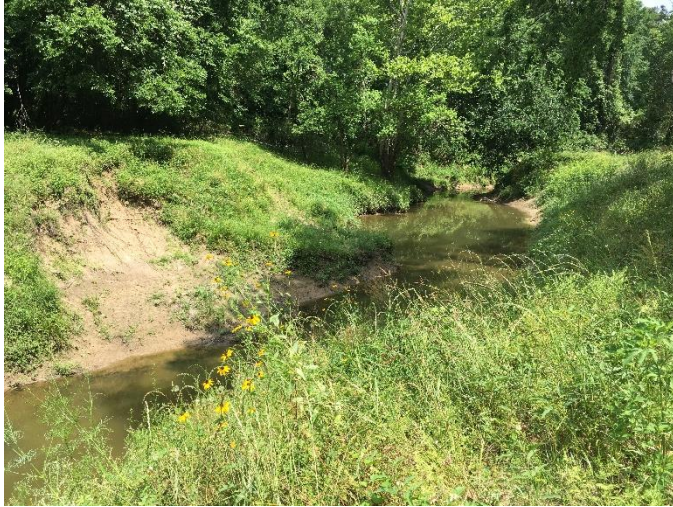
Stream: Jackson Bayou (R100-00-00)		Field Grid: N/A	HMS Subbasin:
OBJECTID: 138229_b	View of downstream face of culvert southwest of Backstay Ct. and east of Golf Club Dr. Culvert is 6'W x 5'H with 2 barrels.	OBJECTID: 138630_a	View of channel upstream of culvert on Stem Way Dr. between W Kingscoate Dr. and Taffrail Way. Evident erosion on bank.

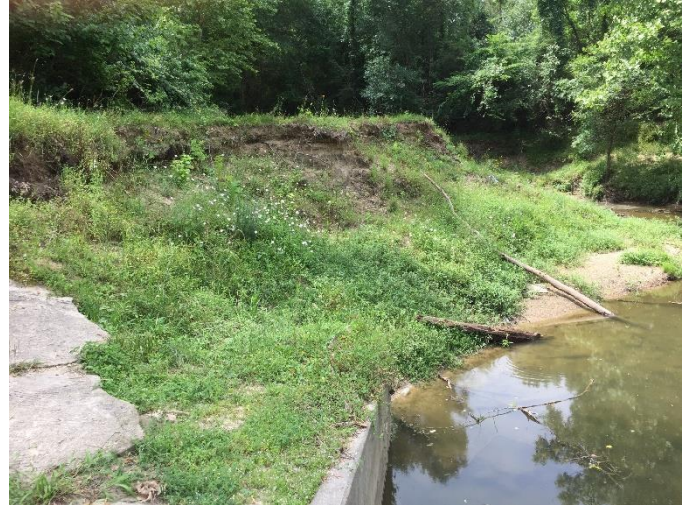
Stream: Jackson Bayou (R100-00-00)		Field Grid: N/A		HMS Subbasin:			
OBJECTID: 138230_b		View of downstream face of culvert southwest of Backstay Ct. and east of Golf Club Dr. Culvert is 4'W x 6'H with 3 barrels.		OBJECTID: 138230_c		View of channel downstream of culvert on Stem Way Dr. between W Kingscoate Dr. and Taffrail Way. Evident erosion on banks.

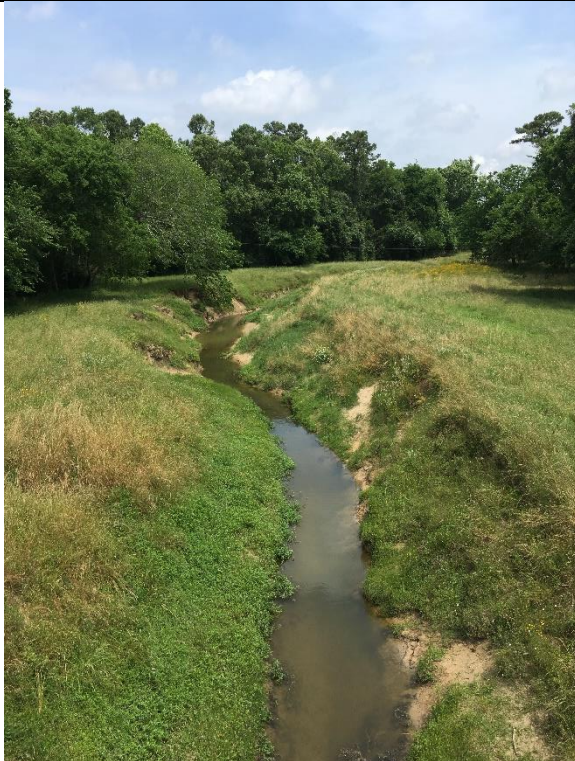
OBJECTID: 138631_a		View of channel upstream of bridge on S Diamondhead Blvd between Golf Club Dr. and Afore Dr.		OBJECTID: 138631_b		View of channel upstream of bridge on S Diamondhead Blvd between Golf Club Dr. and Afore Dr. Evident bank erosion.

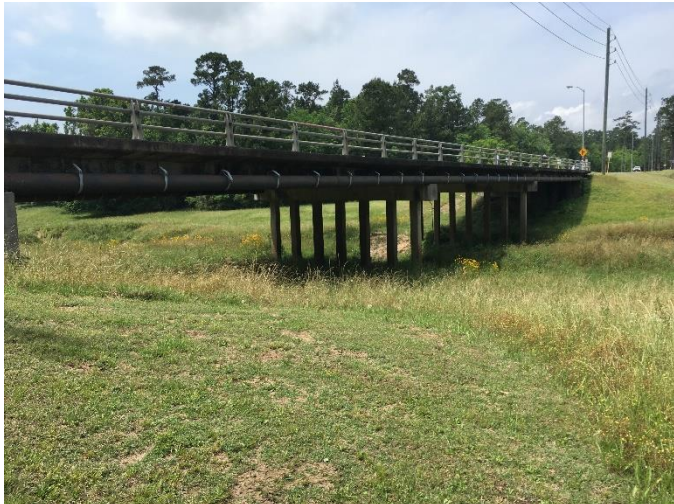
Stream: Jackson Bayou (R100-00-00)		Field Grid: N/A		HMS Subbasin:	
OBJECTID: 138631_c	View of upstream face of bridge on S Diamondhead Blvd between Golf Club Dr. and Afore Dr.	OBJECTID: 138631_d	View of channel upstream of bridge on S Diamondhead Blvd between Golf Club Dr. and Afore Dr. Evident bank erosion.

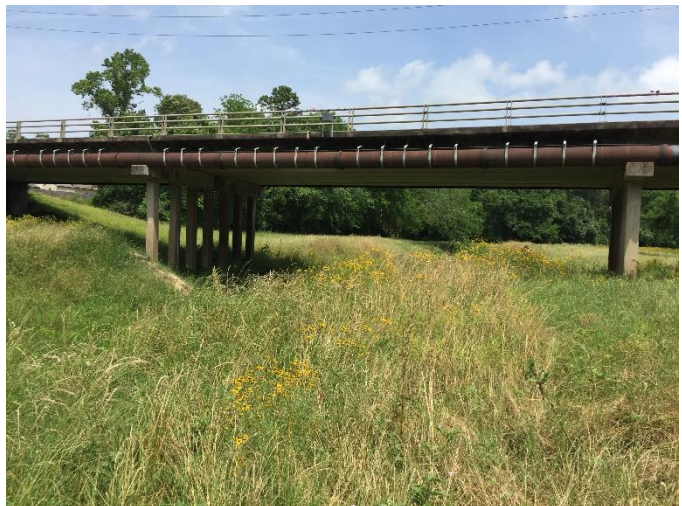
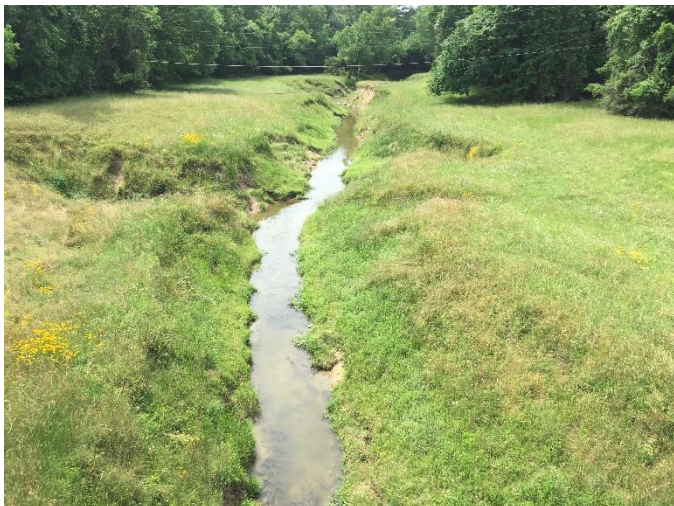
OBJECTID: 138231_a	View of channel downstream of bridge on S Diamondhead Blvd between Golf Club Dr. and Afore Dr. Evident bank erosion.	OBJECTID: 138231_b	View of downstream face of bridge on S Diamondhead Blvd between Golf Club Dr. and Afore Dr.

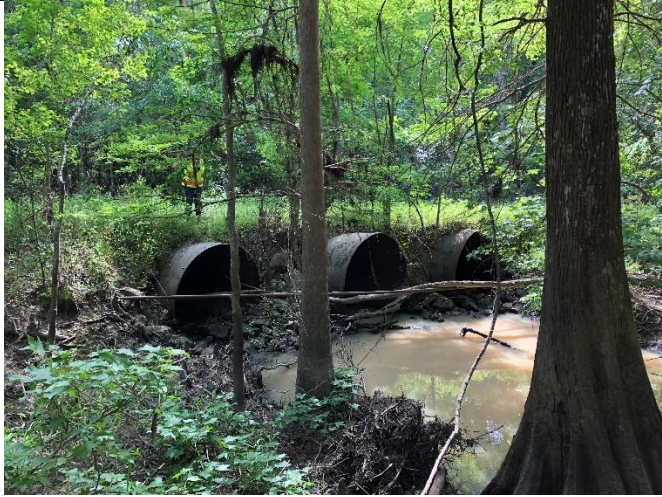
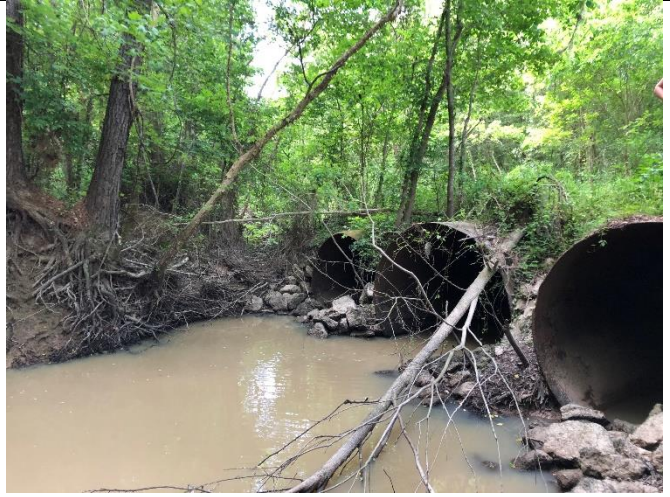
Stream: STB		Field Grid: T-2	HMS Subbasin:
OBJECTID: 386	Upstream of the crossing at FM 1960.	OBJECTID: 390	Downstream face of culvert

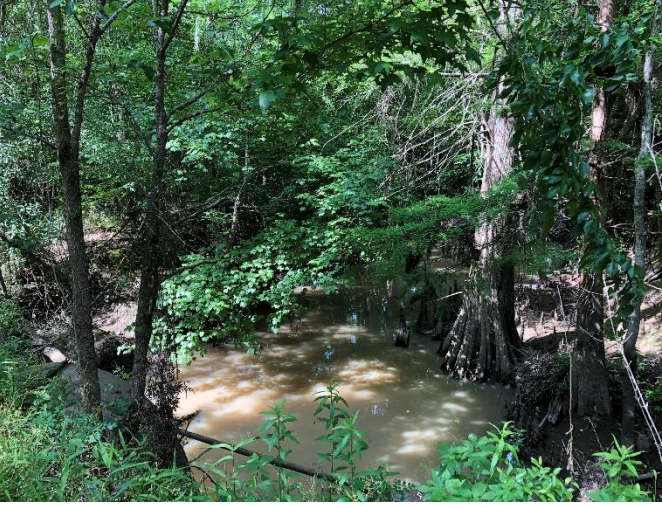
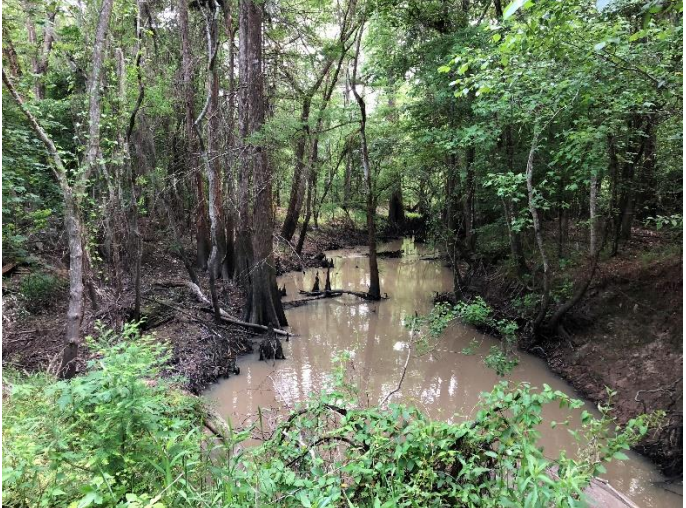
OBJECTID: 385	Channel looking upstream of culvert	OBJECTID: 389	Channel looking downstream of culvert

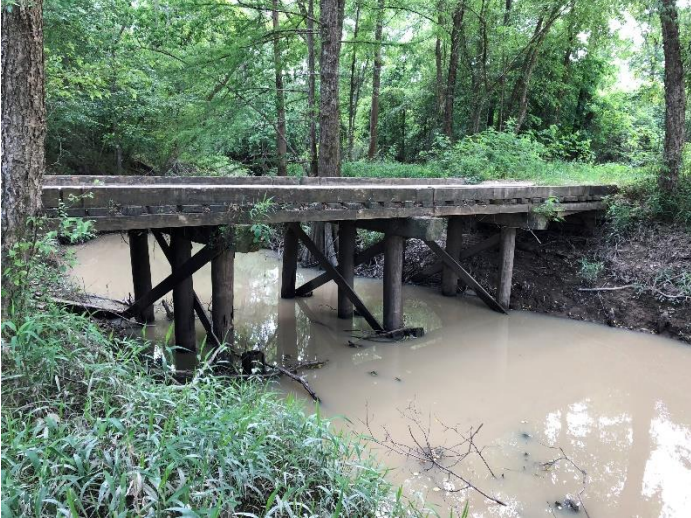
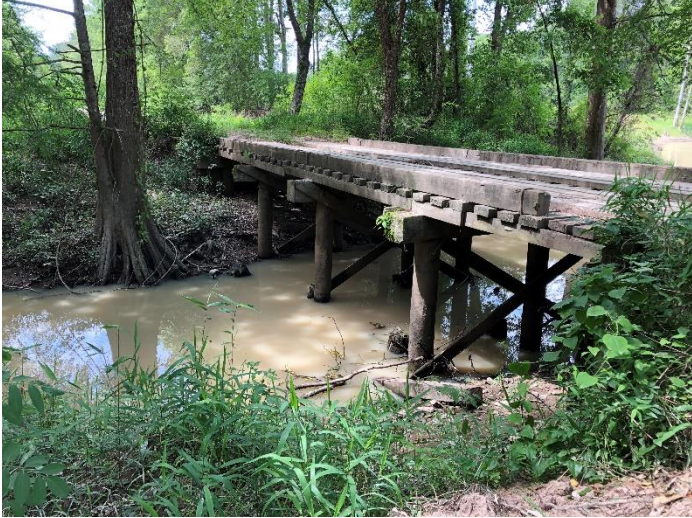
Stream: STB		Field Grid: T-4	HMS Subbasin:
OBJECTID: 399	Upstream face of County Rd. 331 bridge.	OBJECTID: 400	Downstream face of County Rd. 331 bridge.

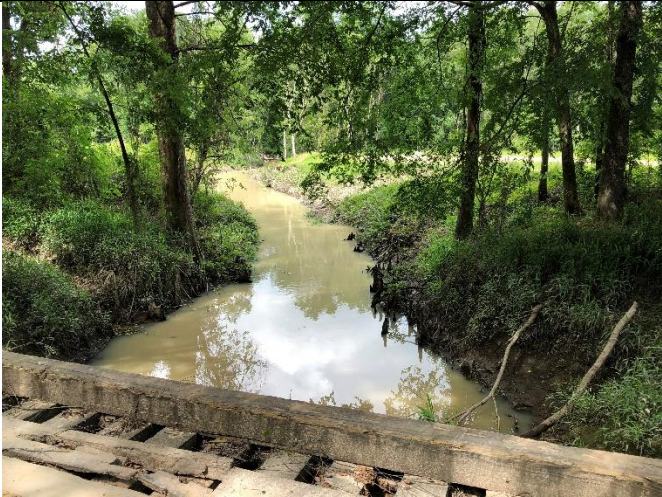
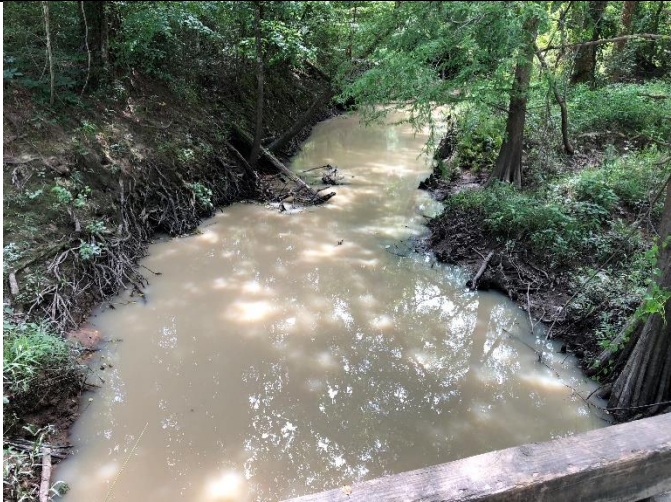
OBJECTID: 401	Channel upstream of County Rd. 331 bridge.	OBJECTID: 402	Channel downstream of the County Rd. 331 bridge

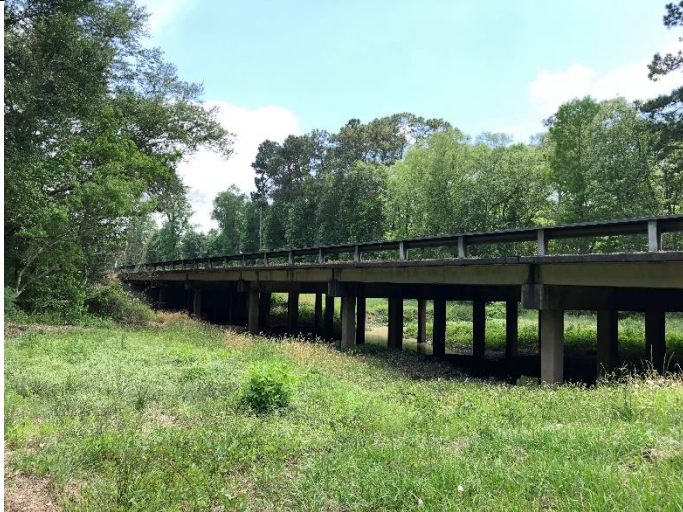
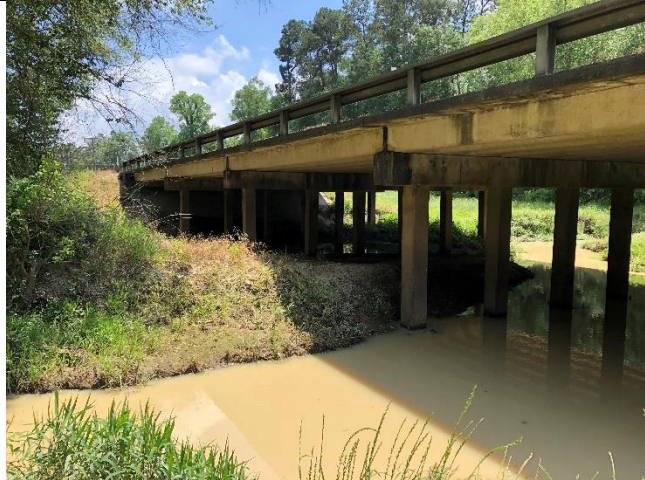
Stream: STB		Field Grid: T-5	HMS Subbasin:
OBJECTID: 404	Upstream face of FM 321 bridge.	OBJECTID: 406	Upstream face of FM 321 bridge.

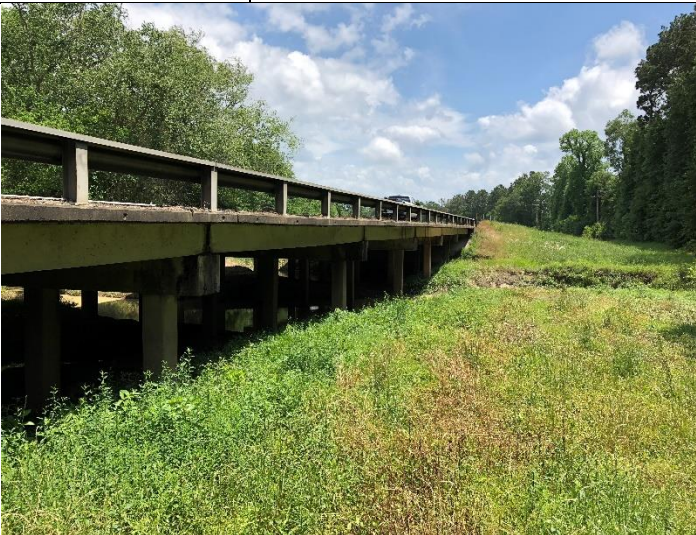
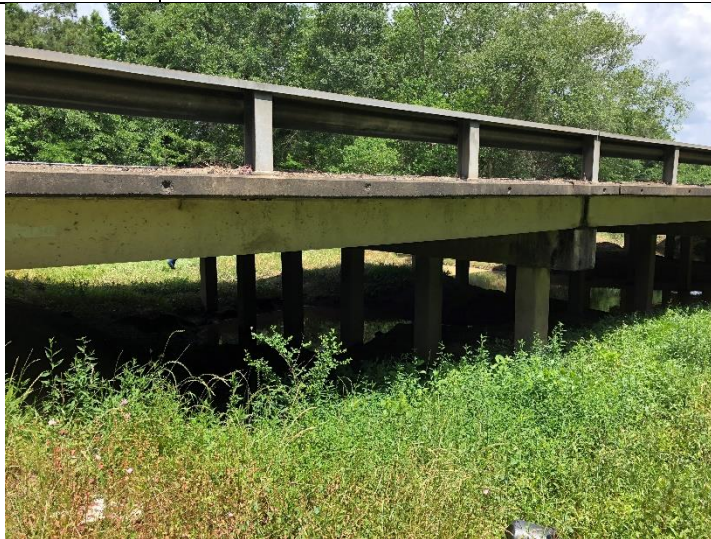
OBJECTID: 408	Downstream face of FM 321 bridge.	OBJECTID: 407	Quality of FM 321 bridge.

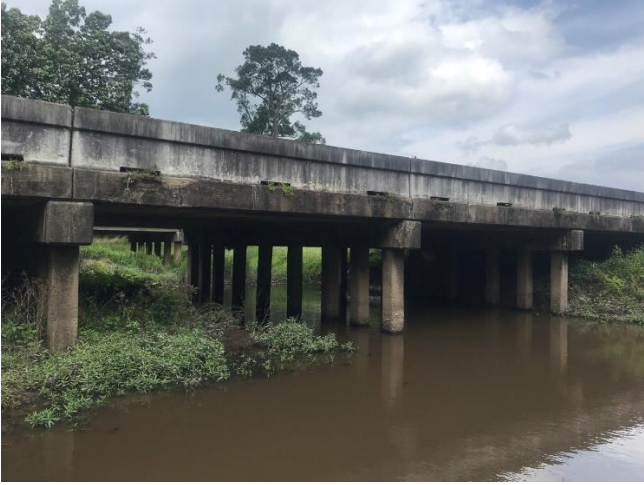
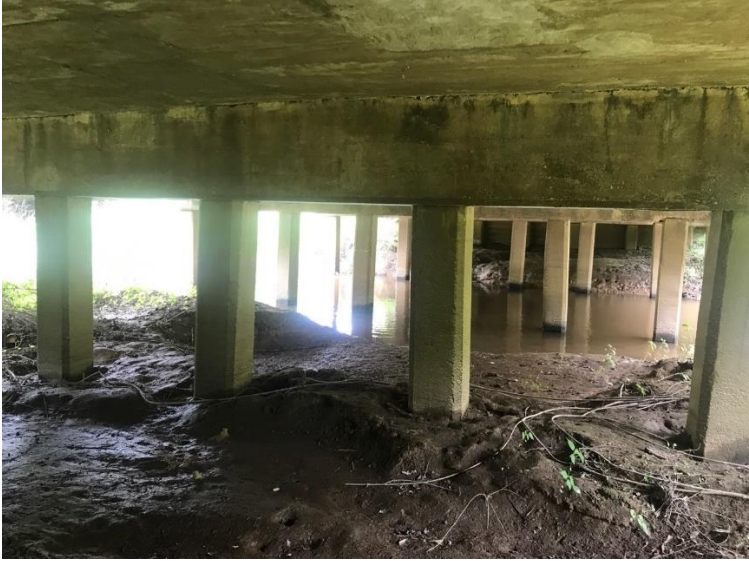
Stream: STB		Field Grid: T-12	HMS Subbasin: Q112C
OBJECTID: 317	Downstream face of Highway 59 bridge.	OBJECTID: 318	Underneath Highway 59 bridge.

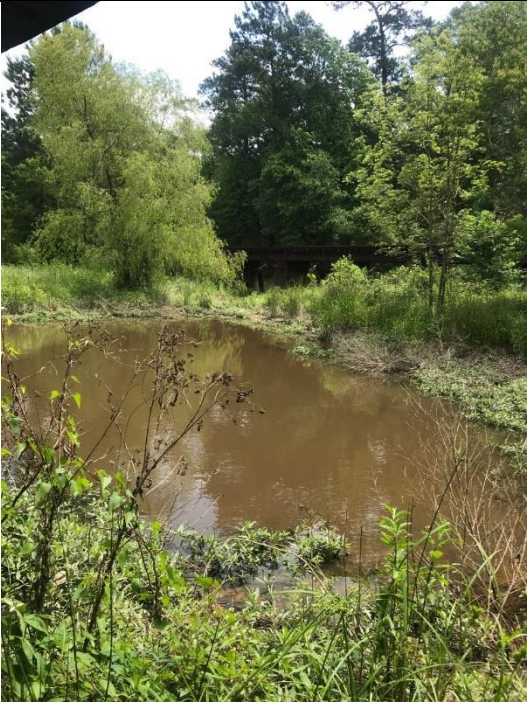
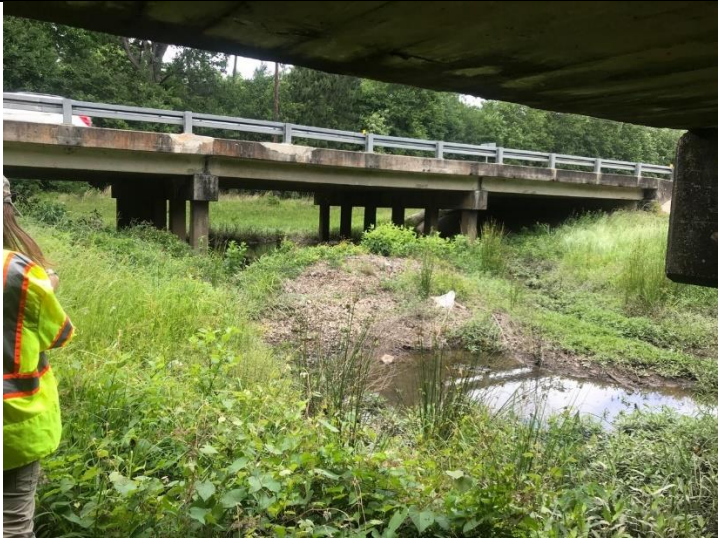
OBJECTID: 319	Looking downstream from Highway 59 bridge.	OBJECTID: 320	Looking upstream from Highway 59 bridge.

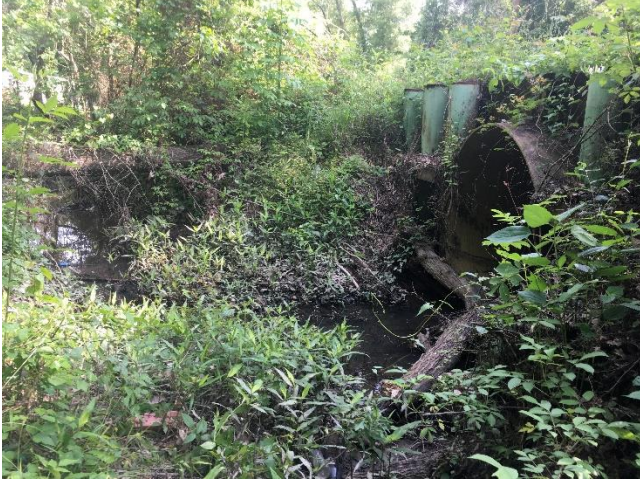
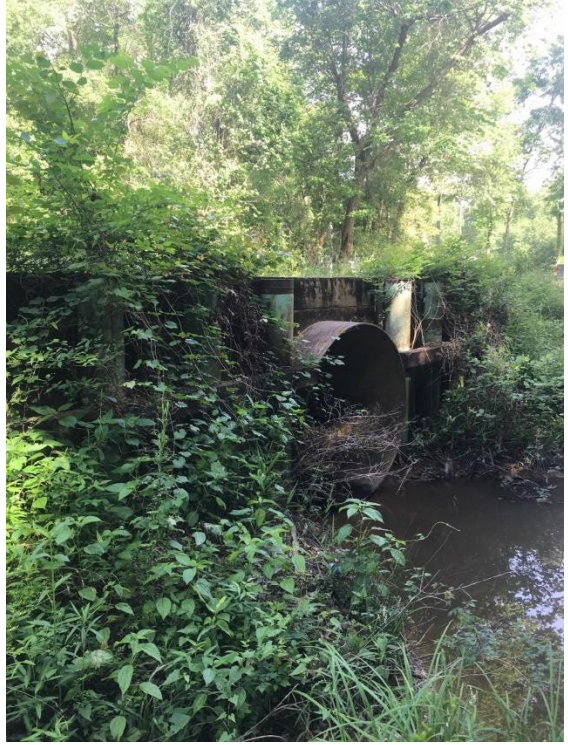
Stream: STB		Field Grid: T-14	HMS Subbasin:
OBJECTID: 335	Upstream face of Little John St. culvert.	OBJECTID: 333	Downstream face of Little John St. culvert.
