REGIONAL WATERSHED MASTER DRAINAGE PLAN

APPENDIX B DATA COLLECTION AND REVIEW

**San Jacinto Regional Watershed
Master Drainage Plan**

**Halff Associates, Inc.
TBPE Firm Registration No. 312**

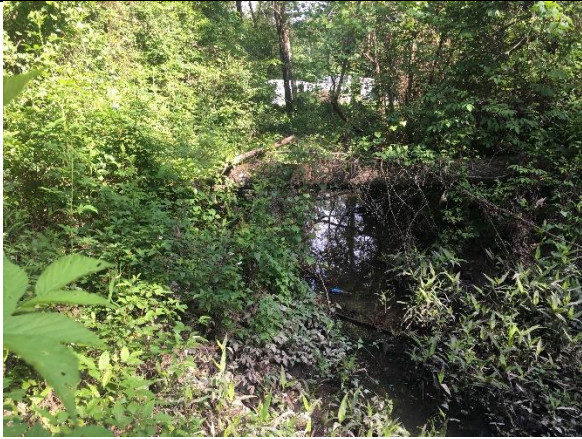
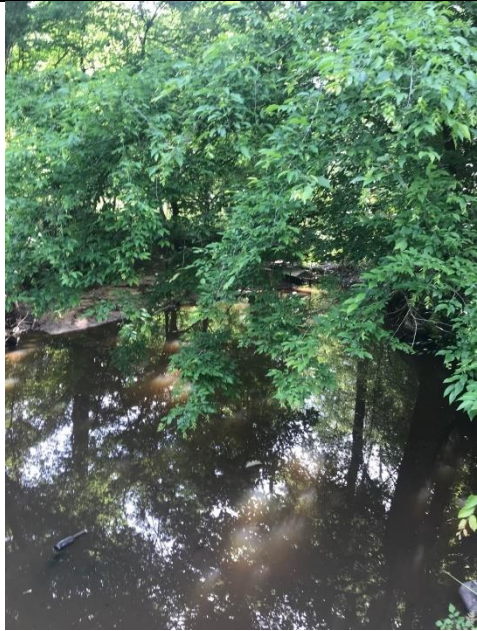
OBJECTID: 334	Channel looking upstream from Little John St. culvert.	OBJECTID: 331	Channel looking downstream from Little John St. culvert.

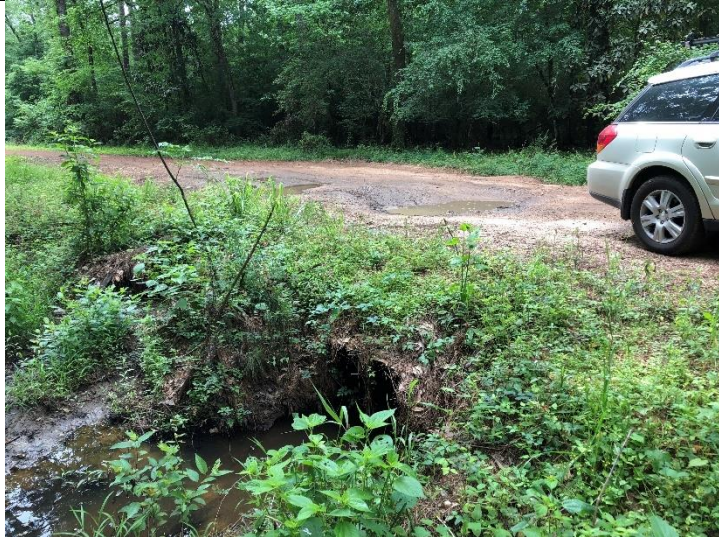
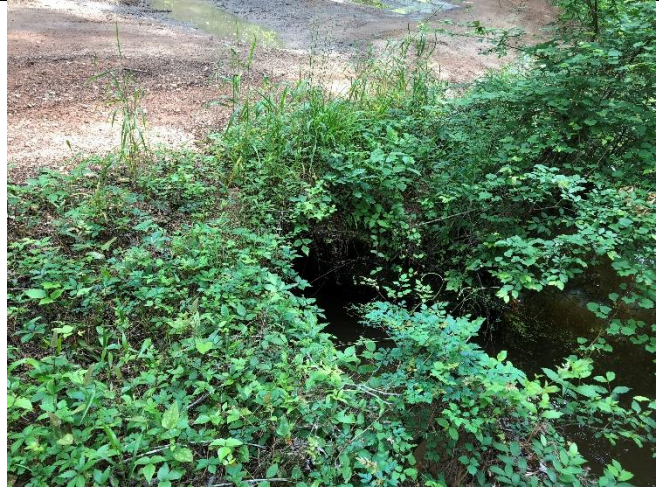
Stream: STB		Field Grid: T-23		HMS Subbasin:			
OBJECTID: 382		Upstream face of Forest Service Rd. 221 culvert.		OBJECTID: 333		Downstream face of Forest Service Rd. 221 culvert.
